**INITIAL REPORT ON THE  
POWER OUTAGES IN  
NORTHWEST QUEENS  
IN JULY 2006**

**AUGUST 2, 2006**

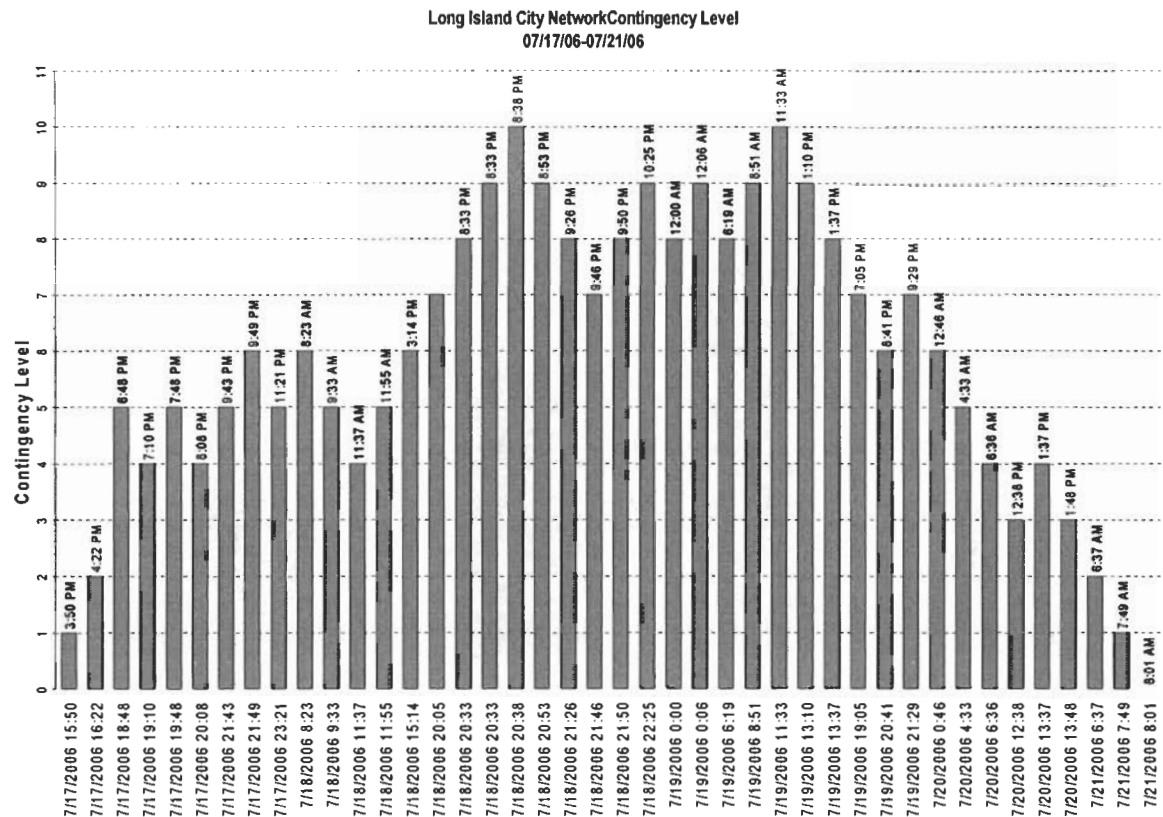
**Figure 6 – LIC Network Contingency Level**

The LIC network experienced two 10th, six 9th, six 8th, four 7th, five 6th, seven 5th, five 4th, two 3rd, two 2nd, and two 1st contingency levels of various duration between July 17 and July

23. Figure 6, illustrates the levels of contingency sustained by the LIC network through the course of this event.

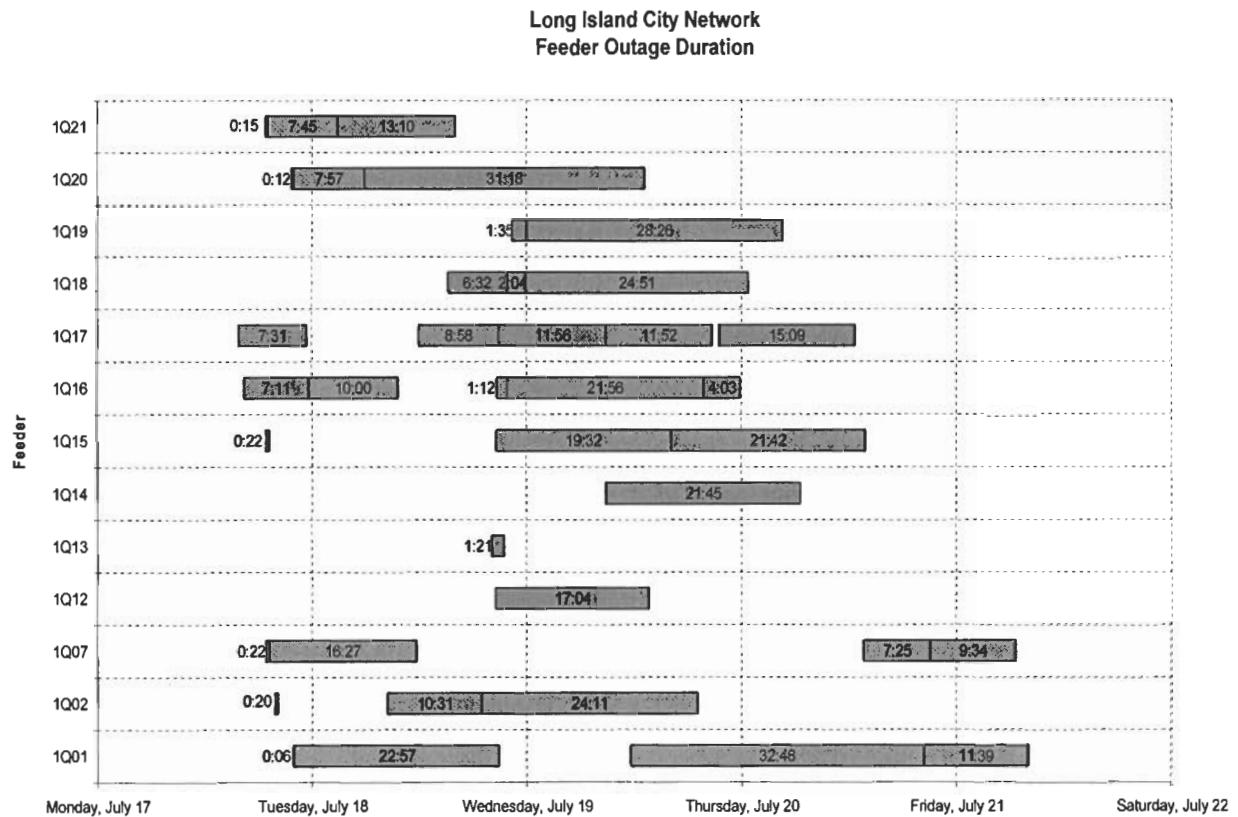
**Figure 7 – LIC Network Feeder Outage Duration**

The following Gantt chart, Figure 7, illustrates the various duration of feeder outages in the LIC network between 15:50 on Monday July 17 and 08:00 on Friday July 22.

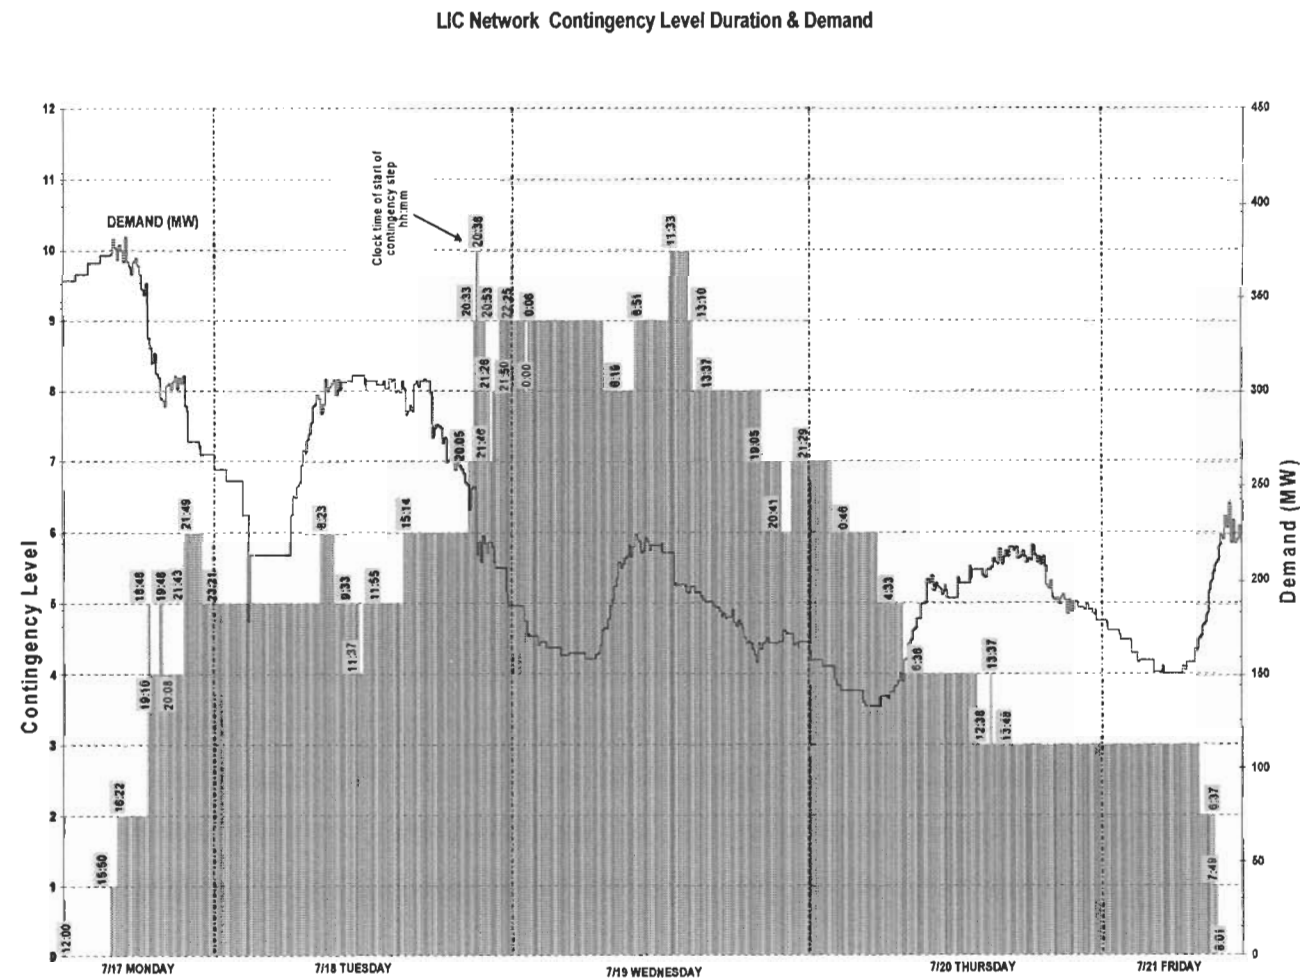
**Figure 8 – LIC Network Contingency & Demand**

Figure 8 shows the LIC network demand variation with the network contingencies experienced during the course of this event between 00:00 on Monday, July 17, and 09:00 on Friday, July 22.

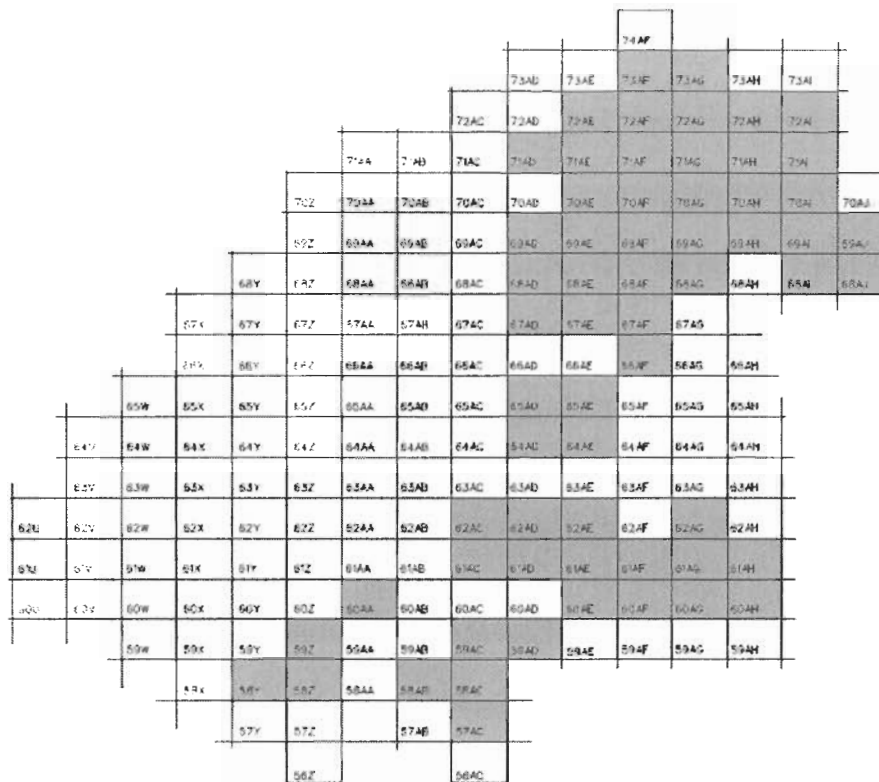
**Figure 11: Graphical Display of LIC Network Depicting Affected Areas**

The restoration progress within zones was further divided by M&S plates. The plates were categorized by customer outages into lead and adjacent plates. Zone 1 was grouped by 17 M&S plates, with 8,446 estimated customer outages. Zone 2 was grouped by 27 M&S plates with 10,049 customer outages. Zone 3 was grouped by 18 M&S plates with 6,570 customer outages. Figure 11 illustrates the tracking of the outage area in the LIC network by M&S Plates. Restoration was prioritized by targeting M&S plates that had the greatest numbers of customers interrupted, affording the opportunity to restore the greatest number of customers in the least amount of time.

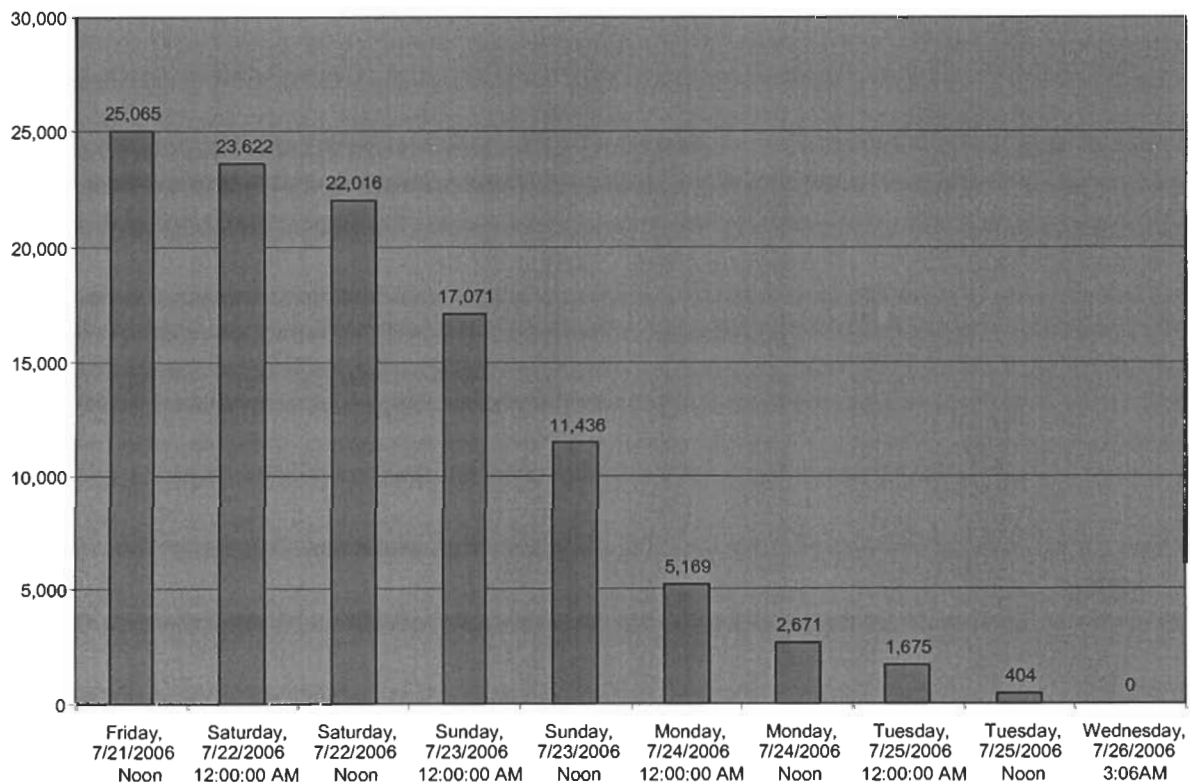
**Figure 12: Display of Customer Outage by Date**

Figure 12 below represents the restoration progress beginning Friday, July 21, 2006. All customers were restored by Wednesday, July 25, at 03:06.

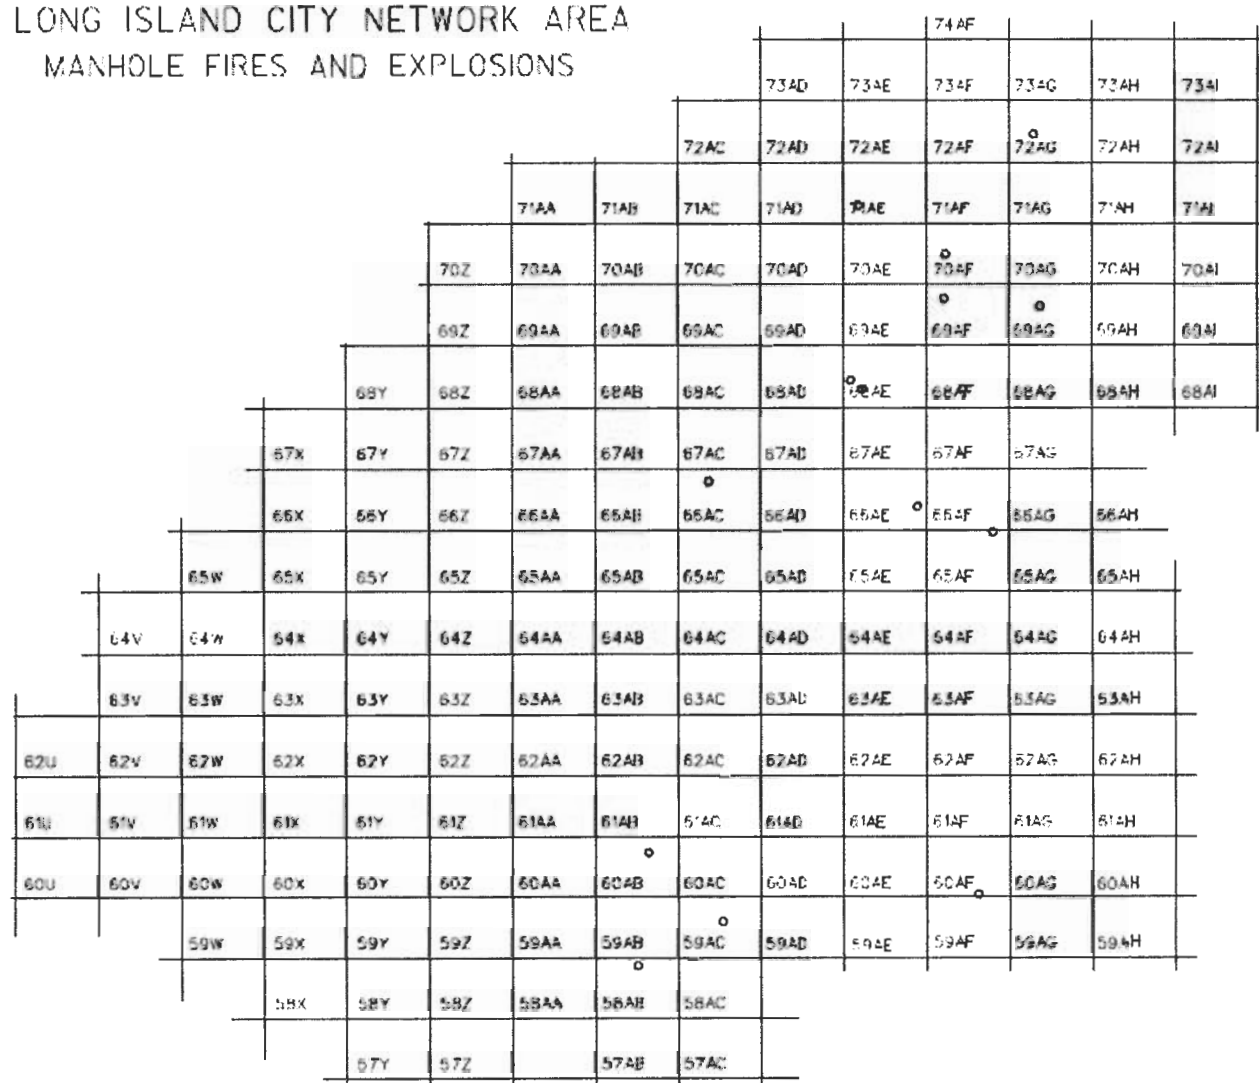
**Figure 13: Figure Depicting Locations of Manhole Fires and Explosions in LIC Network**

From Monday, July 17, to Friday, July 21, there were a total of 91 manhole events in LIC network – two manhole explosions and 16 manhole fires, as shown in Figure 13, and 73 smoking manholes, as shown in Figure 14.
