Steam Pipeline Rupture Con Edison Steam System

*41st Street & Lexington Ave.
July 18, 2007*

*PSC Session Presentation
February 13, 2008*

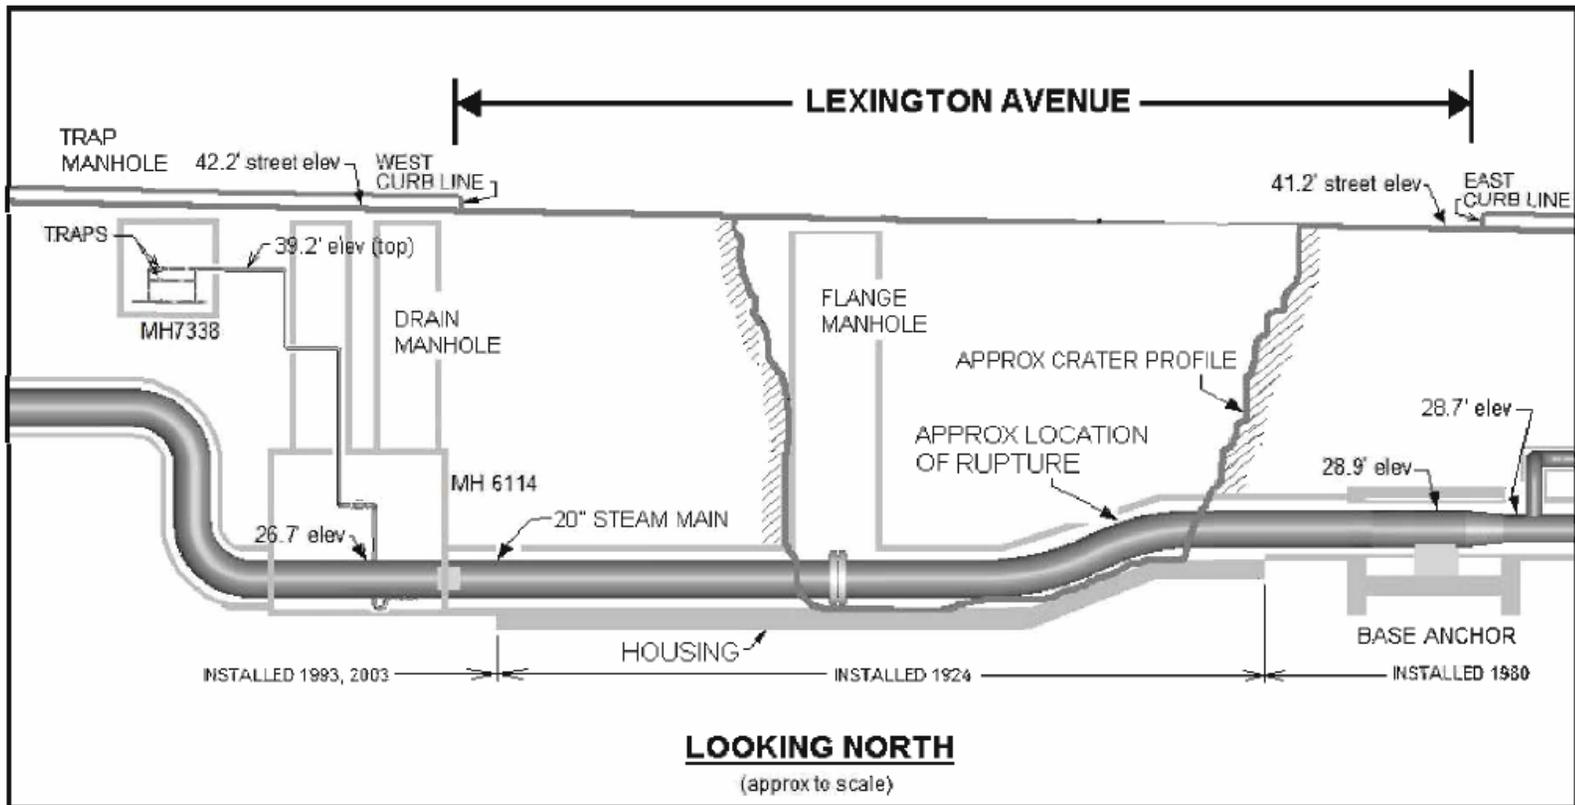
Figure 1-2: Elevation View of Steam Main Beneath Lexington Avenue

Steam Main Profile

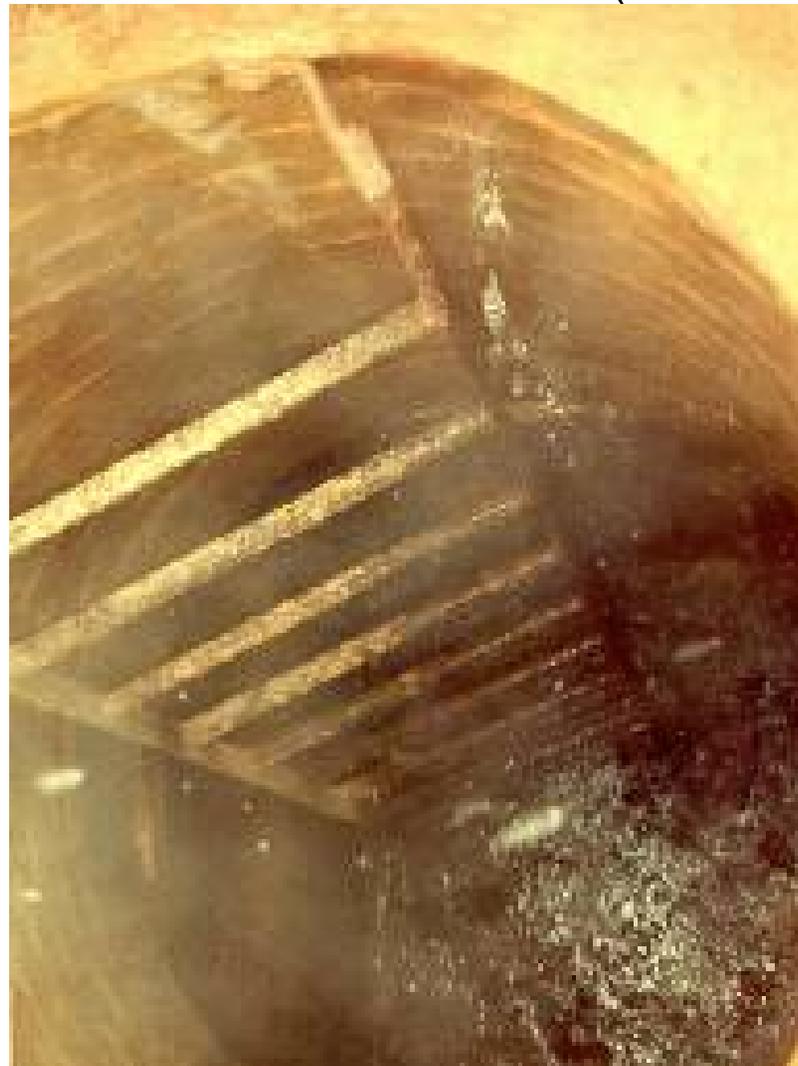
Illustration of Manhole Vapor Condition

Not a Con Edison manhole

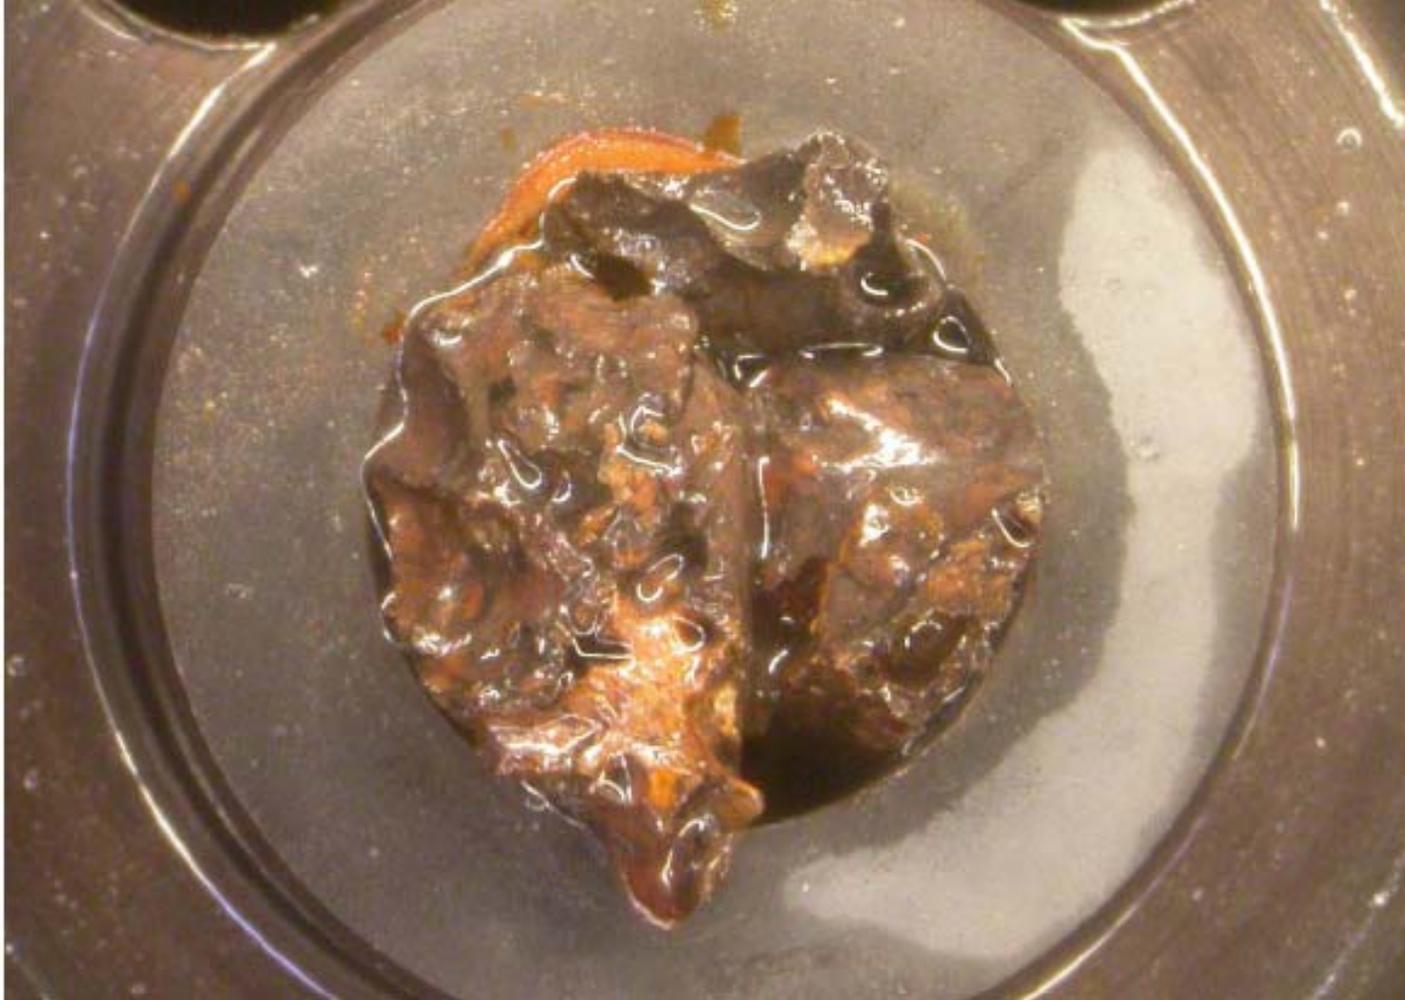
Debris in Trap

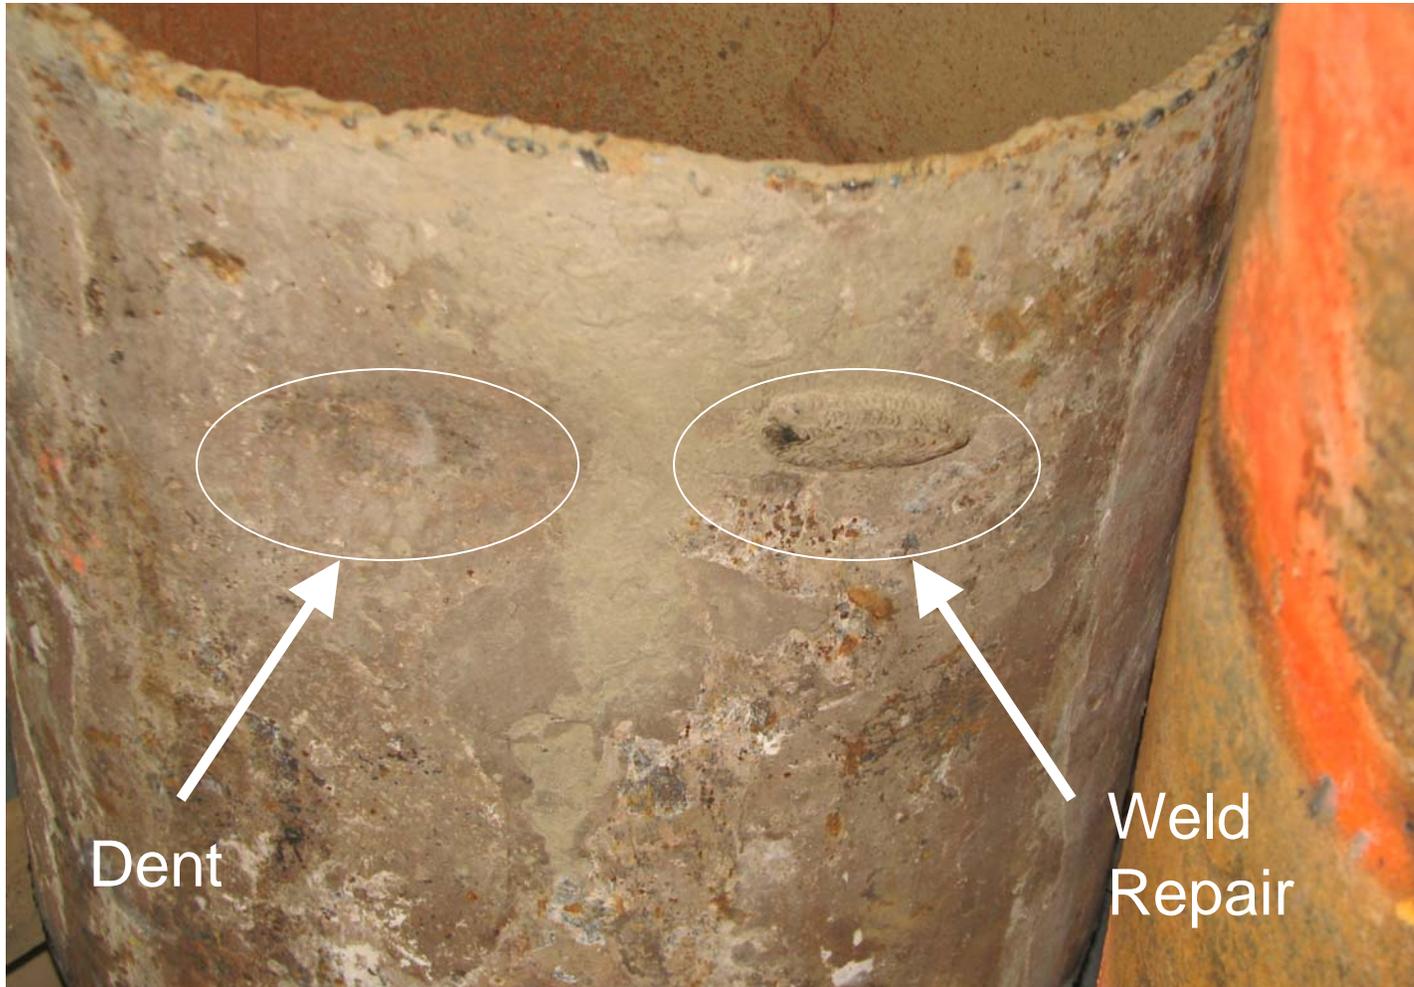
Dents & Repair Near Flange

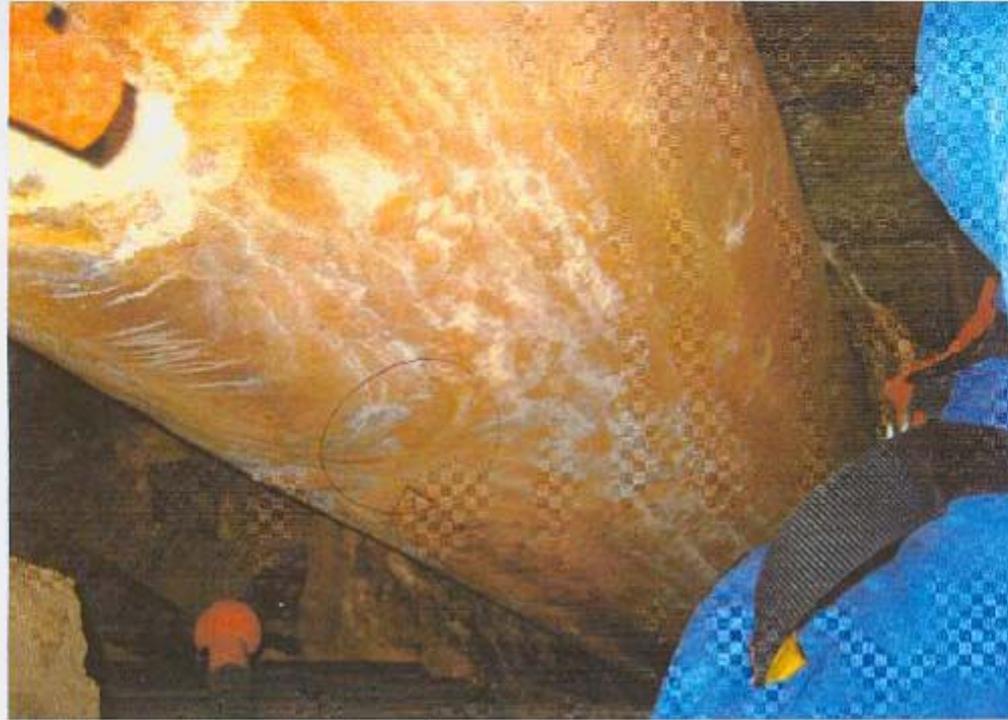
● ● ● | *Con Edison June 2006 Record
Identifying Dent and Need for Pipe
Replacement*

(4115th & Lex Ave)
Single. Hears rpt
Flange leak

Previous welds repair
Pipe is scuffed & pitted in several
places. Should change pipe!
