**RESULTS OF OUTSIDE PLANT INSPECTION  
OF VERIZON FiOS**

**In The  
County of Westchester**

**Report No. S036-08-4221**

**SUMMARY OF INSPECTION OF VERIZON FiOS FACILITIES IN THE COUNTY OF WESTCHESTER FOR UNSAFE AND NONSTANDARD SUBSCRIBER INSTALLATION PRACTICES.**

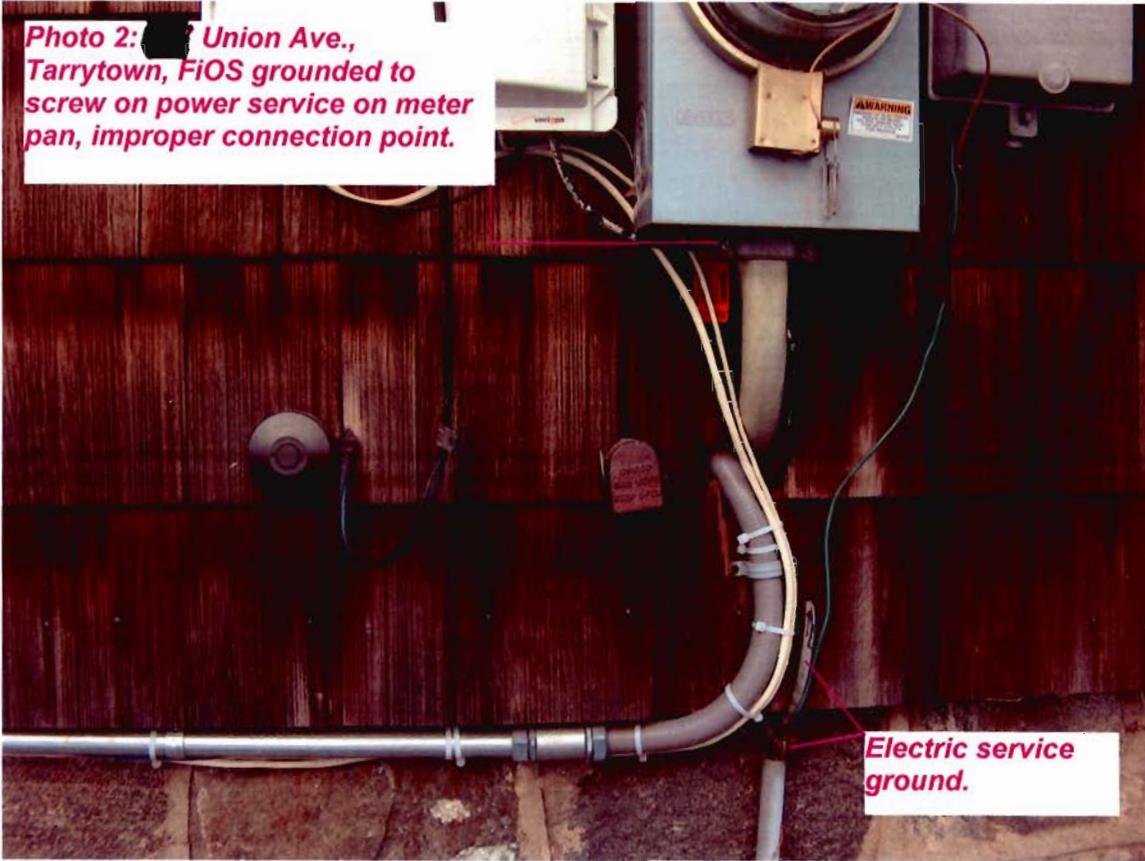
**FiOS ground conductor attached to screw on power service clamp on meter pan (improper connection point). Electric system ground approximately 30 inches from FiOS ONT. (Photo 2)**

**Photo 2:** [redacted] Union Ave.,  
Tarrytown, FiOS grounded to  
screw on power service on meter  
pan, improper connection point.

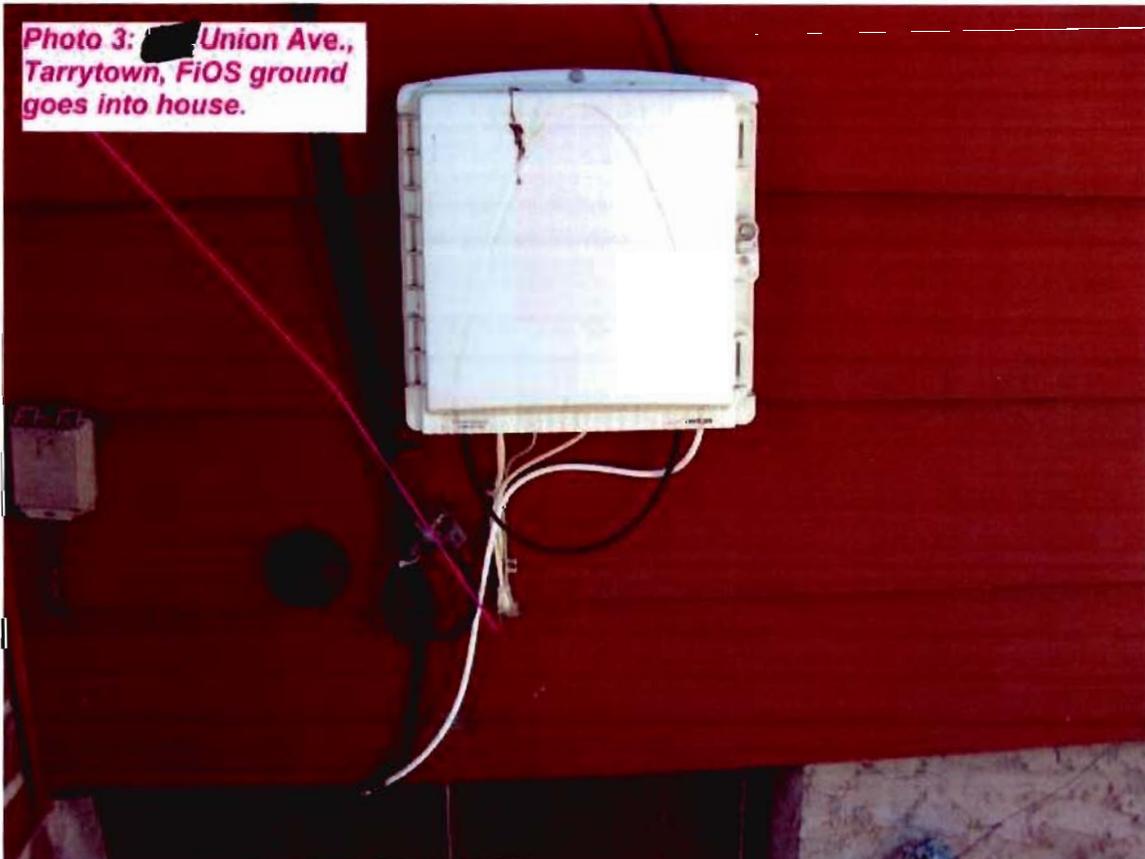
**Photo 3:** [redacted] Union Ave.,  
Tarrytown, FiOS ground  
goes into house.

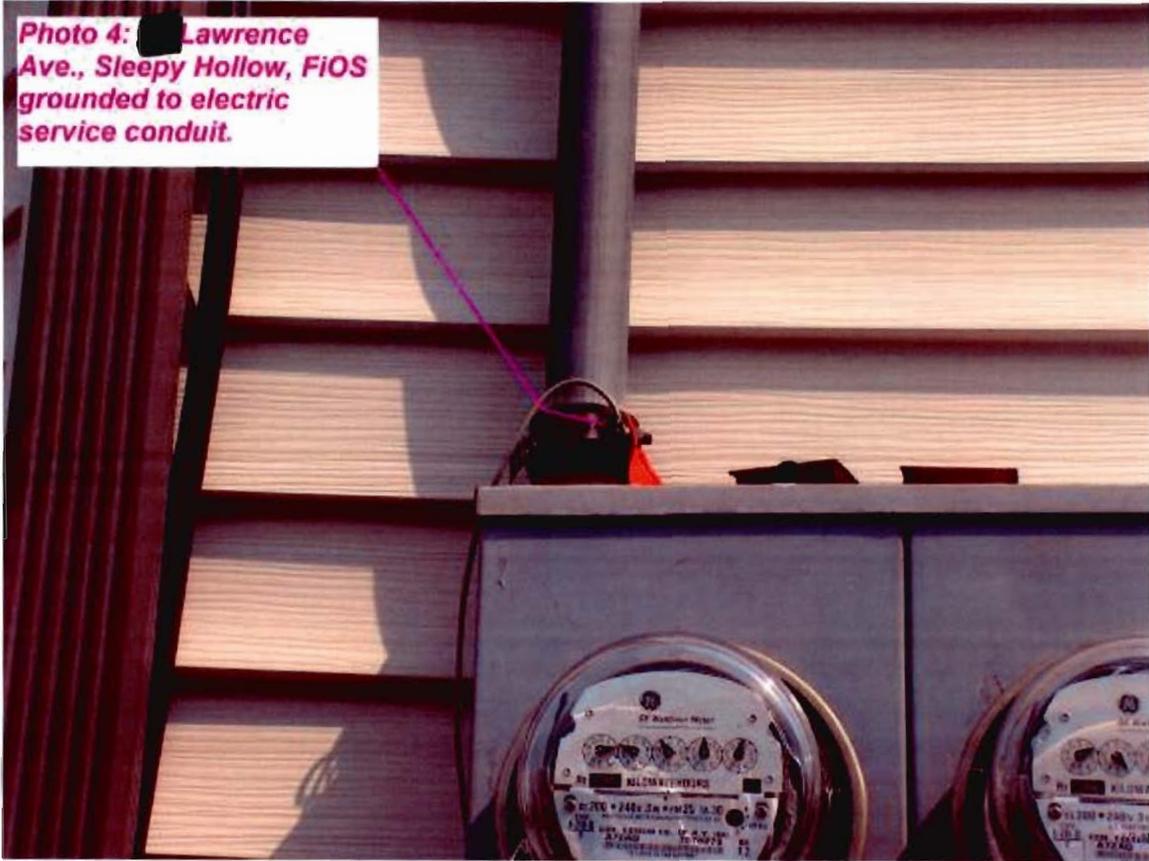
**Photo 4:** [redacted] Lawrence Ave., Sleepy Hollow, FiOS grounded to electric service conduit.

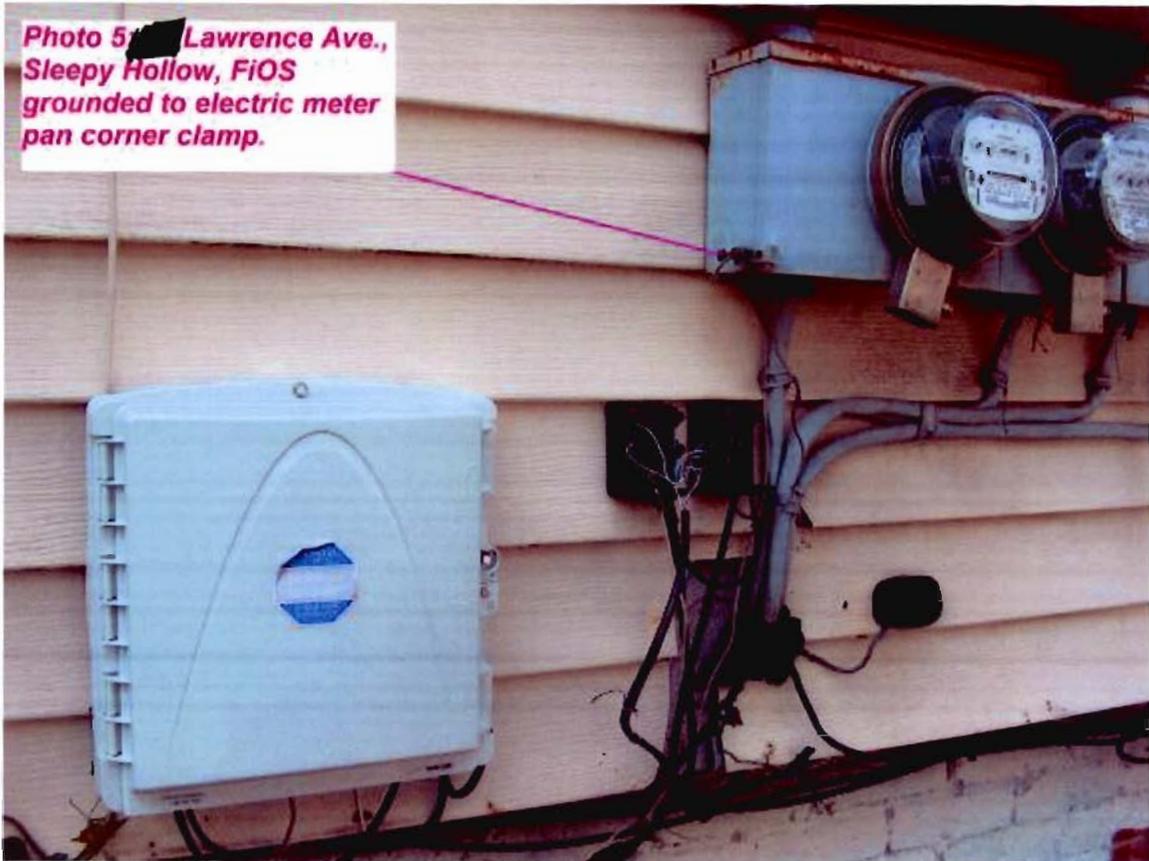
**Photo 5:** [redacted] Lawrence Ave., Sleepy Hollow, FiOS grounded to electric meter pan corner clamp.

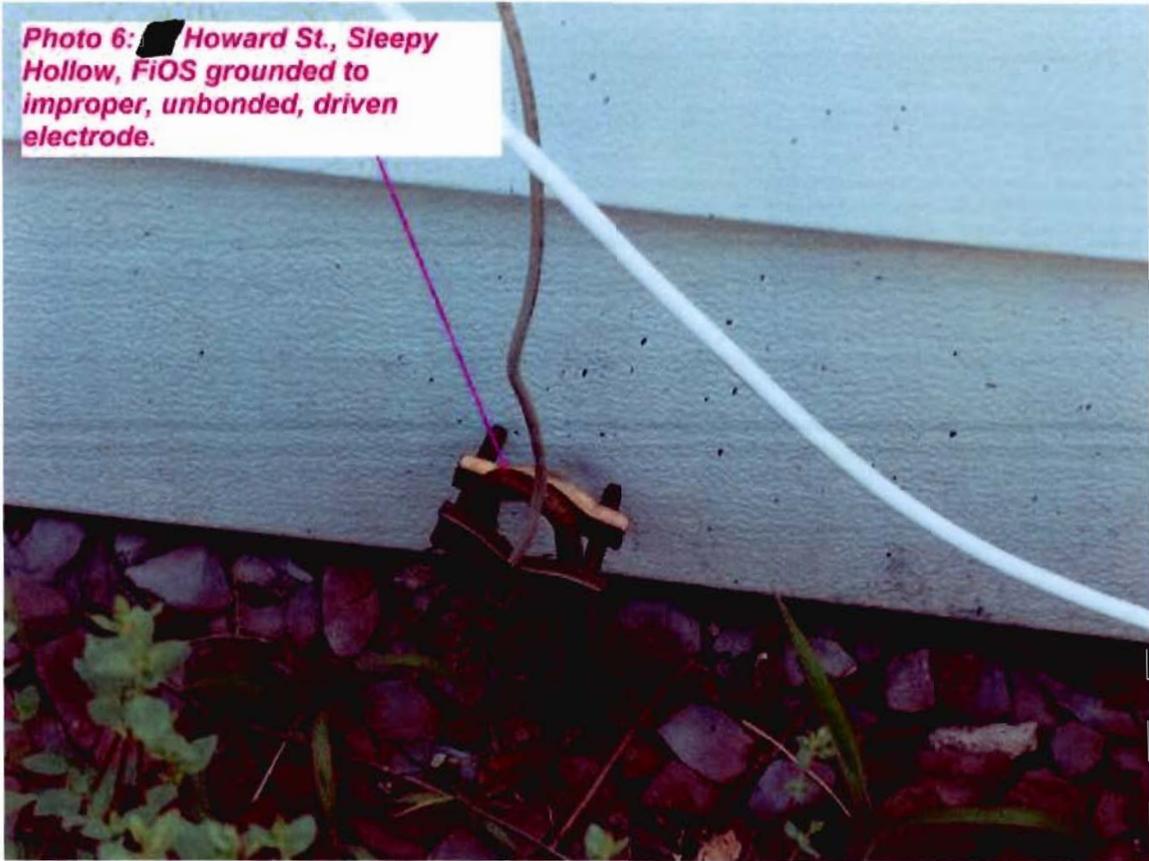
**FiOS grounded to improper, driven electrode. (Photo 6)**

**Photo 6:** [REDACTED] Howard St., Sleepy Hollow, FiOS grounded to improper, unbonded, driven electrode.

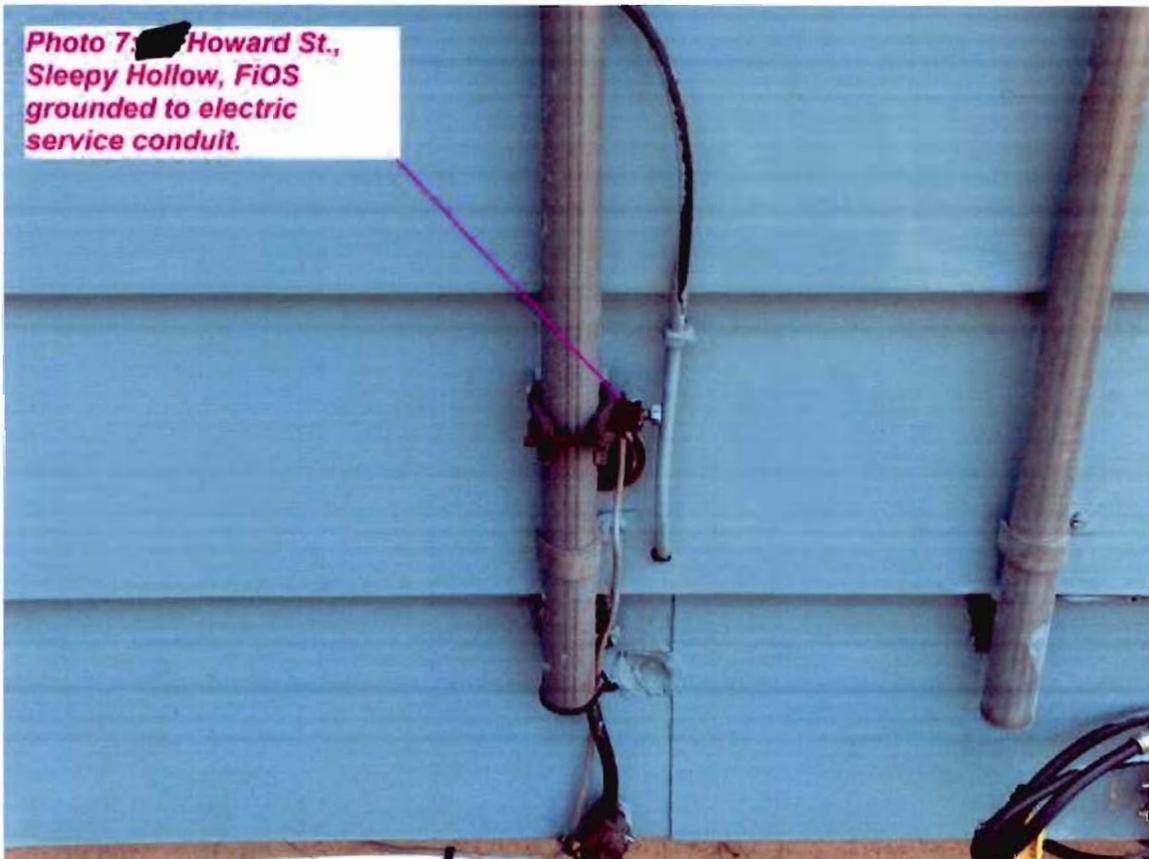
**Photo 7:** [REDACTED] Howard St., Sleepy Hollow, FiOS grounded to electric service conduit.

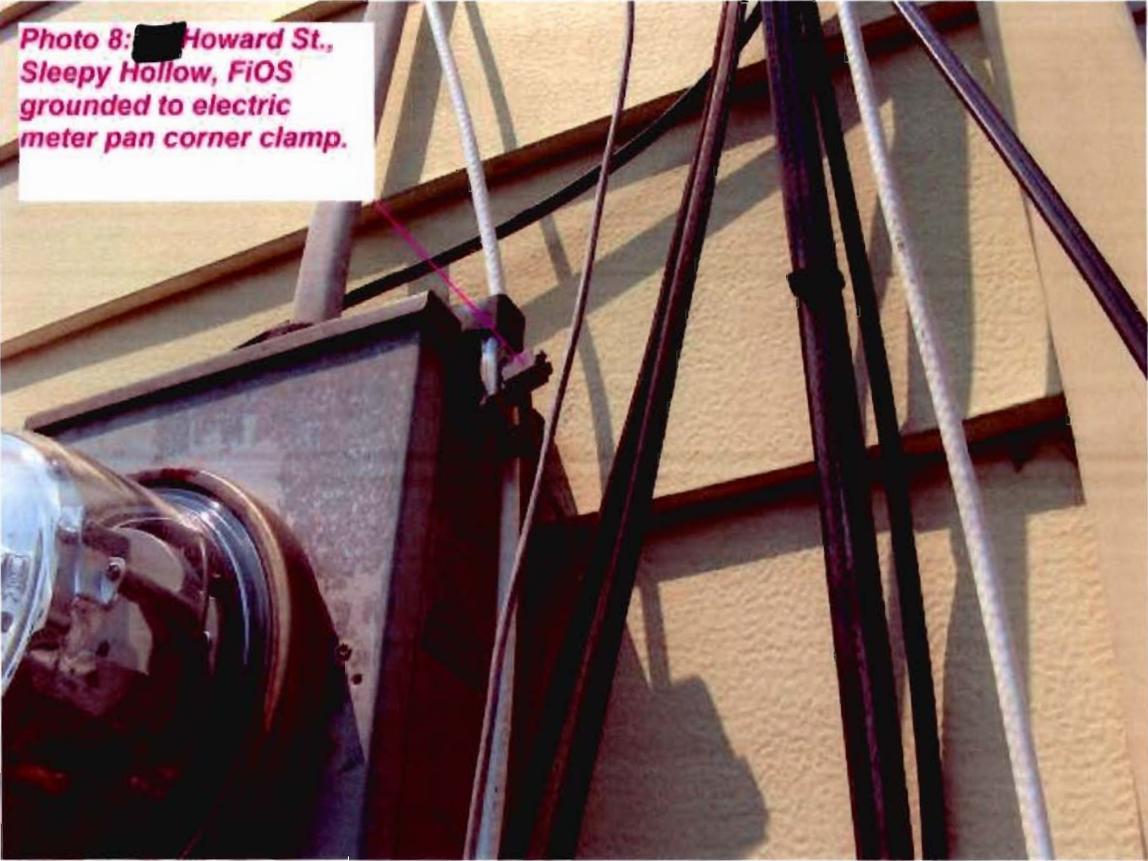
**Photo 8:** [redacted] Howard St.,  
Sleepy Hollow, FiOS  
grounded to electric  
meter pan corner clamp.

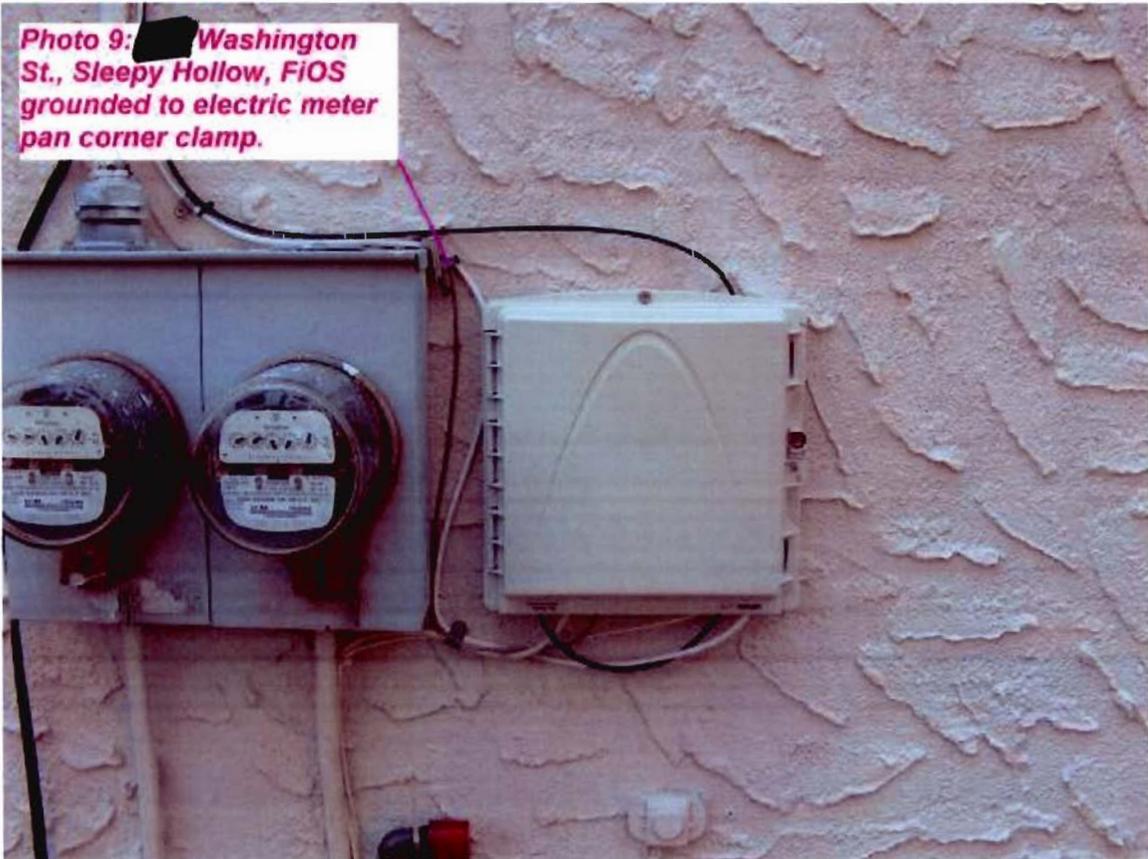
**Photo 9:** [redacted] Washington  
St., Sleepy Hollow, FiOS  
grounded to electric meter  
pan corner clamp.

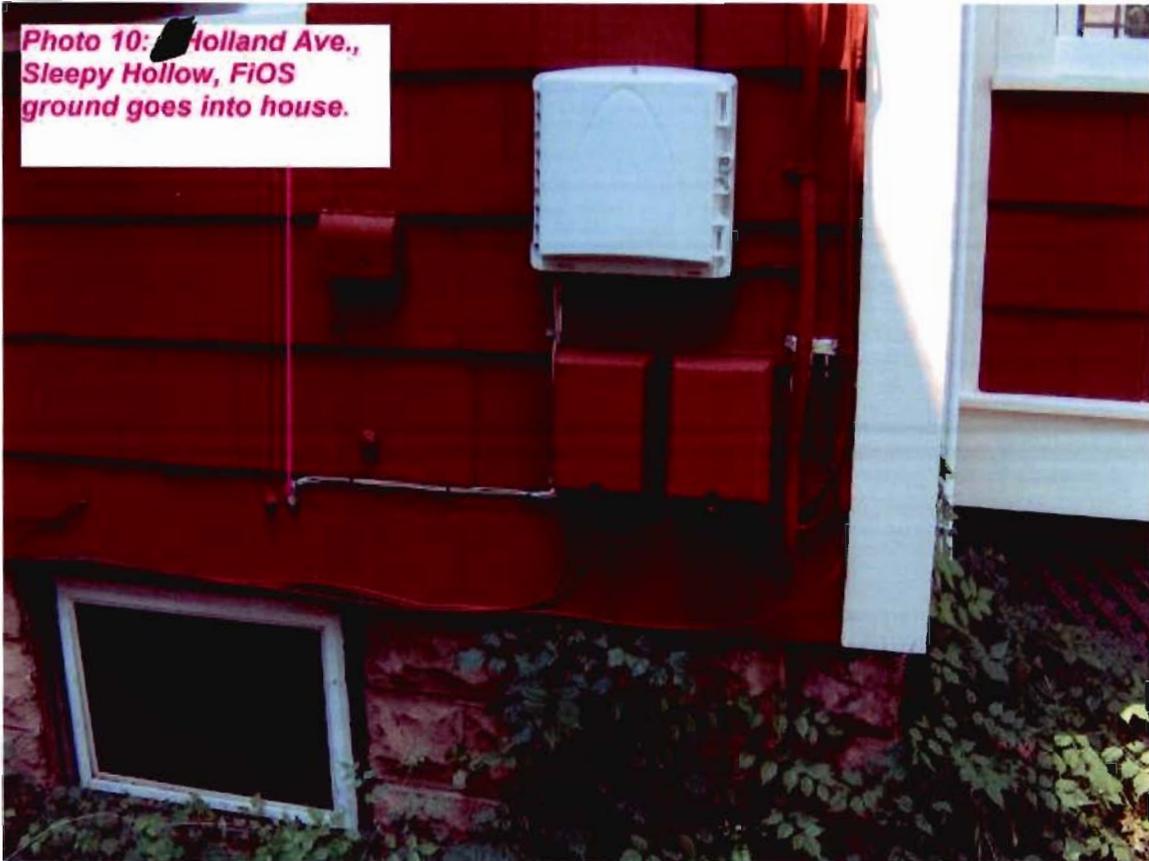
**Photo 10:** [redacted] Holland Ave.,  
Sleepy Hollow, FiOS  
ground goes into house.

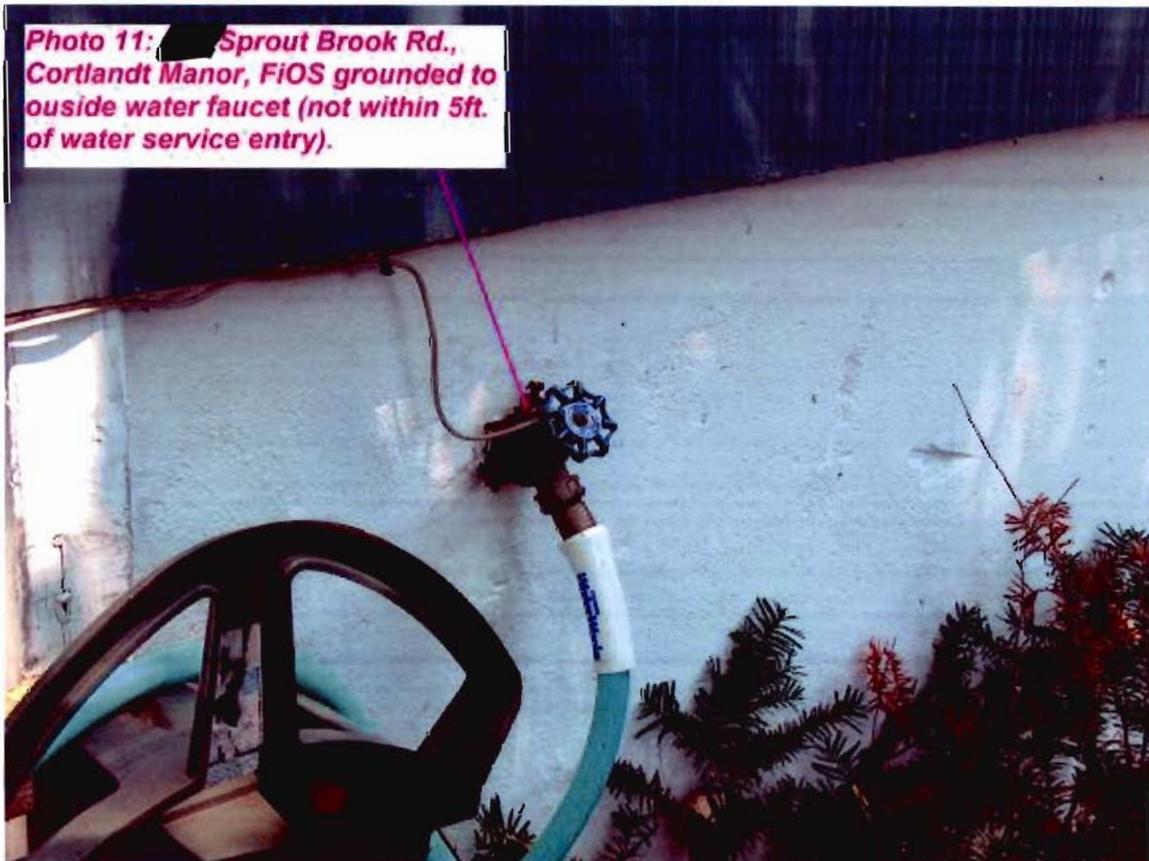
**FiOS grounded to outside water faucet (not within 5 ft. of water service entrance). (Photo 11)**

**Photo 11:** [redacted] Sprout Brook Rd.,  
Cortlandt Manor, FiOS grounded to  
outside water faucet (not within 5ft.  
of water service entry).

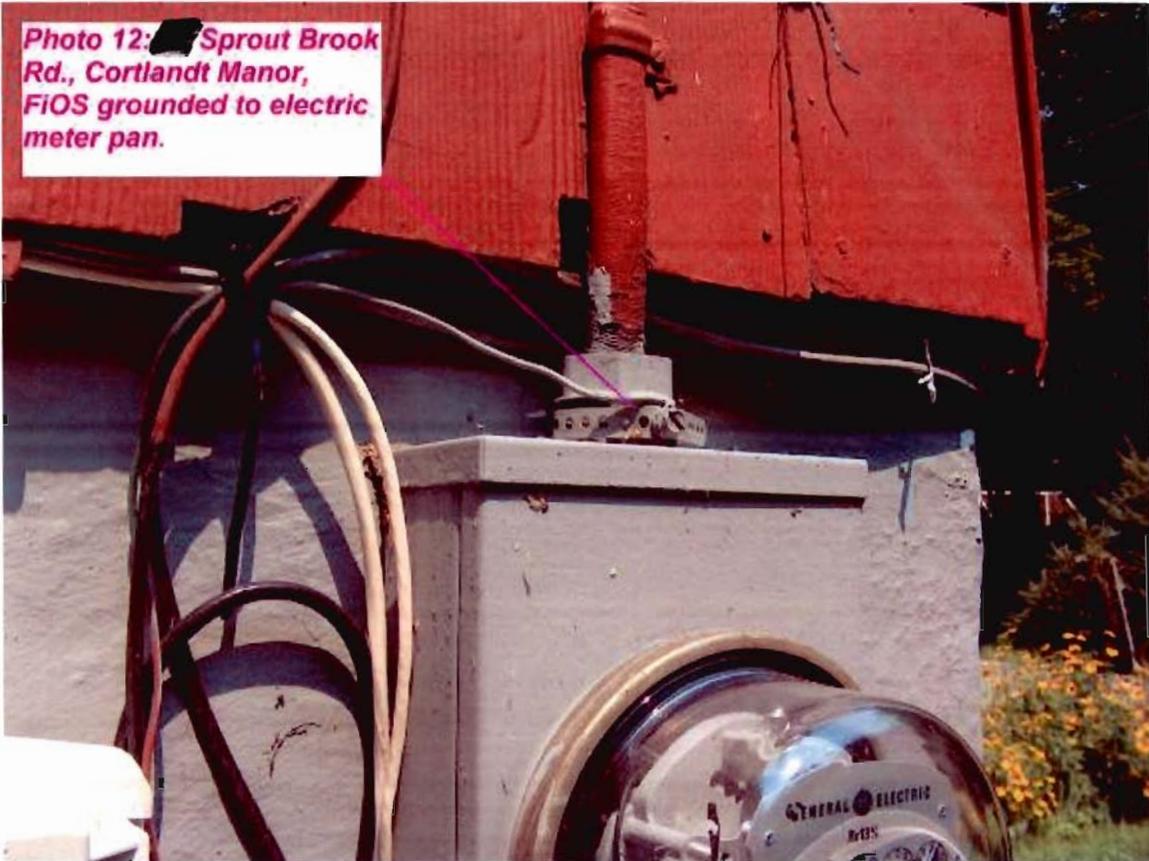
**Photo 12:** [redacted] Sprout Brook Rd., Cortlandt Manor, FIOS grounded to electric meter pan.

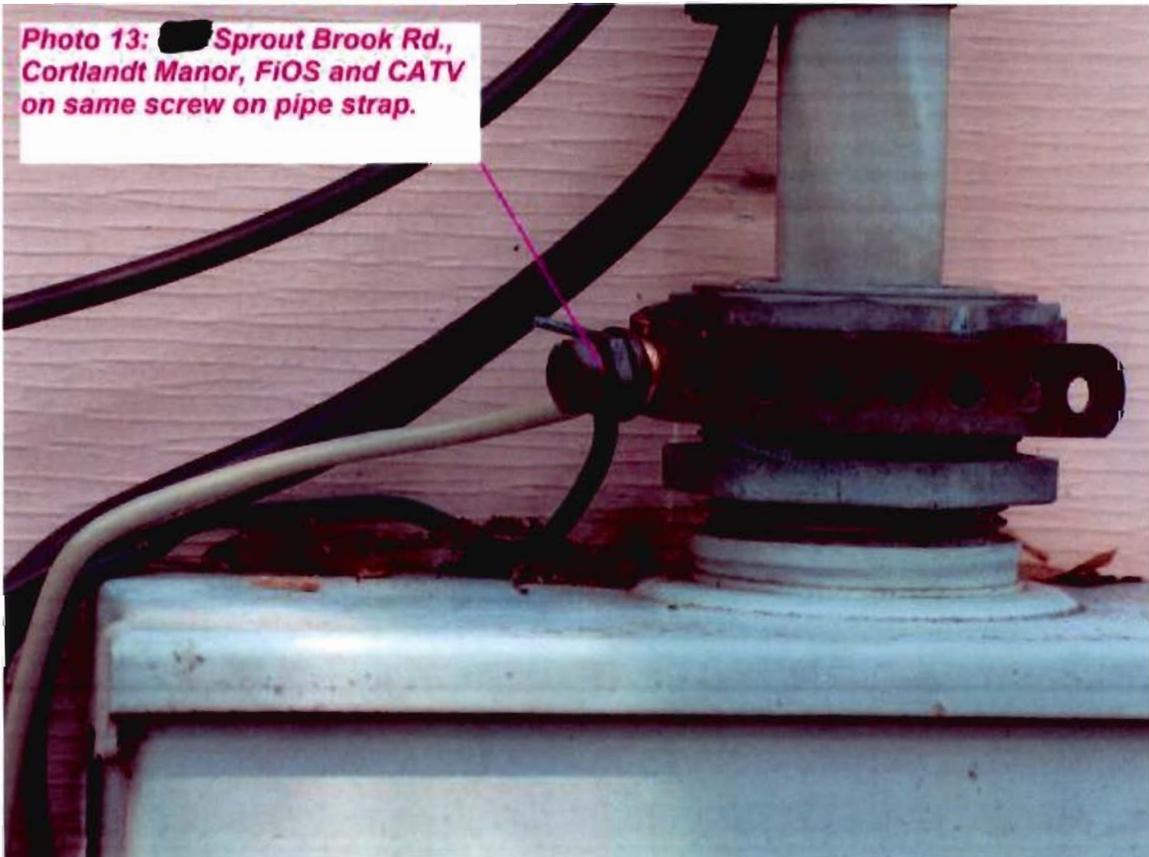
**FiOS and CATV ground conductors attached to same screw on pipe strap on meter pan entry coupling. (Photo 13)**

**Photo 13:** [redacted] Sprout Brook Rd., Cortlandt Manor, FIOS and CATV on same screw on pipe strap.

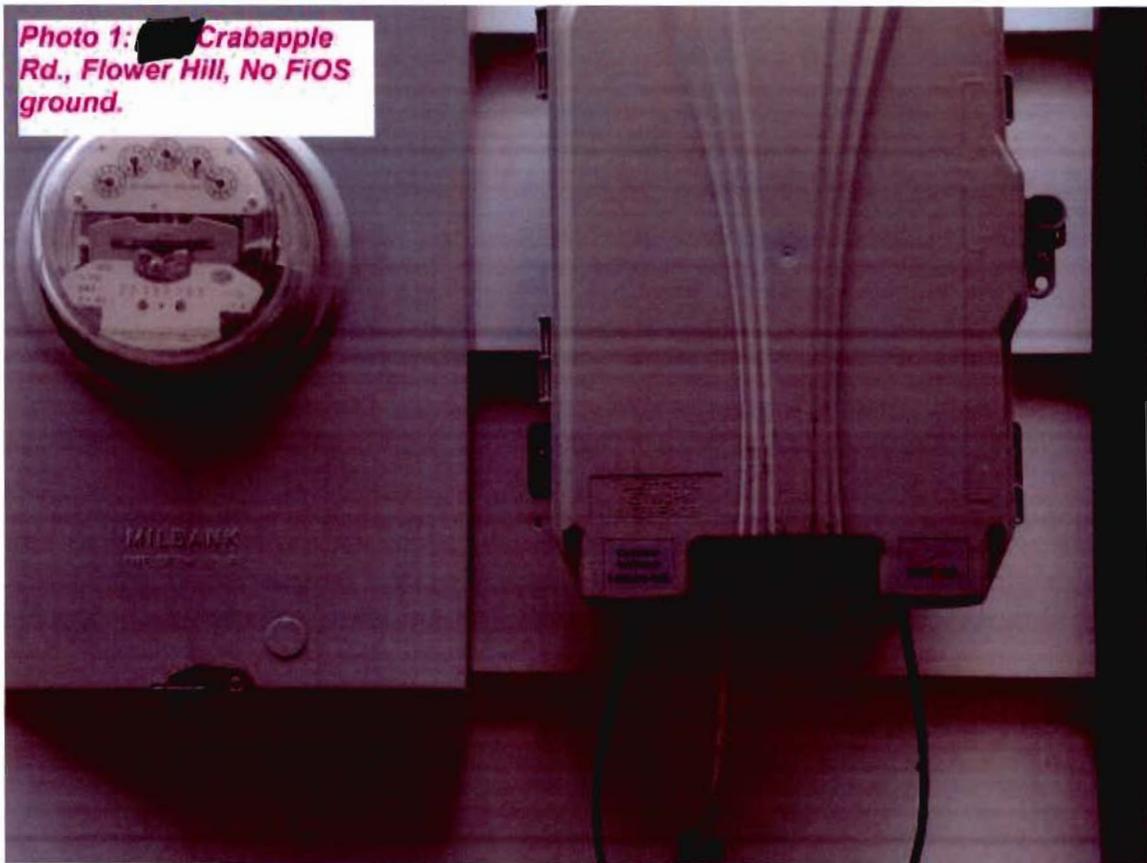
**FiOS not grounded. (Photo 1)**

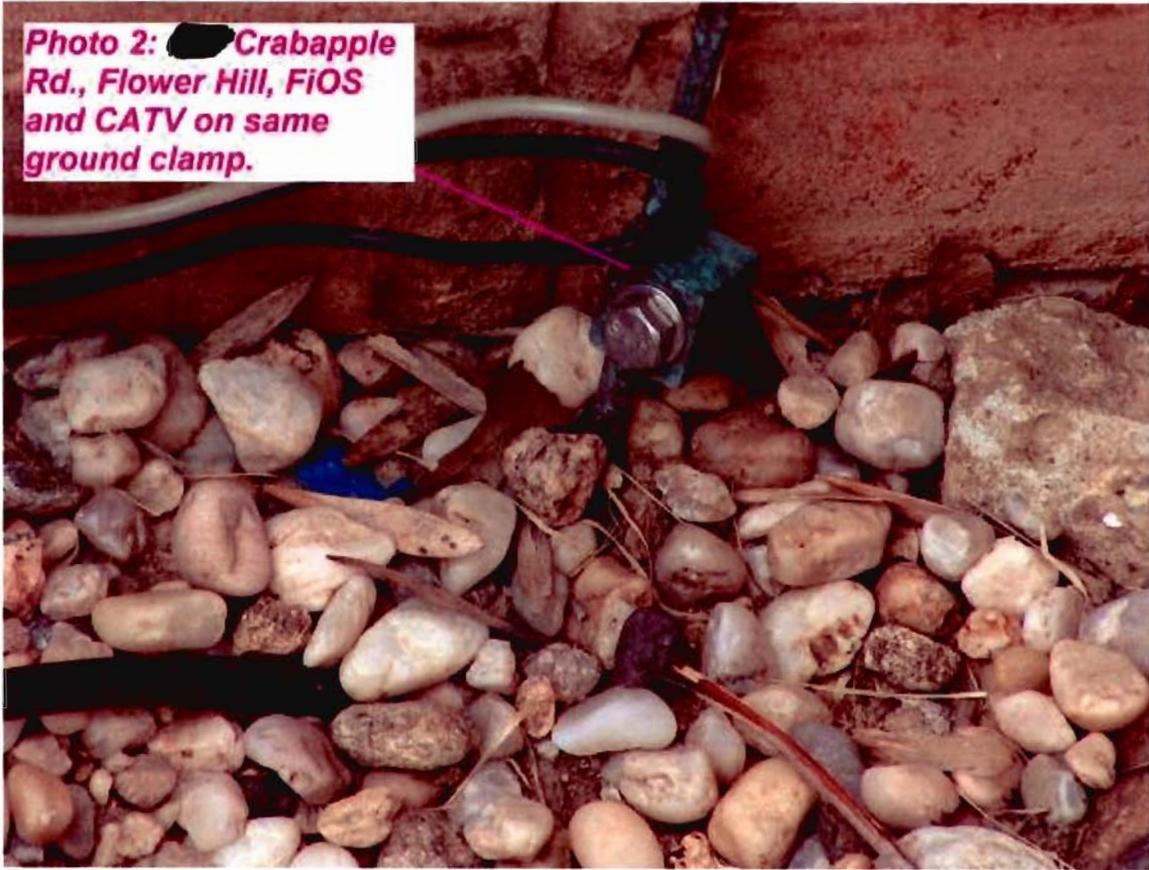
**FiOS and CATV ground conductors connected to same ground clamp under same screw. (Photo 2)**

**Photo 2:** [redacted] Crabapple Rd., Flower Hill, FiOS and CATV on same ground clamp.

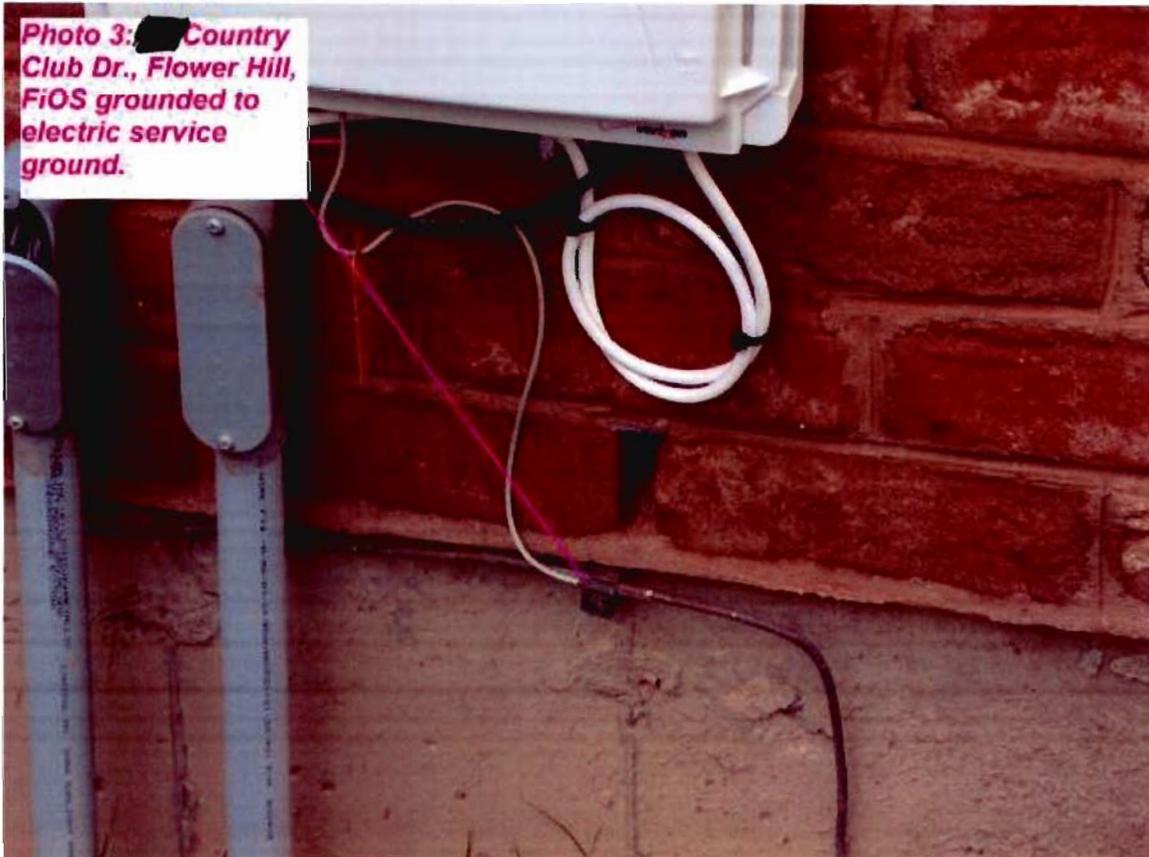
**Photo 3:** [redacted] Country Club Dr., Flower Hill, FiOS grounded to electric service ground.

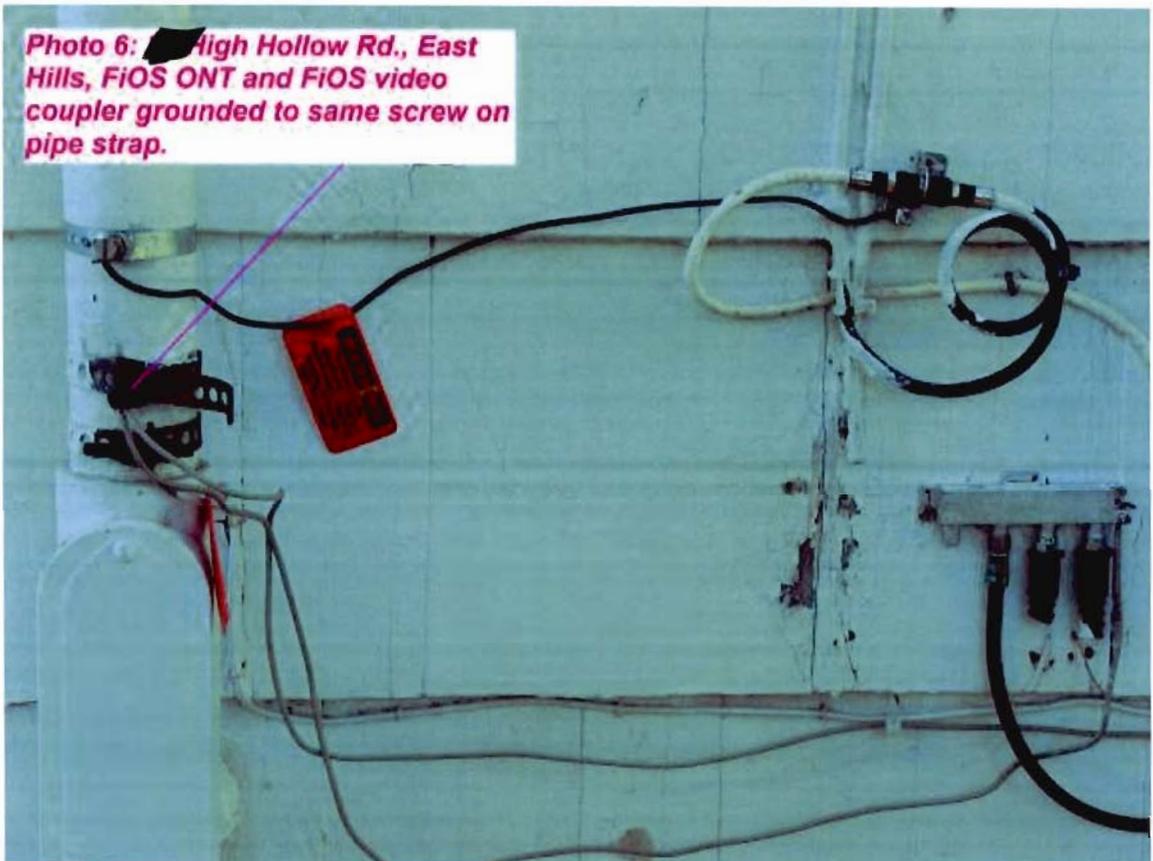
**FiOS ONT and FiOS video coupler ground conductors connected to same screw on pipe strap. (Photo 6)**

**Photo 6:** High Hollow Rd., East Hills, FiOS ONT and FiOS video coupler grounded to same screw on pipe strap.

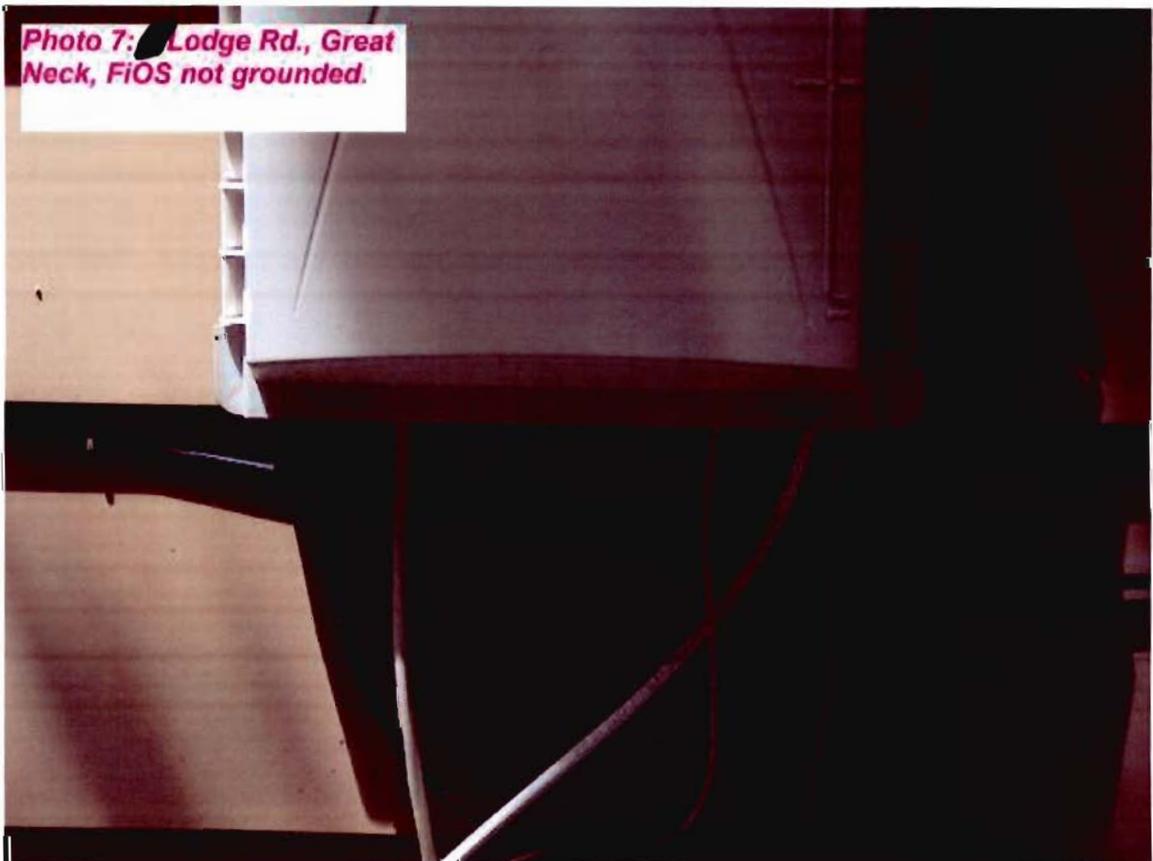
**FiOS not grounded. (Photo 7)**

**Photo 7:** Lodge Rd., Great Neck, FiOS not grounded.

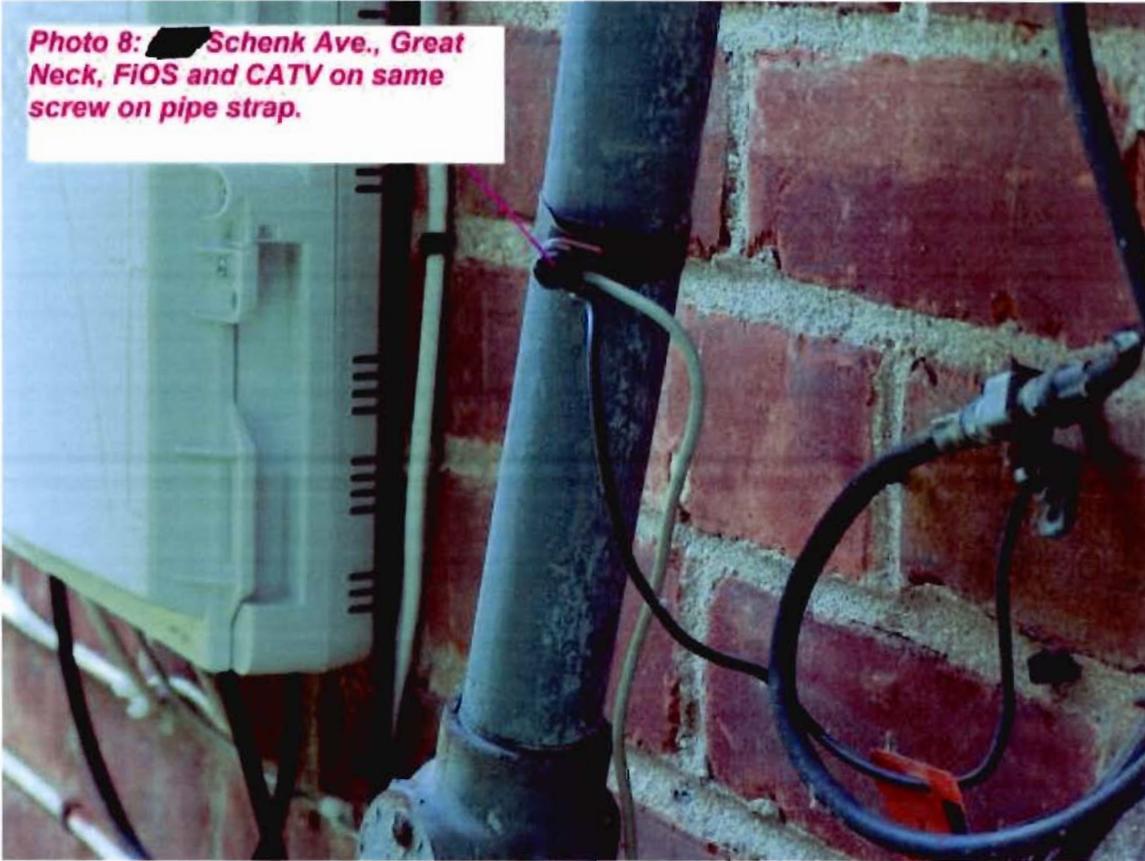
**FiOS and CATV ground conductors attached to same screw on pipe strap. (Photo 8)**

**Photo 8:** [redacted] Schenk Ave., Great Neck, FiOS and CATV on same screw on pipe strap.

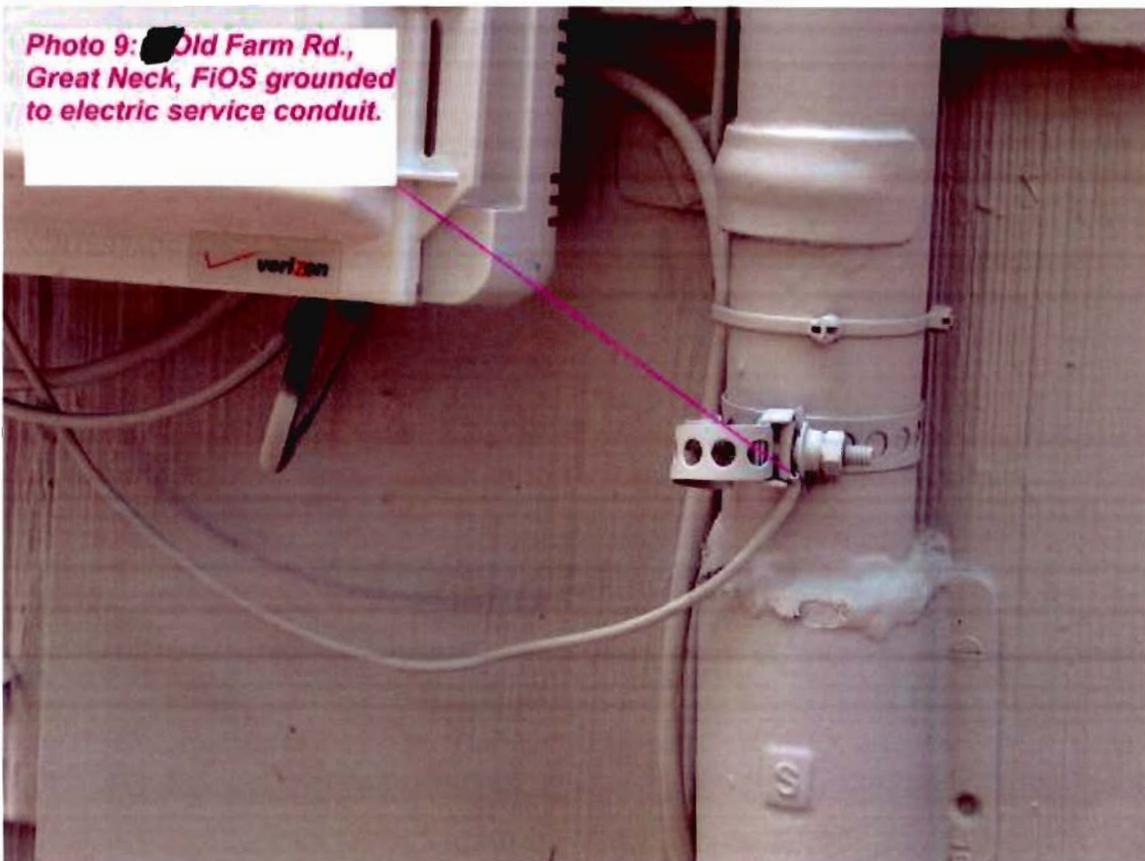
**Photo 9:** [redacted] Old Farm Rd., Great Neck, FiOS grounded to electric service conduit.

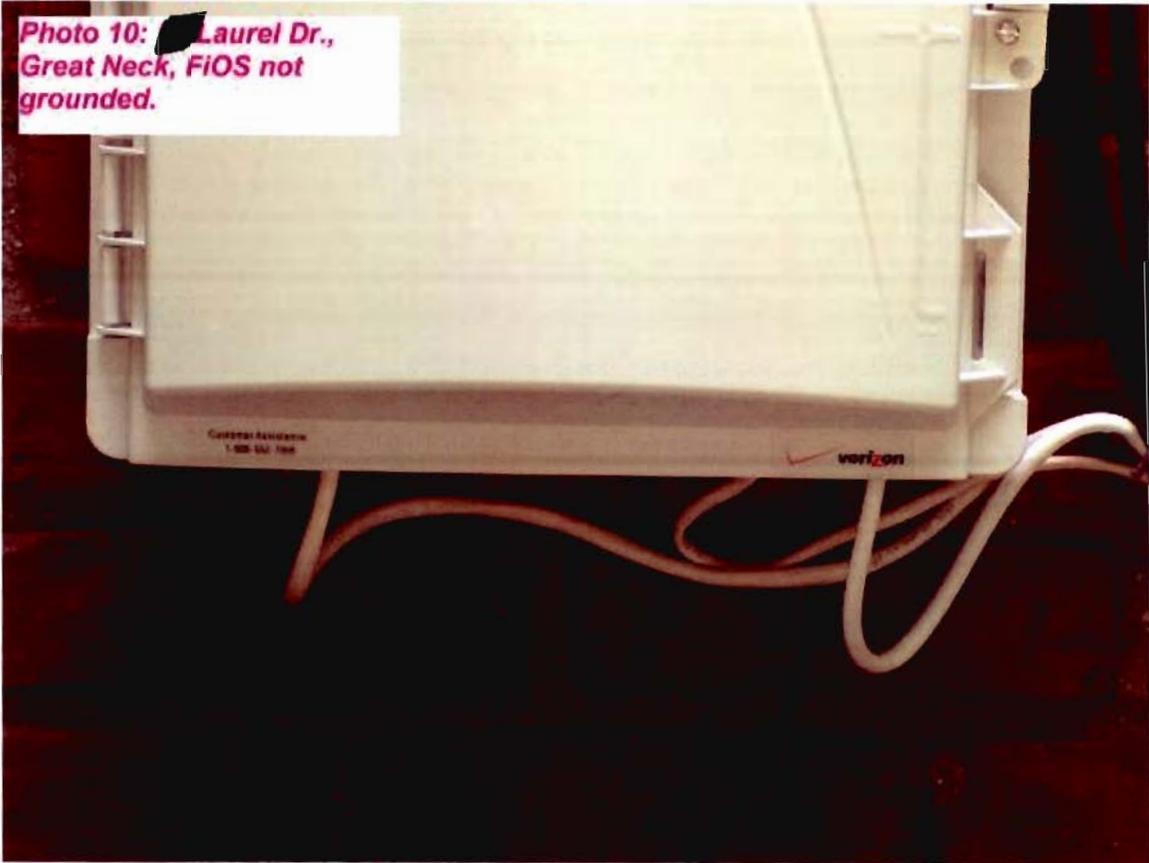
**FiOS not grounded. (Photo 10)**

**Photo 10:** [redacted] Laurel Dr.,  
Great Neck, FiOS not  
grounded.

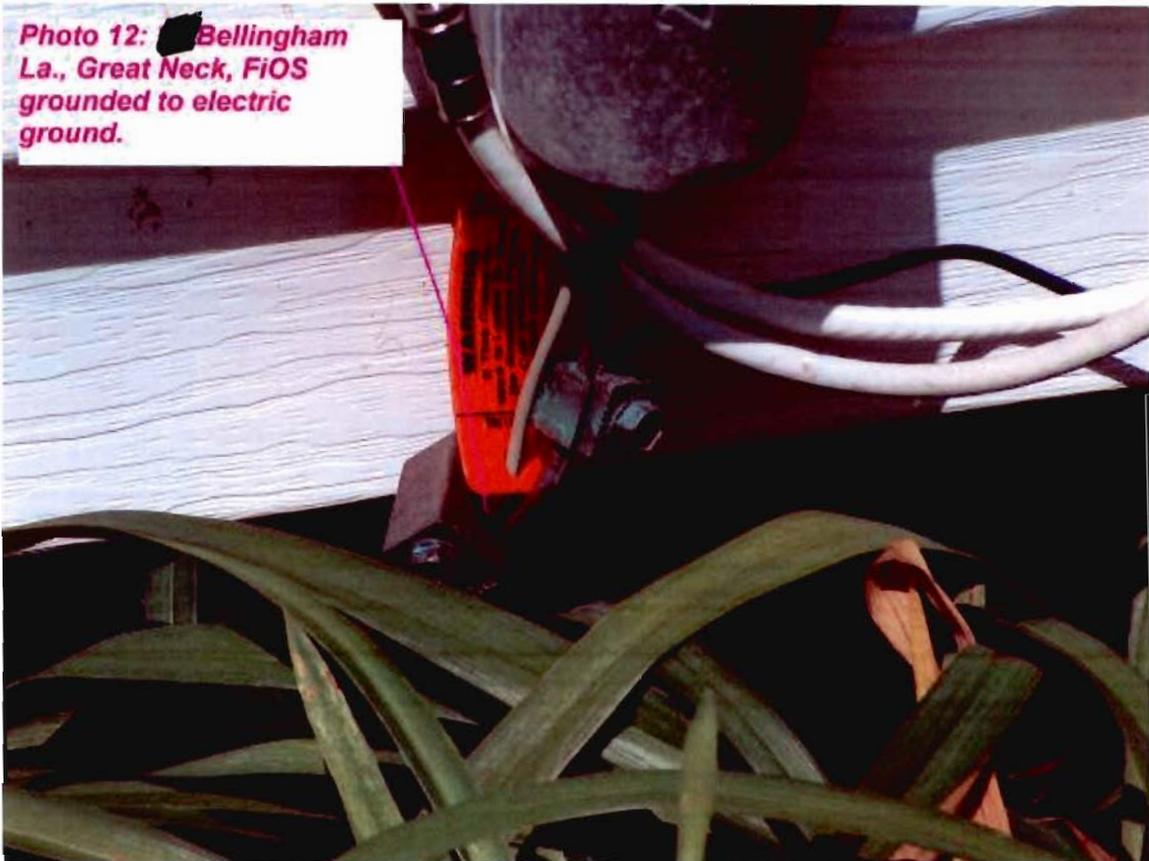
**Photo 12:** [redacted] Bellingham  
La., Great Neck, FiOS  
grounded to electric  
ground.

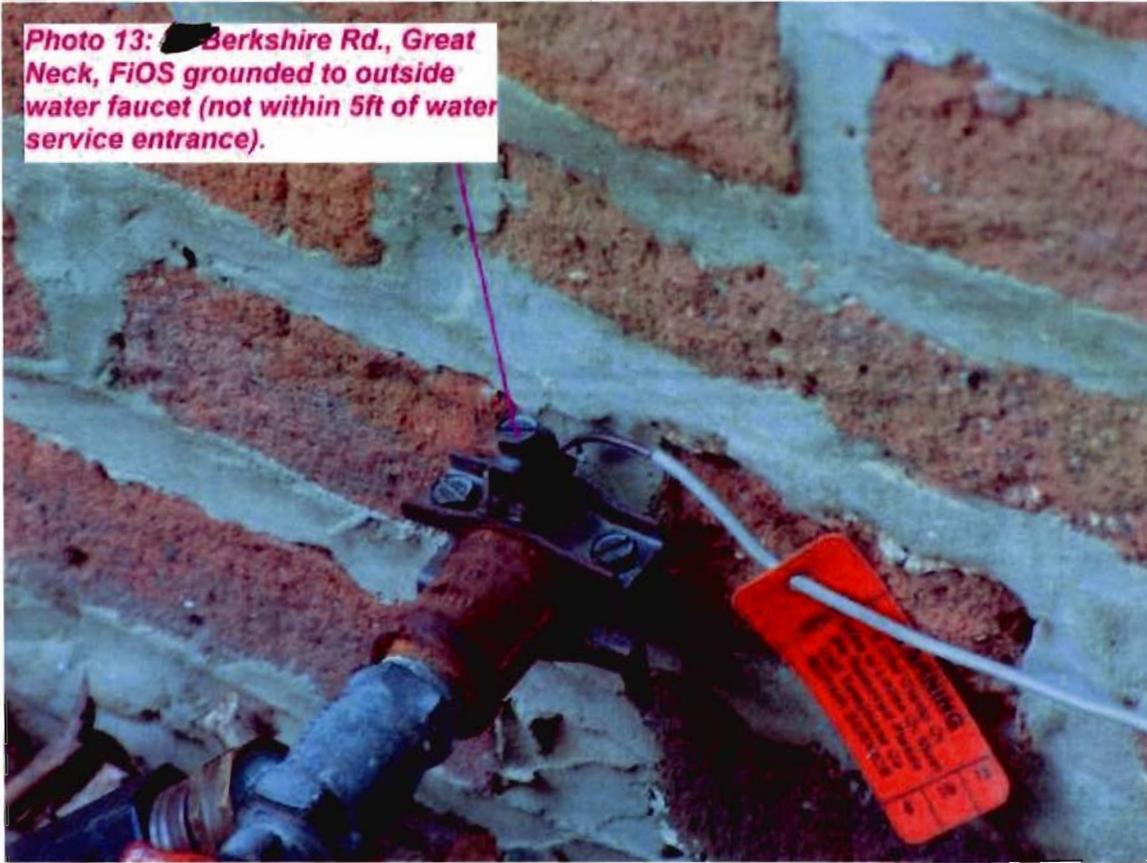
**FiOS grounded to outside water faucet (not within 5ft. of water service entrance). (Photo 13)**

Photo 13: [REDACTED] Berkshire Rd., Great Neck, FIOS grounded to outside water faucet (not within 5ft of water service entrance).
