**RESULTS OF OUTSIDE PLANT INSPECTION  
OF VERIZON FiOS**

**In The  
County of Westchester**

**Report No. S036-08-4221**

**SUMMARY OF INSPECTION OF VERIZON FiOS FACILITIES IN THE COUNTY OF WESTCHESTER FOR UNSAFE AND NONSTANDARD SUBSCRIBER INSTALLATION PRACTICES.**

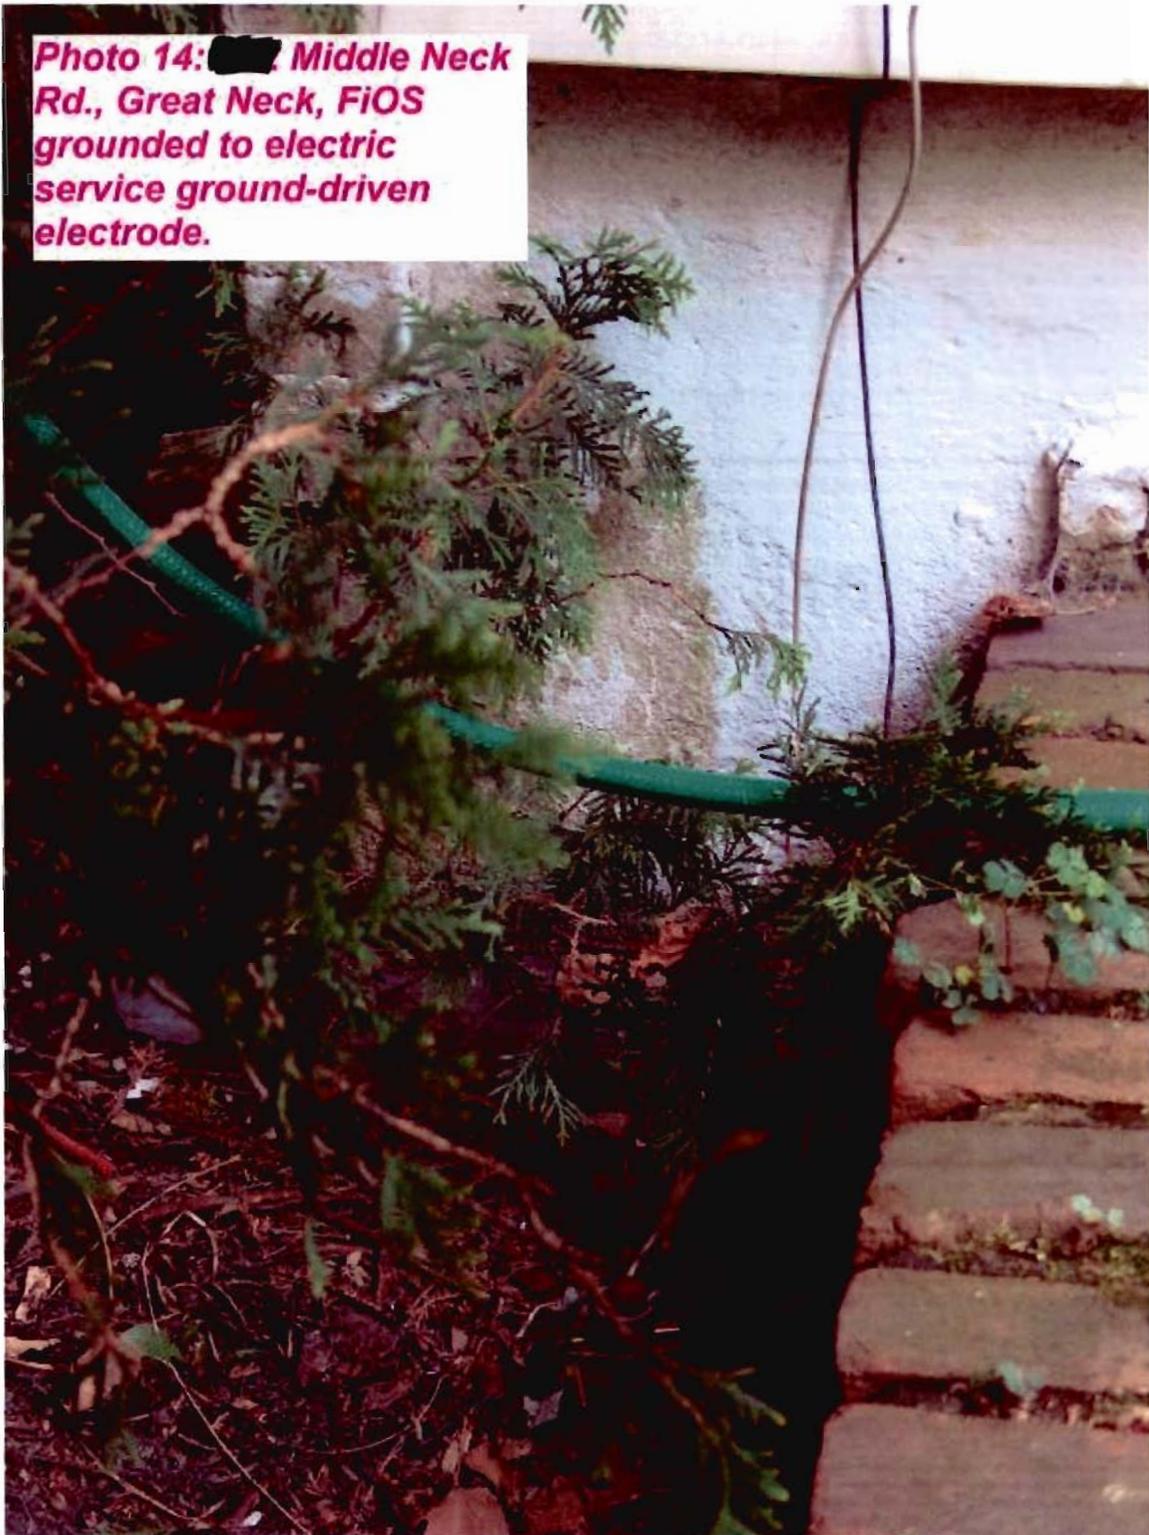
**Photo 14:** [REDACTED] Middle Neck Rd., Great Neck, FiOS grounded to electric service ground-driven electrode.

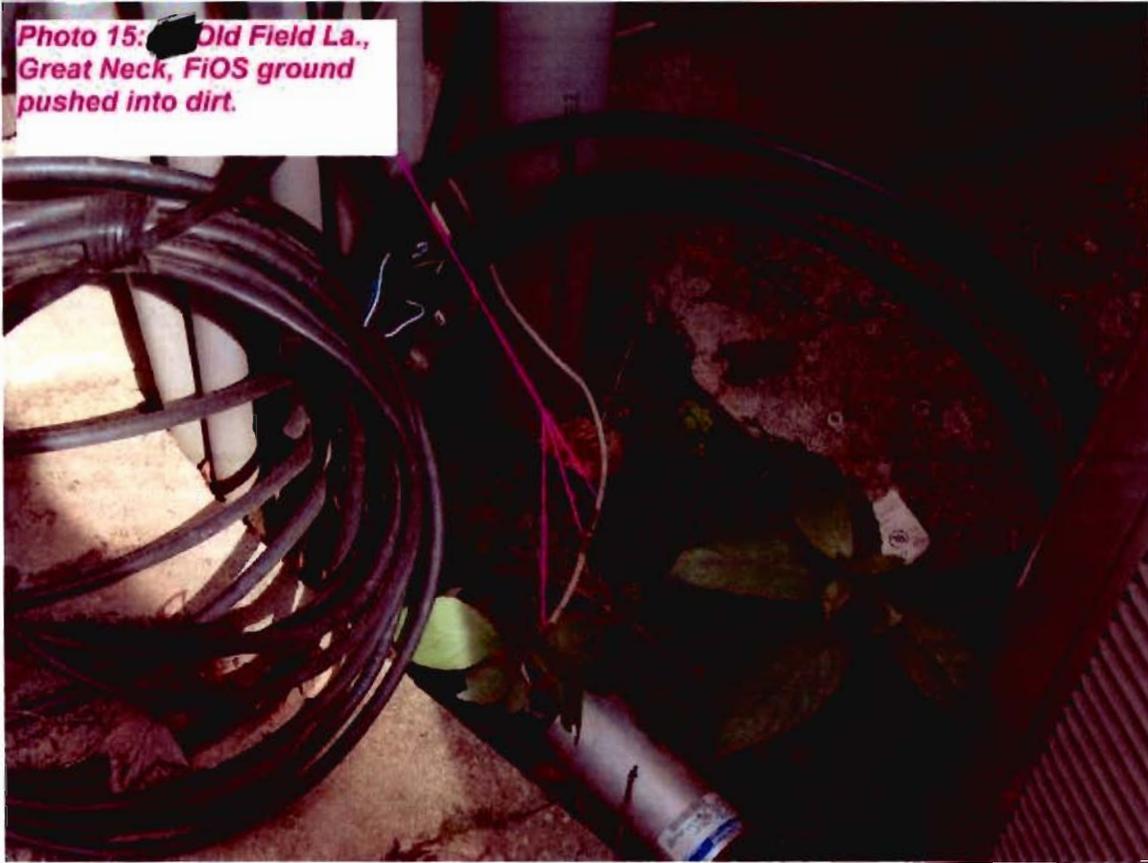
**FiOS ground conductor pushed into dirt; not attached to anything. Ground conductor was pulled out for photo and then replaced into dirt. (Photo 15)**

Photo 15: Old Field La.,  
Great Neck, FiOS ground  
pushed into dirt.

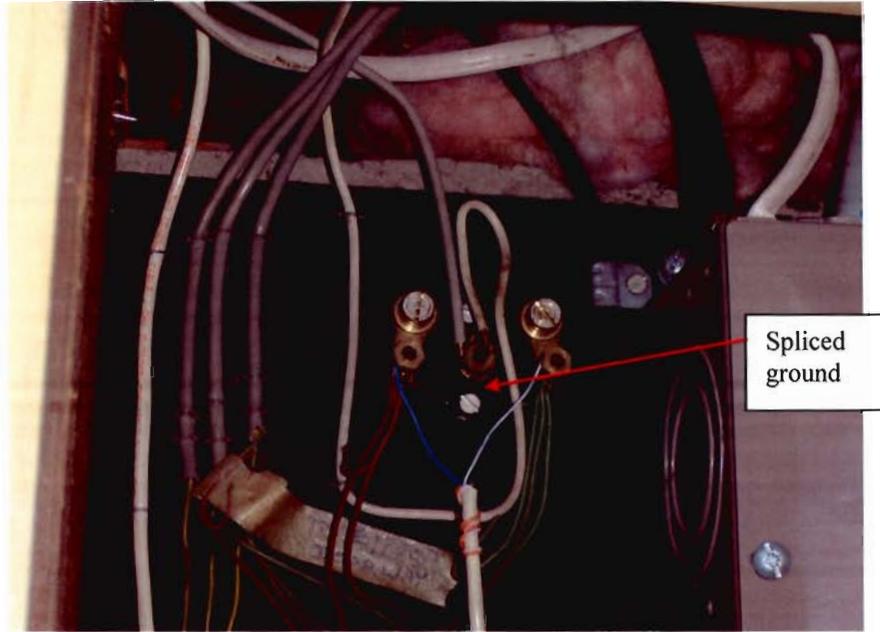
**Photo 1**

**FiOS ground conductor spliced at copper terminal. Copper terminal ground conductor spliced with crimp connector, then attaches to cold water.**

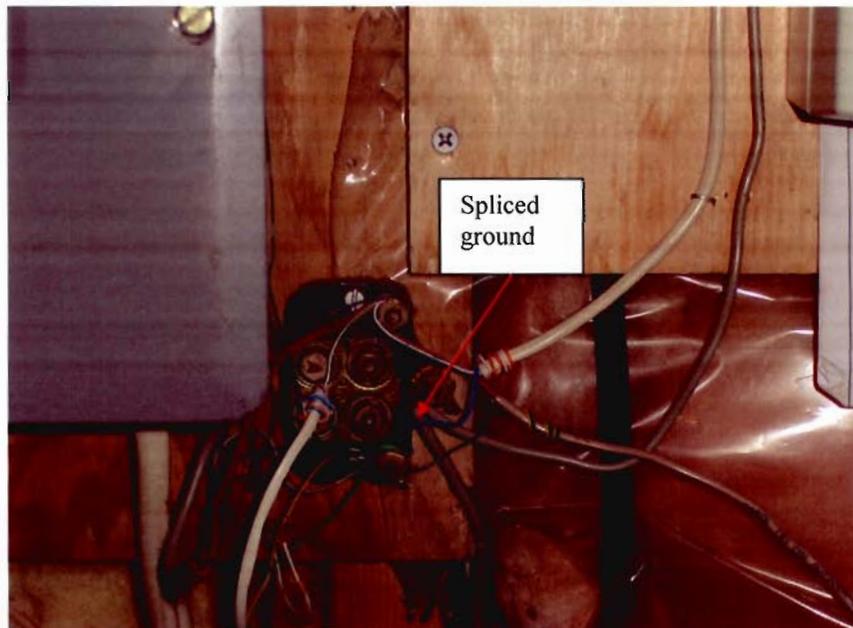
**Photo 2**

**FiOS ground conductor spliced at copper terminal. Copper terminal ground conductor attached to cold water that is more than 5 feet from water line point of entry.**

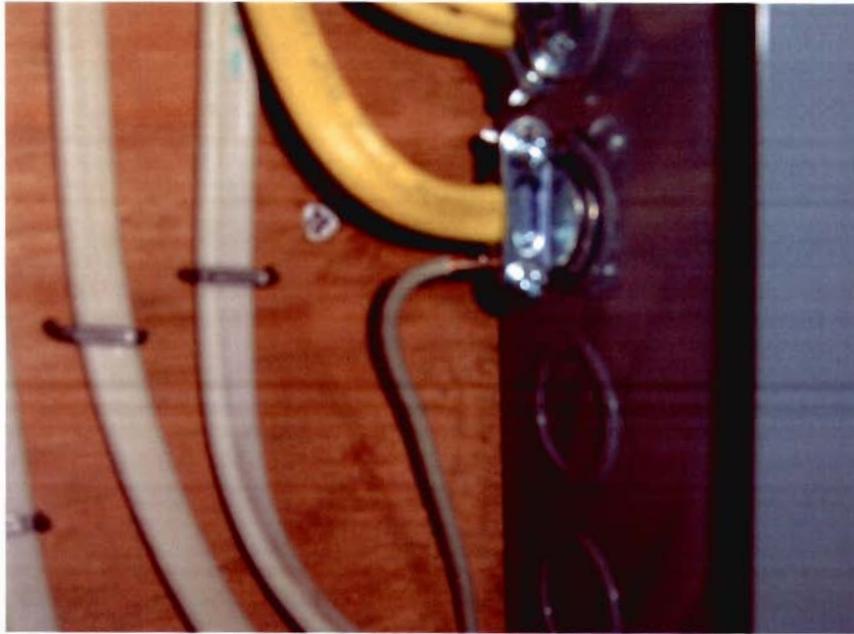
**Photo 3**

**FiOS ground conductor inserted into romex connector on breaker box. Power ground 2 feet away.**

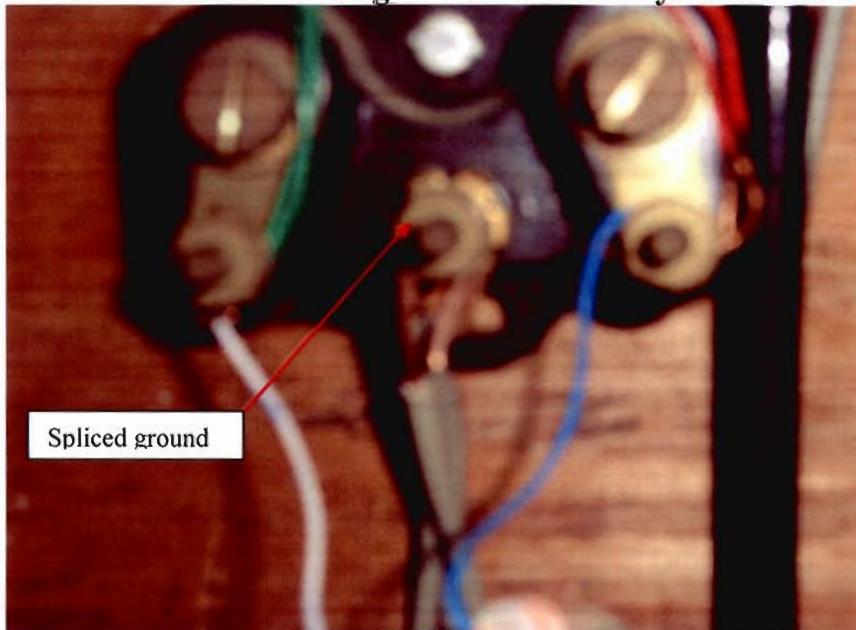
**Photo 4**

**FiOS ground conductor spliced at copper terminal. Copper terminal ground conductor attaches to cold water.**

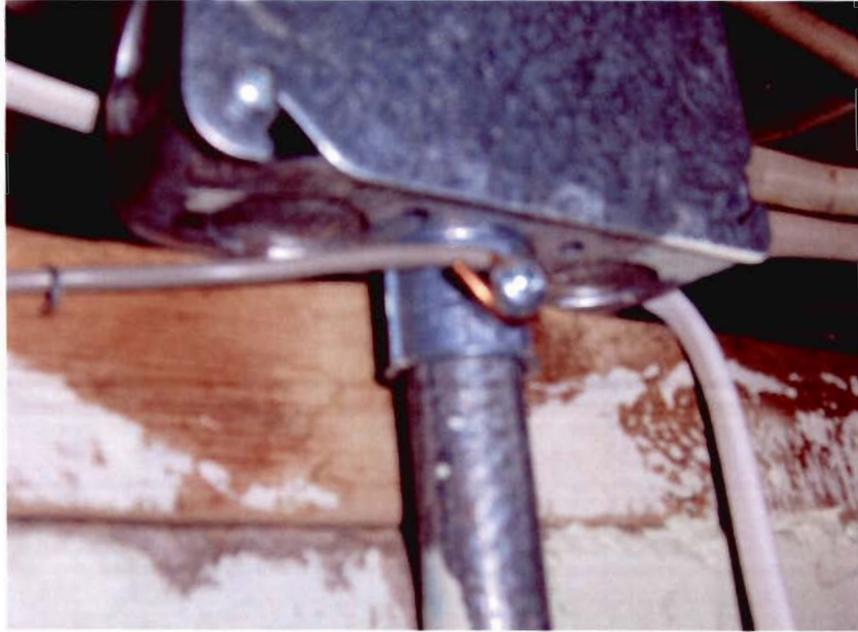
**Photo 5**

Carriage Parkway, West Seneca.  
FiOS ground conductor wrapped around screw on ½ inch conduit connector. Conduit not continuous to breaker box.

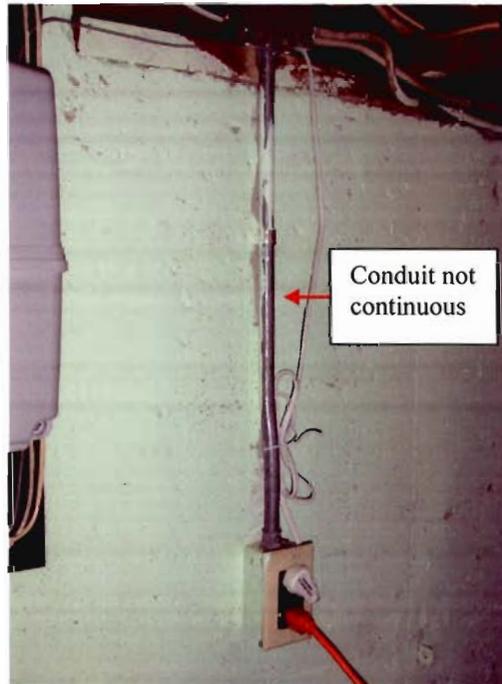
**Photo 6**

Carriage Parkway, West Seneca.  
FiOS ground conductor wrapped around screw on ½ inch conduit connector. Conduit not continuous to breaker box.

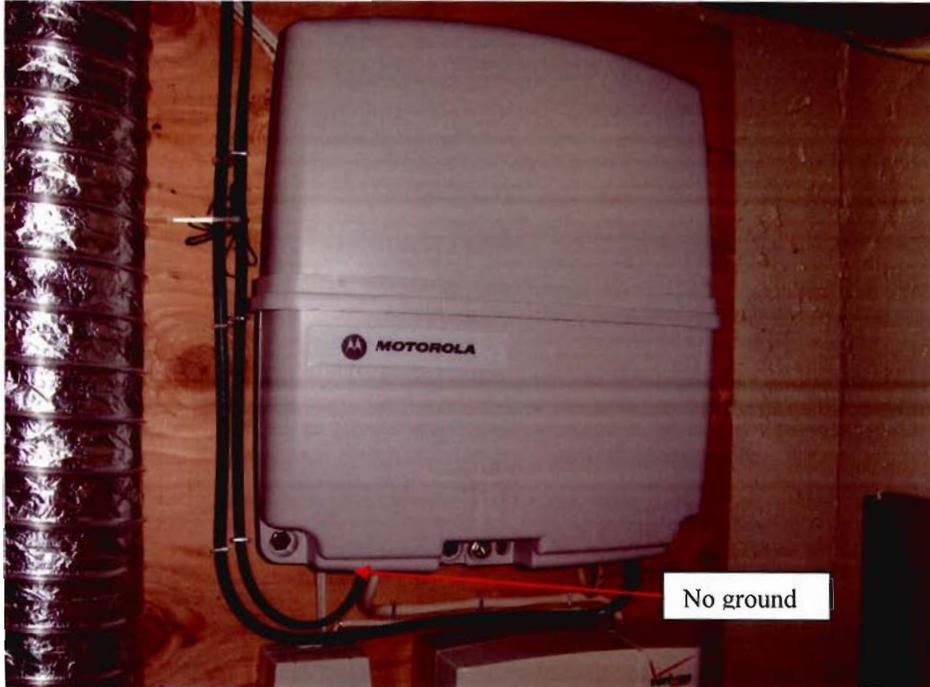
**Photo 7**

█ Pamela Court, West Seneca.  
FiOS not grounded. Power ground 3 feet away.

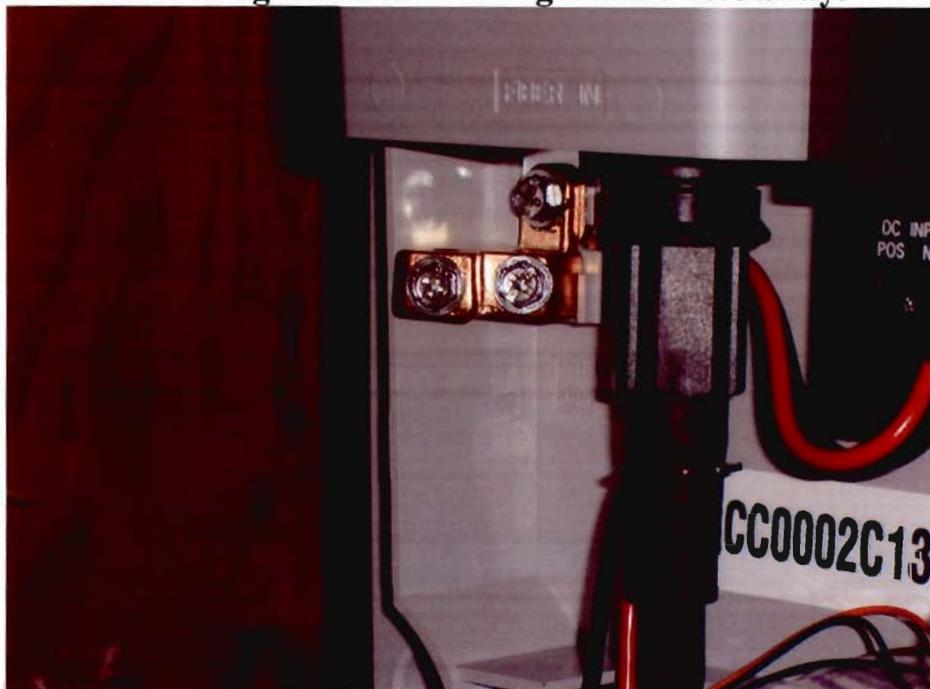
**Photo 8**

█ Mill Road, West Seneca.  
FiOS not grounded. Power ground 2 feet away.

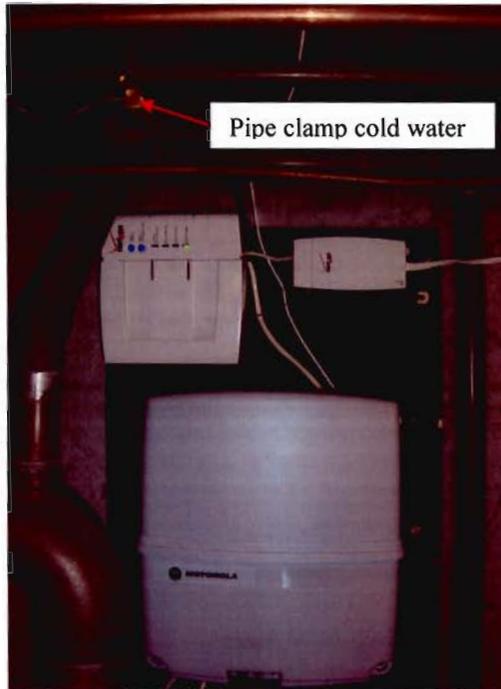
**Photo 9**

**FiOS ground conductor attached to pipe clamp on cold water that is more than 5 feet from water line point of entry.**

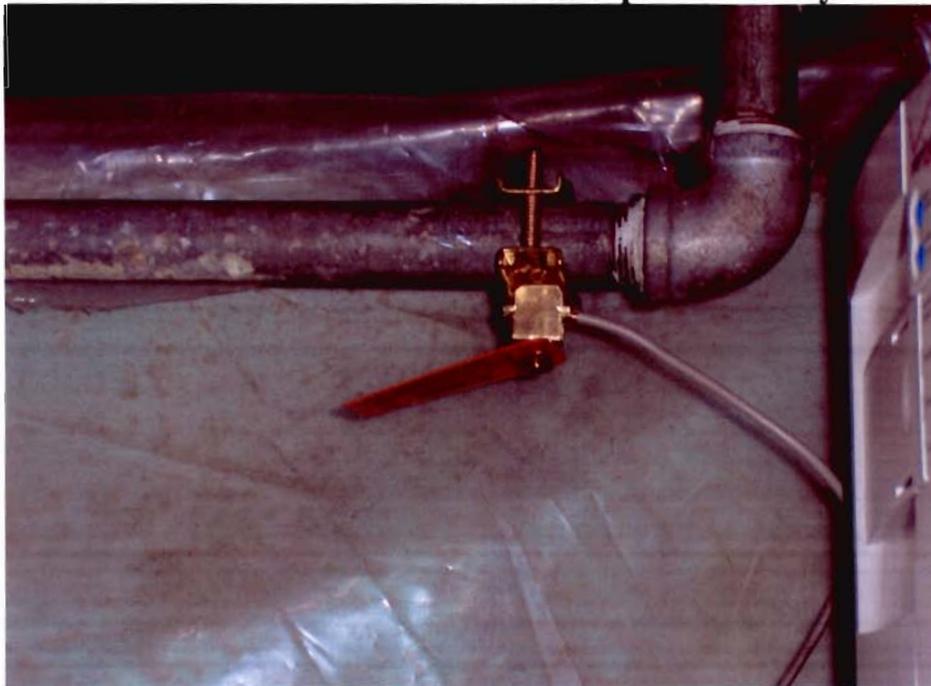
**Photo 10**

**FiOS ground conductor attached to pipe clamp on cold water that is more than 5 feet from water line point of entry.**

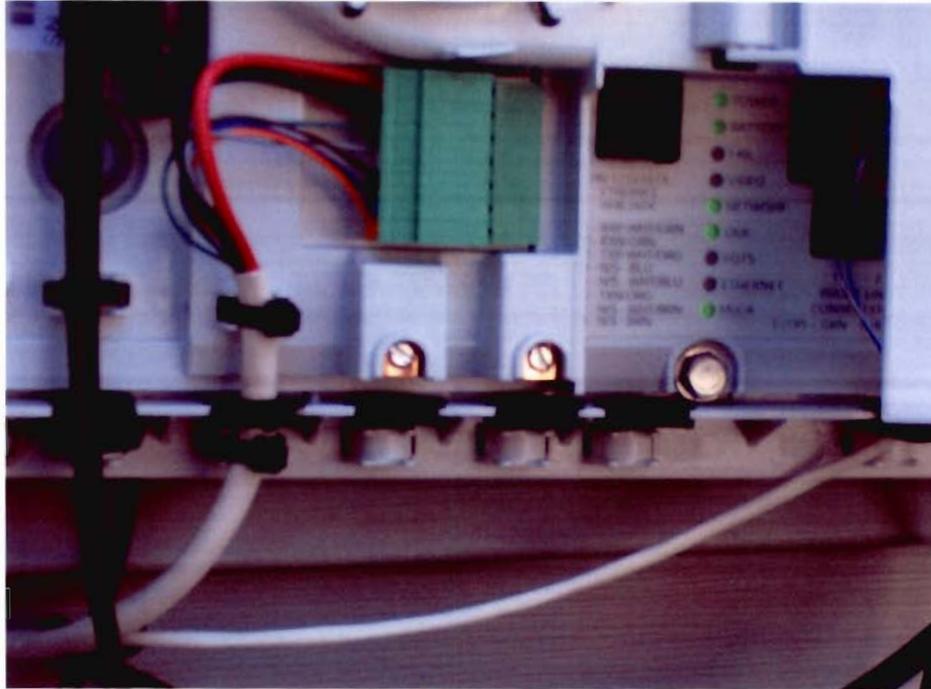
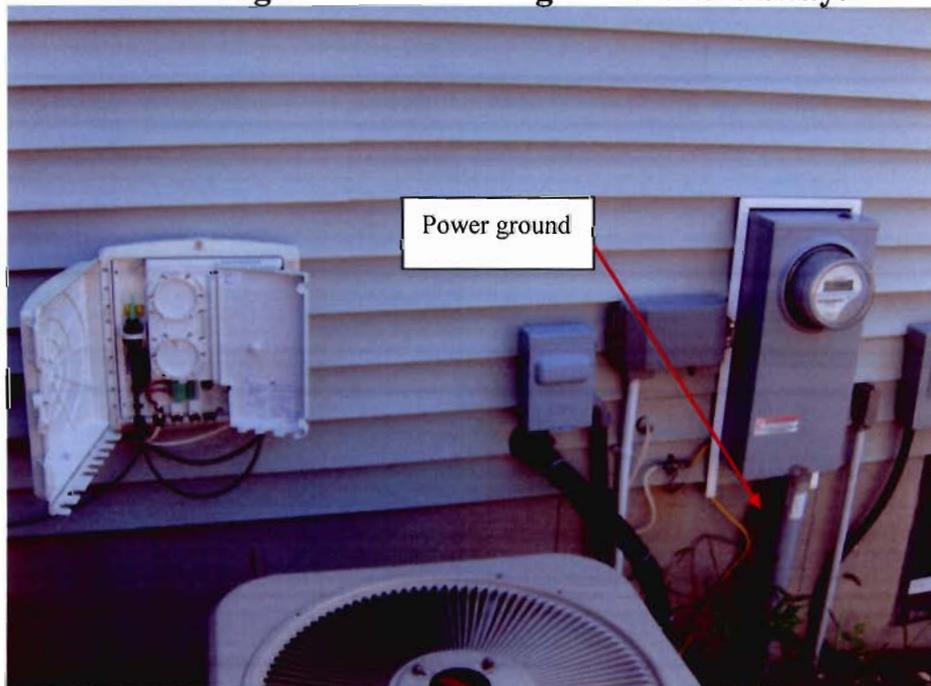
- 1) **█ Peach Tree Lane**  
**FiOS not grounded. Power ground 6 feet away. (Photo 1 and 2)**

■ Peach Tree Lane, Albany.  
**FiOS not grounded. Power ground 6 feet away.**

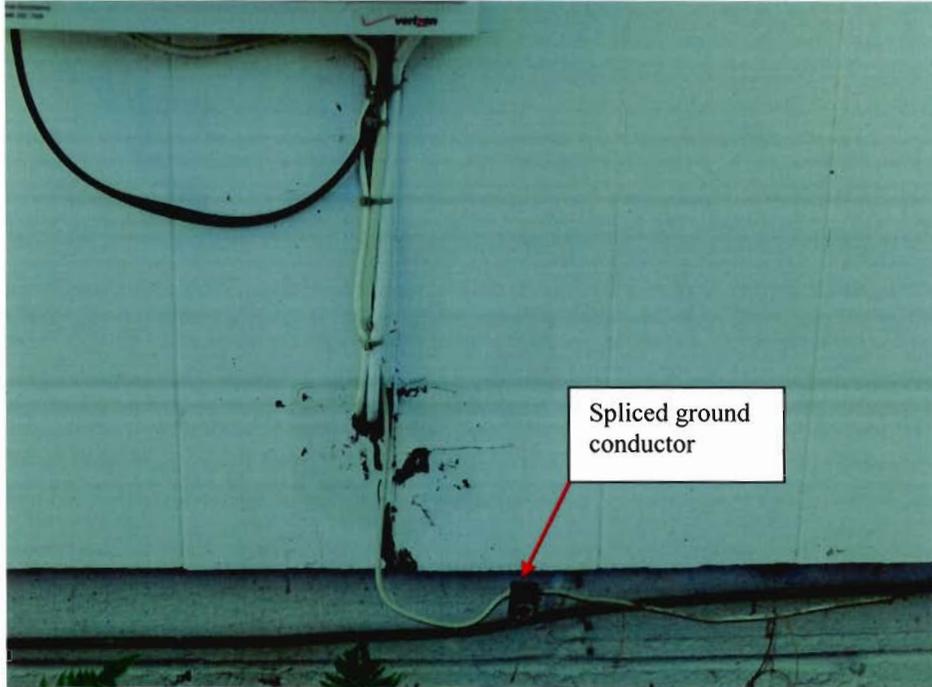
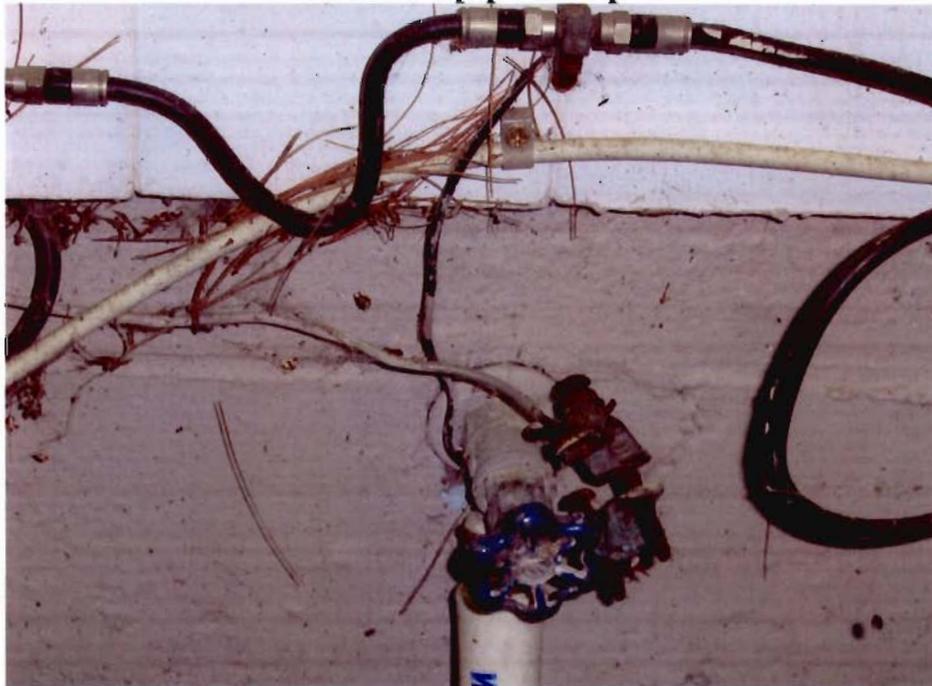
- 3) **█ Pine Ridge Drive.**  
**FiOS ground conductor spliced with Fargo clamp, then attached to same disconnected pipe clamp as CATV. (Photo 3 and 4)**

**FiOS ground conductor spliced with Fargo clamp, then attached to same disconnected pipe clamp as CATV.**

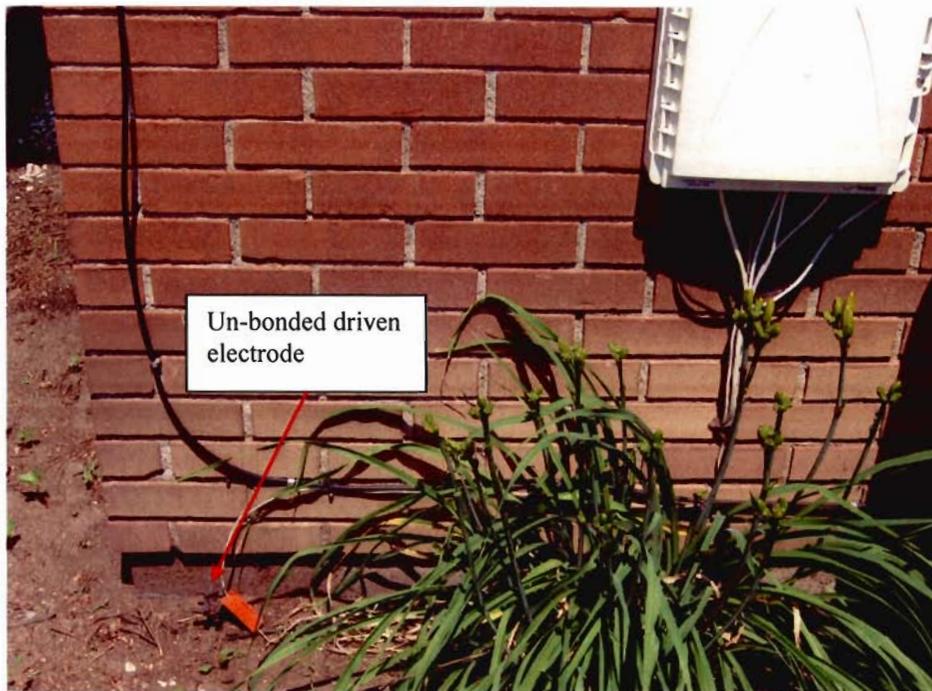
**Photo 5**

- 4) **█ Swayze Drive.**  
**FiOS ground conductor attached to un-bonded driven electrode. (Photo 5)**

**FiOS ground conductor attached to un-bonded driven electrode.**

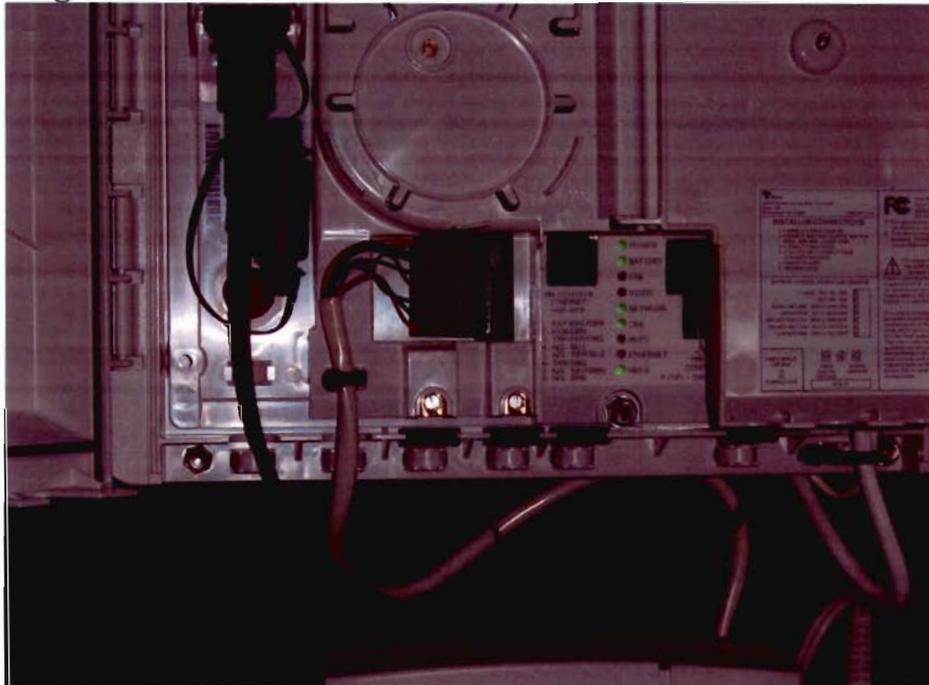
**Photo 6**

**FiOS not grounded. Power ground 2 feet away. (Photo 6)**

**FiOS not grounded. Power ground 2 feet away.**
