DPS Installation Review: FiOS Related Customer Premises Installation Audits

October 2007

AUDIT REPORTS
(Individual Reports Attached)

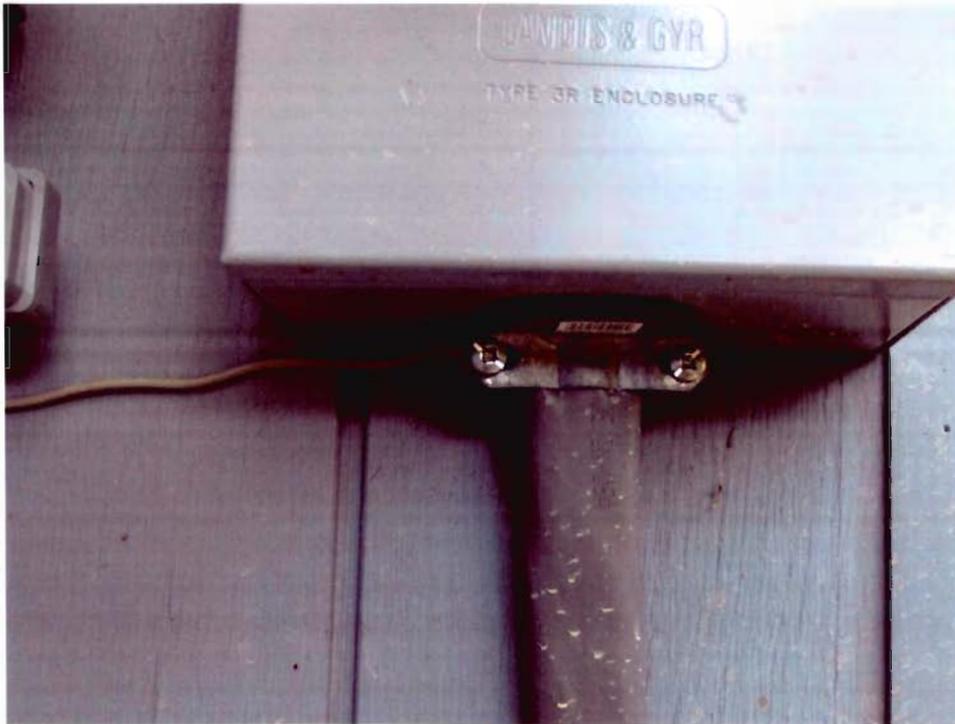
Photo 1

Pole 15: █████ Spencer Court, Greenburgh
Improper attachment of FiOS ground conductor to screw of output clamp on meter pan

FiOS ONT grounded to screw of output clamp at meter pan (improper attachment) (Photo 1).

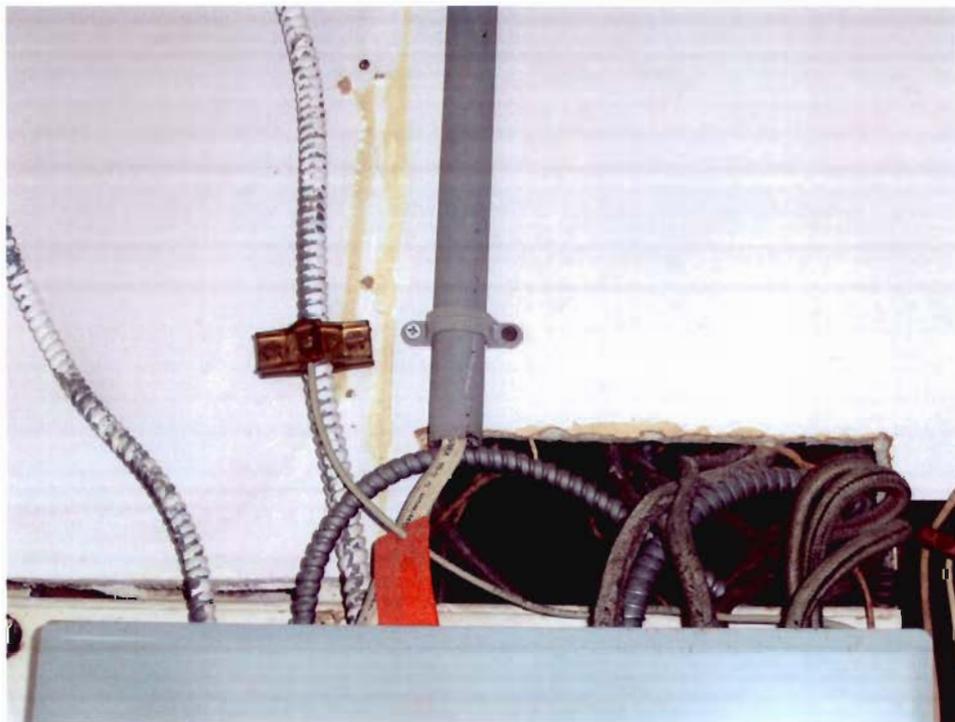
Photo 2

Pole 7: █████ Shaw Place, Greenburgh
FiOS ONT grounded to armored cable with pipe clamp.

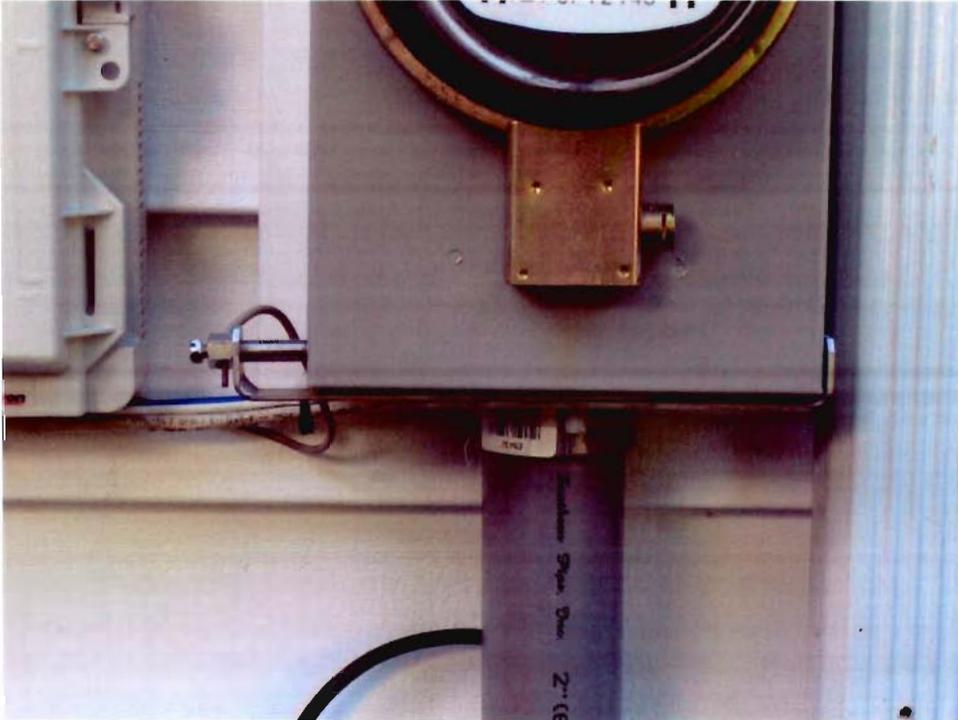
Photo 3

Beacon Hill Road, Ardsley
Example of FiOS adjustable meter box ground clamp.

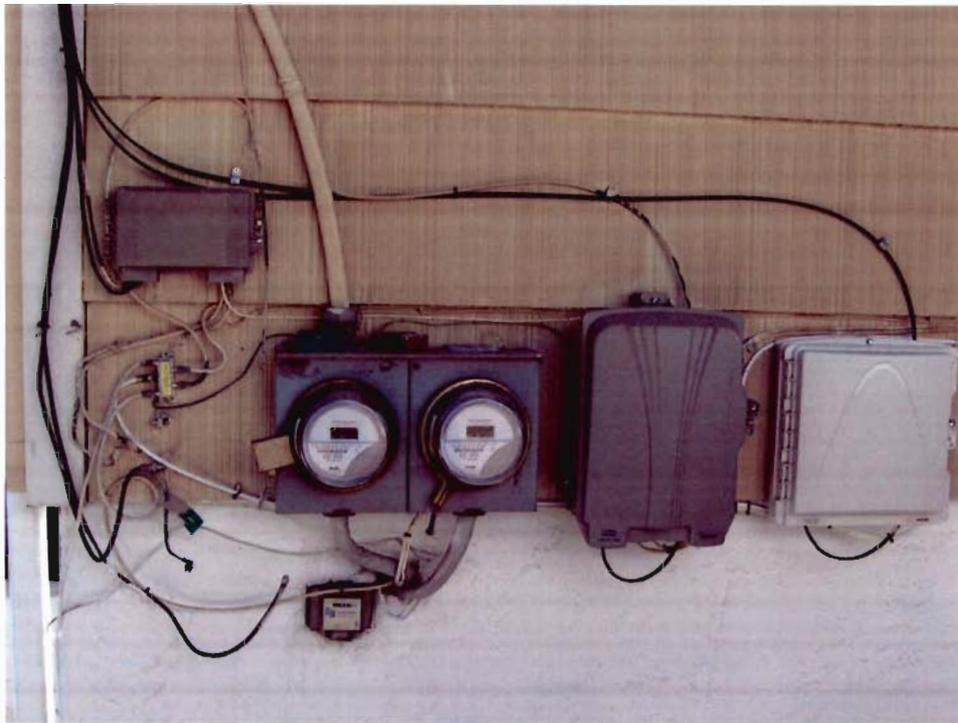
Photo 4

Pole W7: N. Evarts Avenue, Elmsford
One FiOS ONT attached to screw of input flange to meter pan
Second ONT attached to CATV ground strap

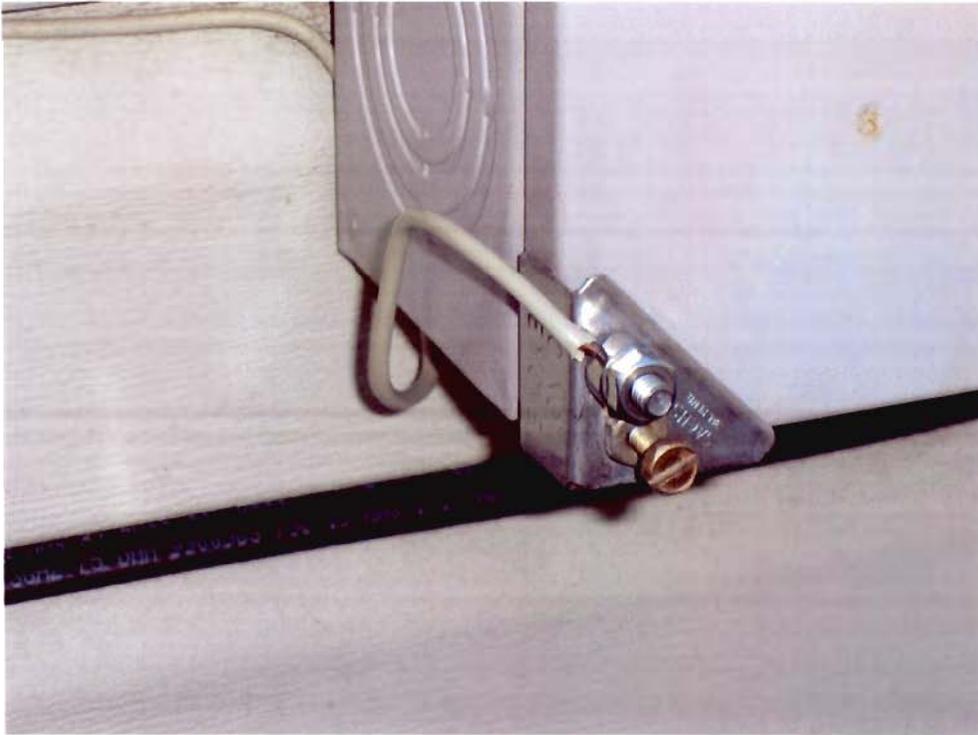
Photo 5

Pole 9: [REDACTED] Evarts Avenue, Elmsford
FiOS attached to Sachs Model SC51-2 meter pan corner clamp using #10 AWG wire;
clamp designed for 6 AWG wire

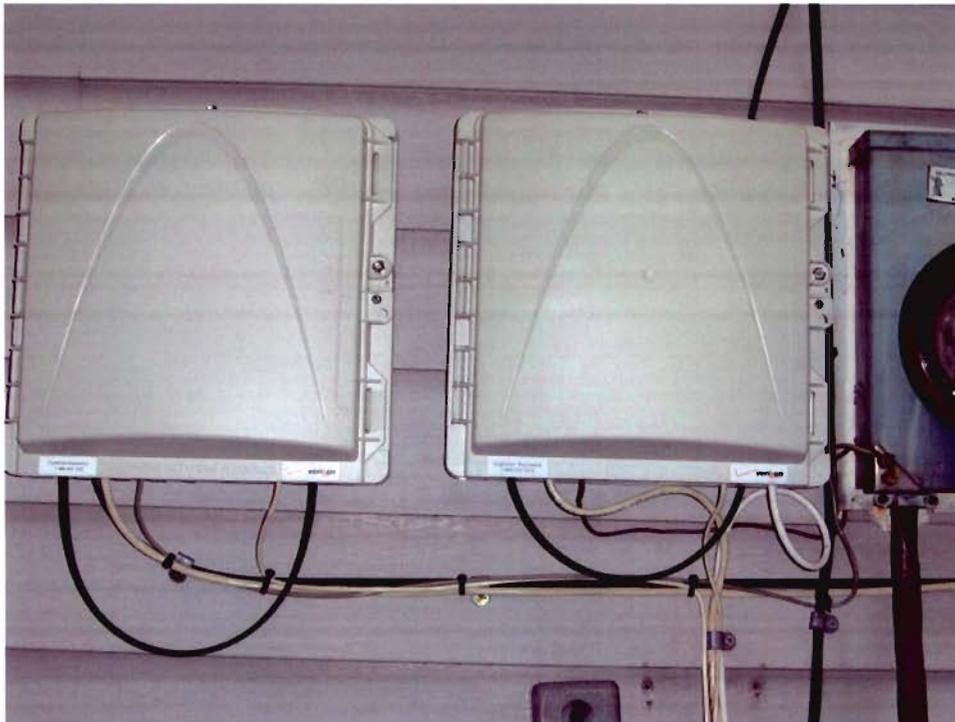
Photo 6

Pole W2: [REDACTED] Cottonet Street, Irvington
Multiple conductors attached to FiOS meter pan corner clamp.

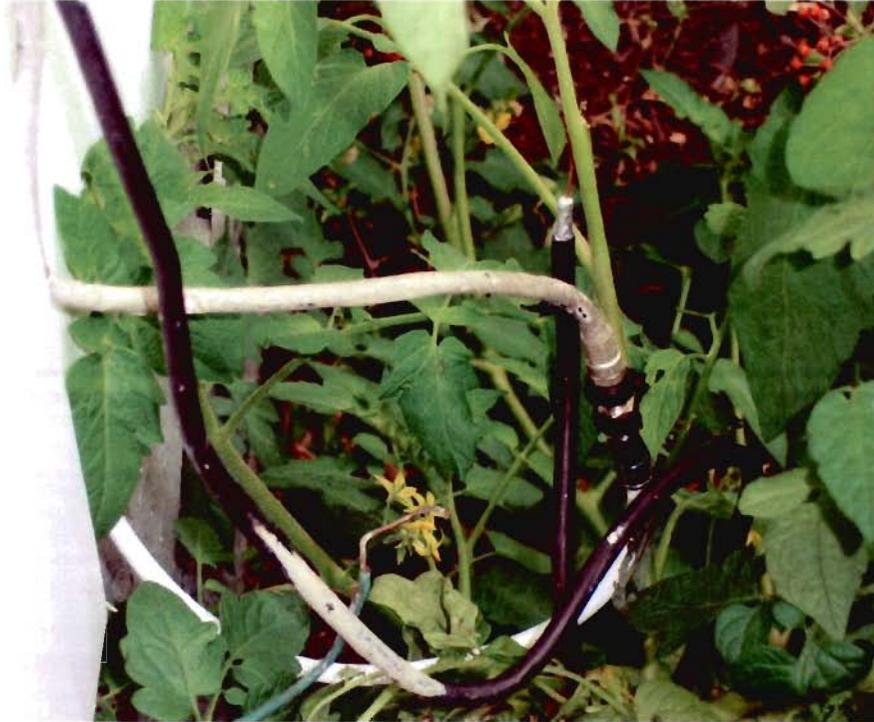
Photo 7

Pole 1: [REDACTED] Cottonnet Street, Irvington
FiOS using CATV coaxial cables. CATV drop and ground conductor left disconnected at house, not terminated, still active at pole.

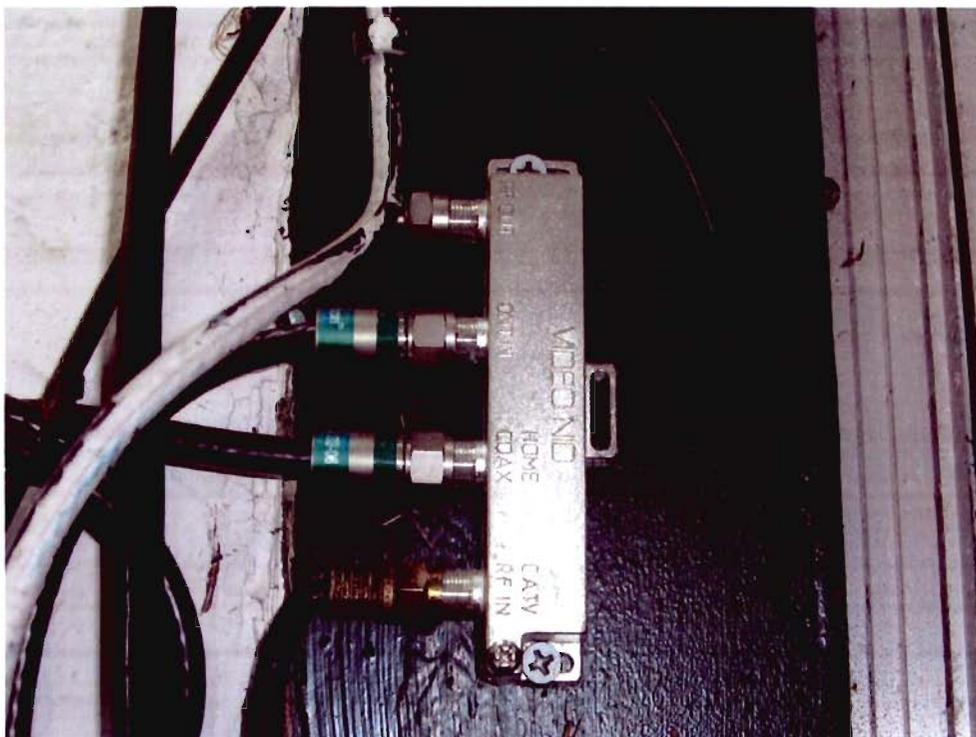
Photo 8

Pole 11: [REDACTED] Cottonnet Street, Irvington
FiOS Video NID installed for MoCa using active CATV drop as RF input

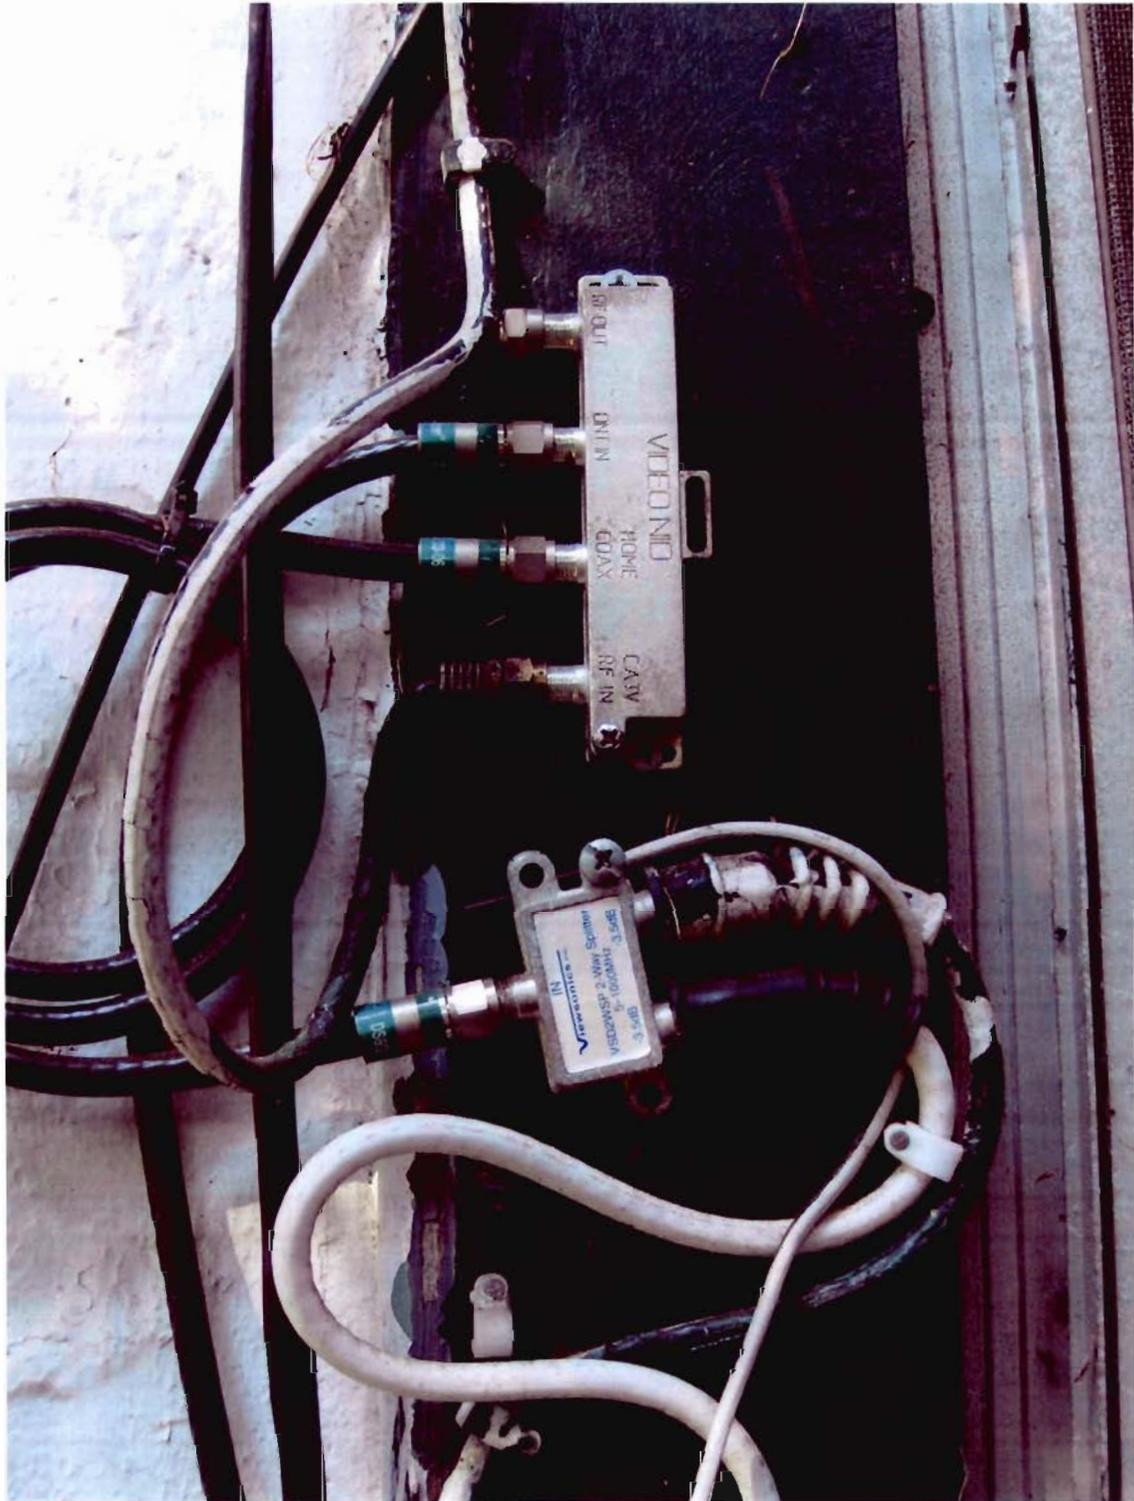
Photo 9

Pole 11: [REDACTED] Cottonet Street, Irvington
FiOS Video NID installed for MoCa using active CATV drop as RF input

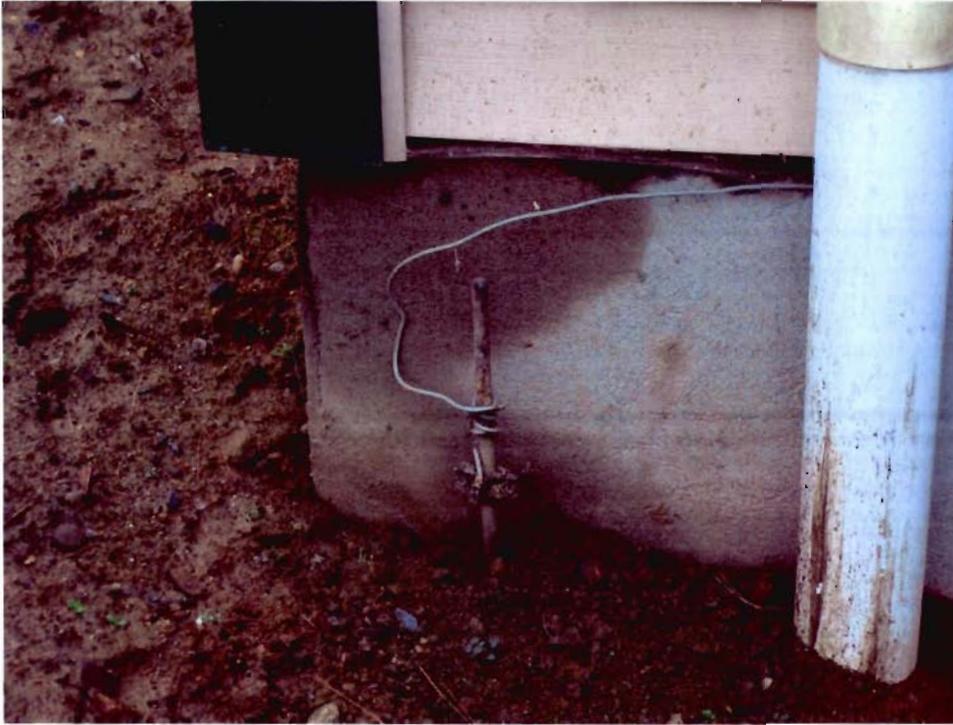
Photo 10

Pole W1: [redacted] Terrace Avenue, Tarrytown
FiOS ONT grounded to un-bonded ground rod.

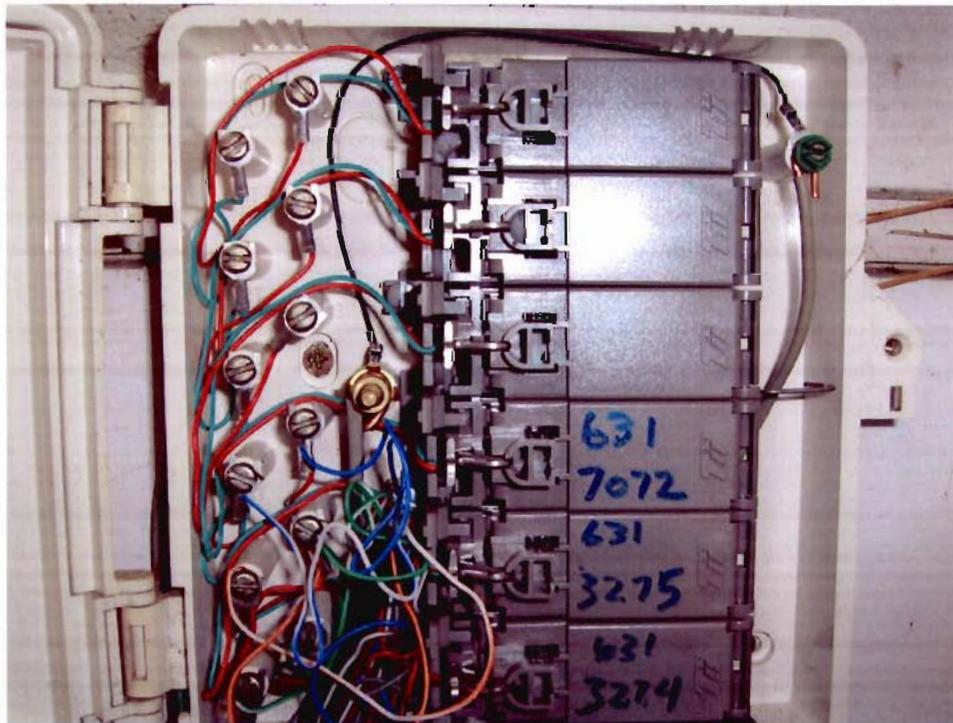
Photo 11

Pole 3: [redacted] Sunnyside Avenue, Tarrytown
FiOS ground conductor spliced inside network interface terminal.

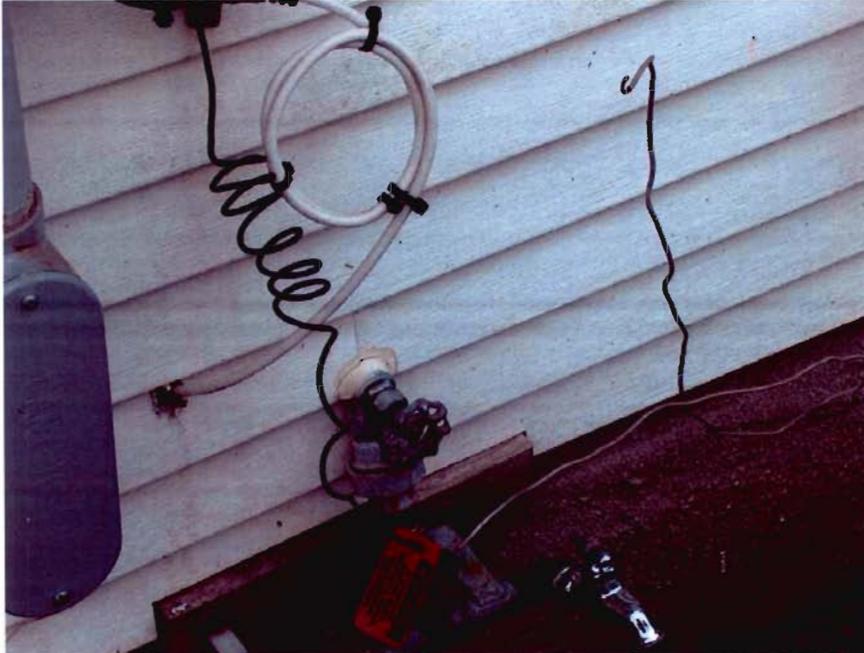
**Photo 1 - Pole # 4, ██████ Barwick Boulevard.
FiOS ground conductor connected to CATV ground.**

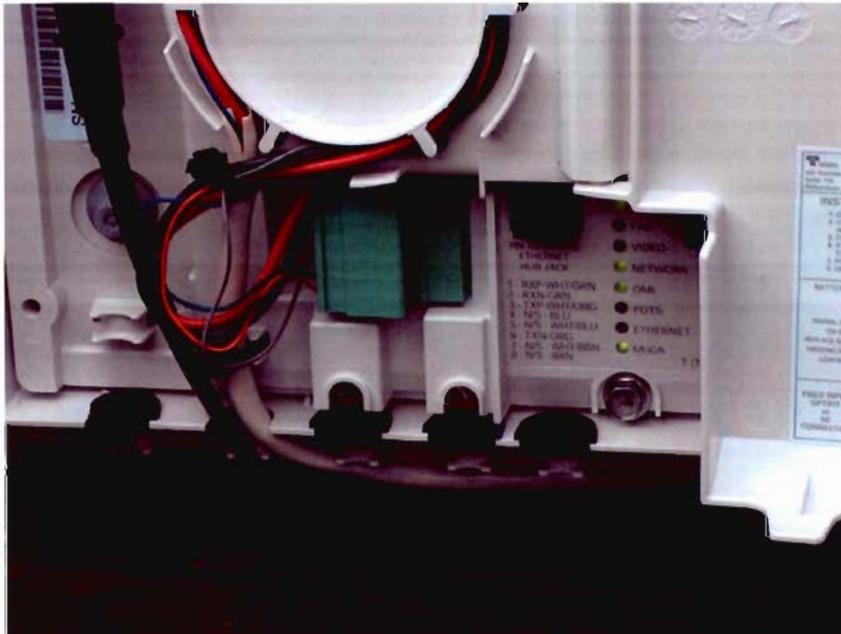
**Photo 2 - Pole # 8, ██████ Clemens Road.
FiOS not grounded, no ground conductor.**

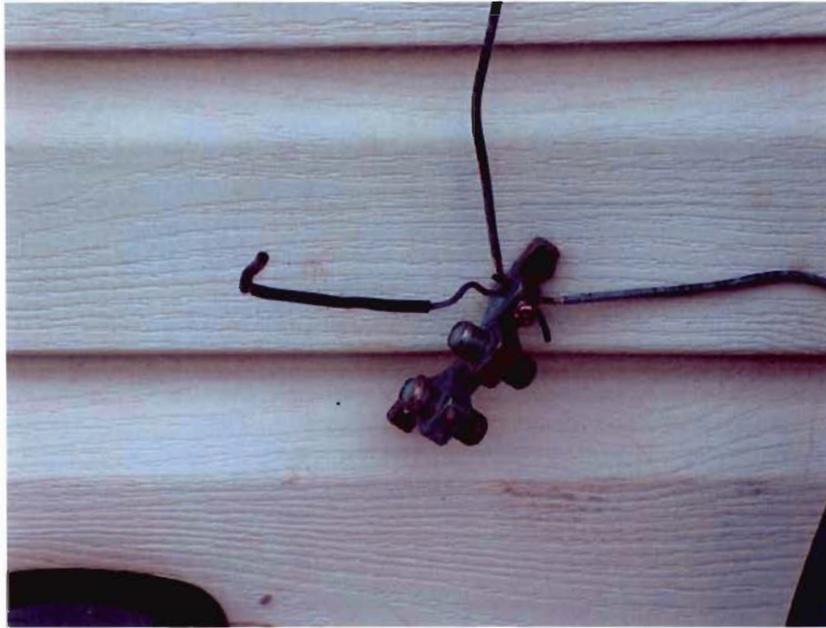
**Photo 3 - Pole # 4, [REDACTED] Jerome Avenue
FiOS ground conductor spliced at CATV ground block. FiOS ground
conductor connected to CATV ground.**

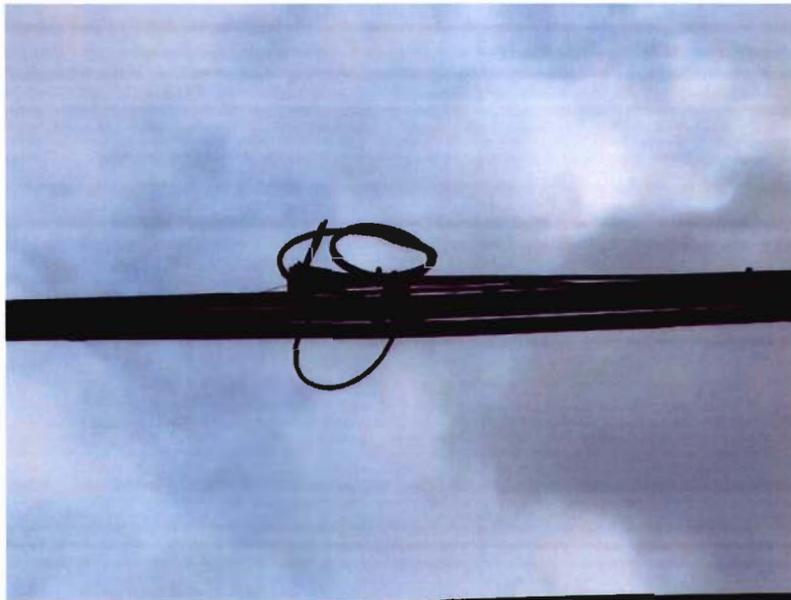
**Photo 4 - Pole # 4, [REDACTED] Jerome Avenue
CATV drop conductor cut at mid-span.**

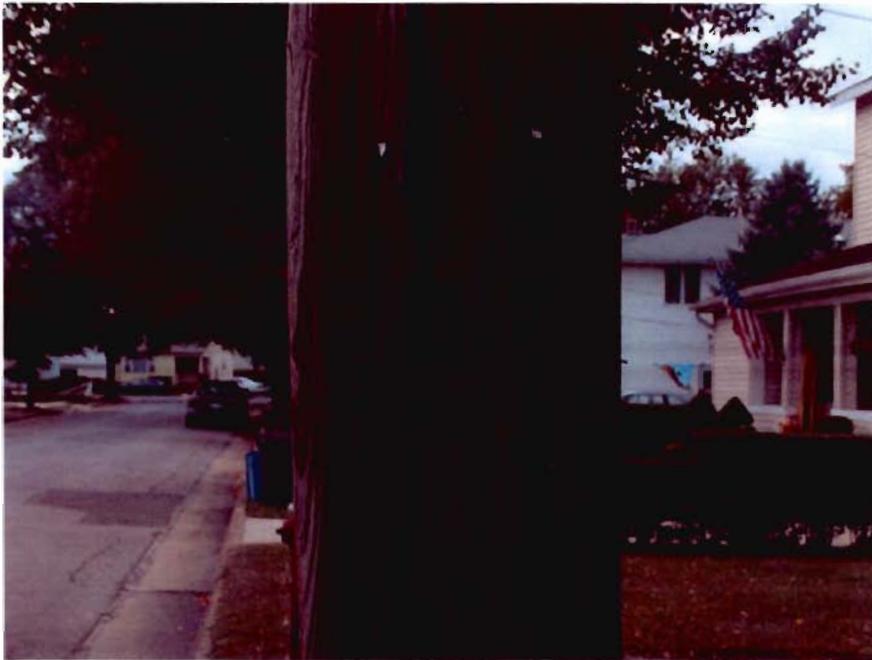
Photo 5 – Pole # 1, [REDACTED] Jerome Avenue FiOS ground conductor connected to CATV ground, CATV drop conductor cut at pole.

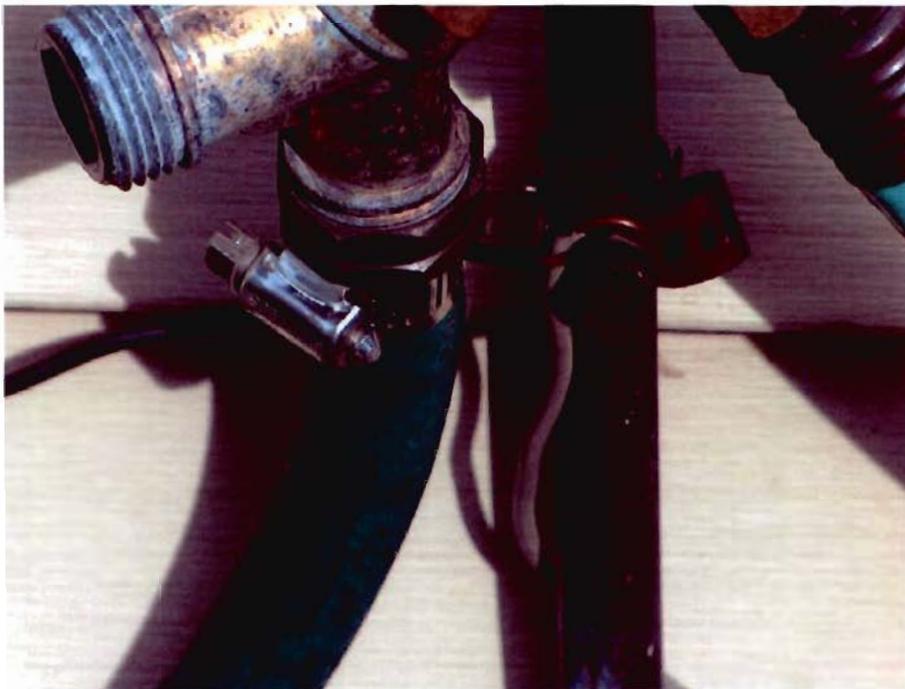
Photo 6 - Pole # 31, [REDACTED] Jefferson Avenue FiOS ground conductor connected to CATV ground.

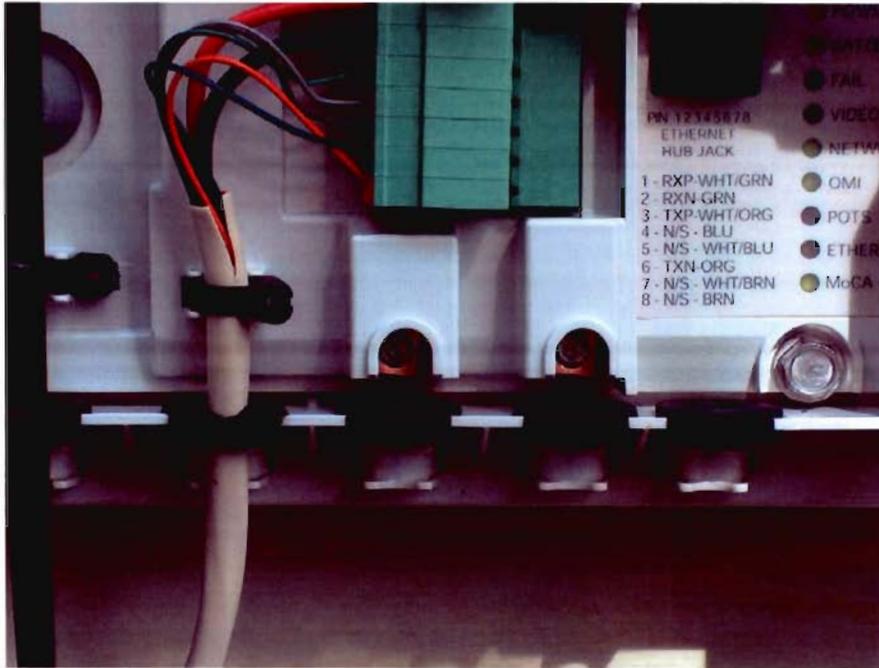
**Photo 7 - Pole # 31, [REDACTED] Jefferson Avenue
FiOS not grounded, no ground conductor.**

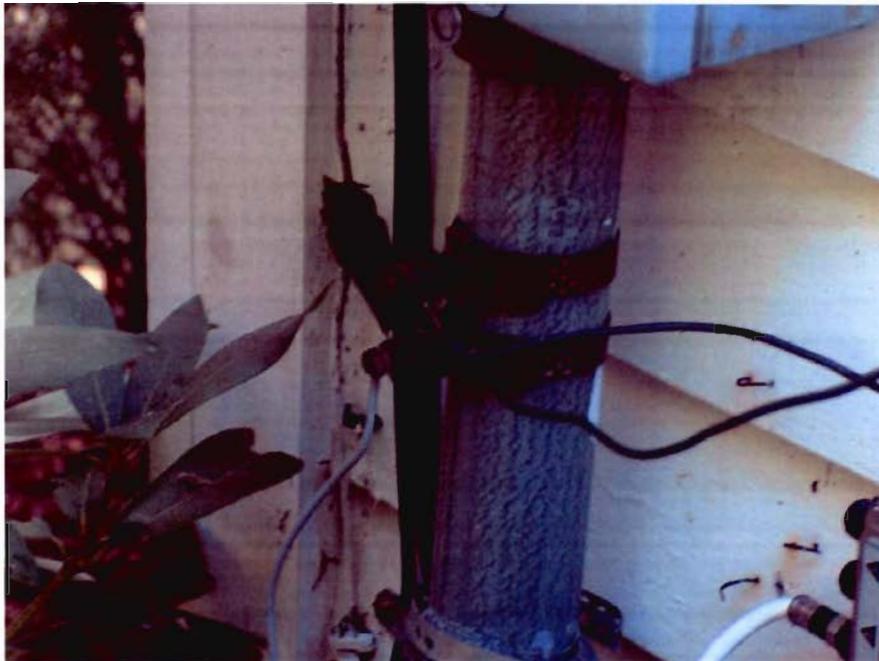
**Photo 8 - Pole # 15, [REDACTED] Laurel Hollow Road.
FiOS ground conductor connected to CATV ground.**

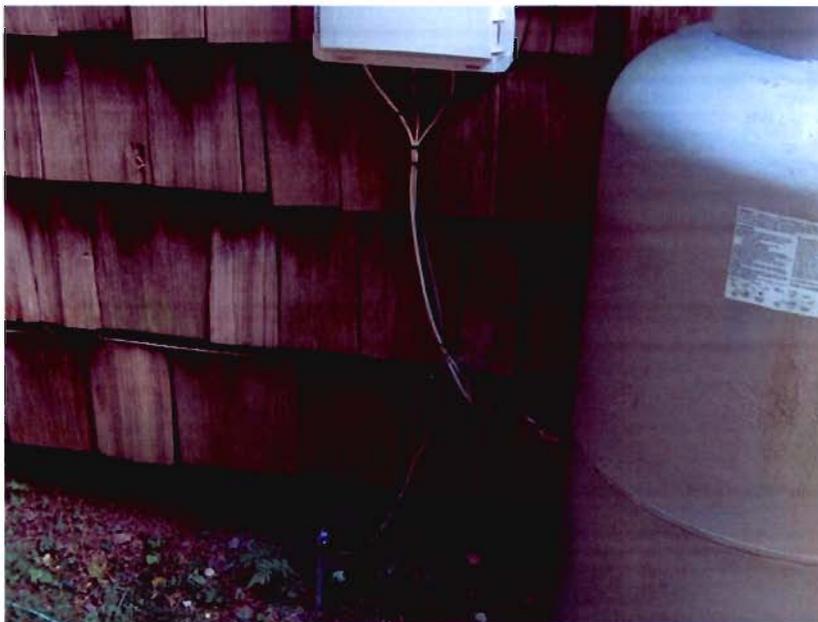
**Photo 10 - Pole # 16, [REDACTED] Laurel Hollow Road.
FiOS ground conductor connected to CATV ground.**

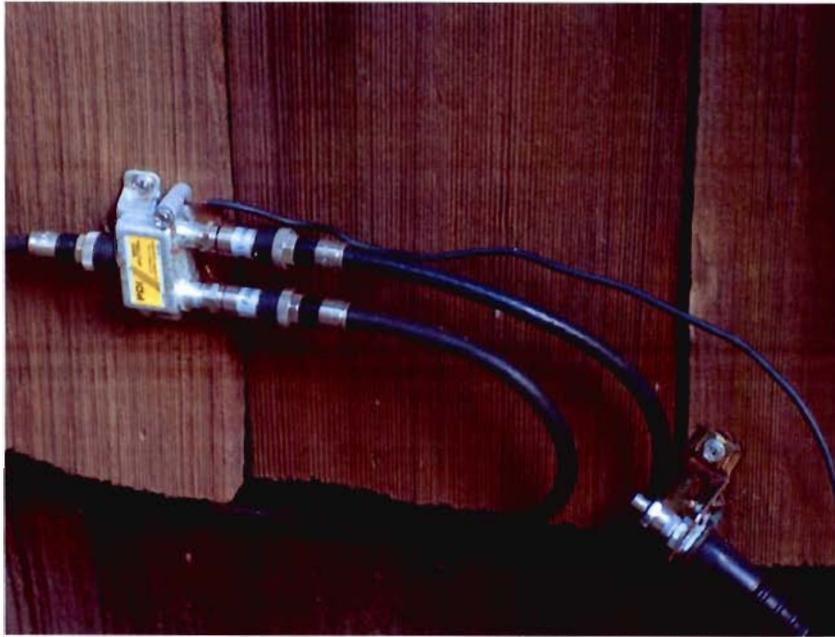
**Photo 11 - Pole # 13, [REDACTED] Laurel Hollow Road.
FiOS ground conductor connected to CATV ground.**

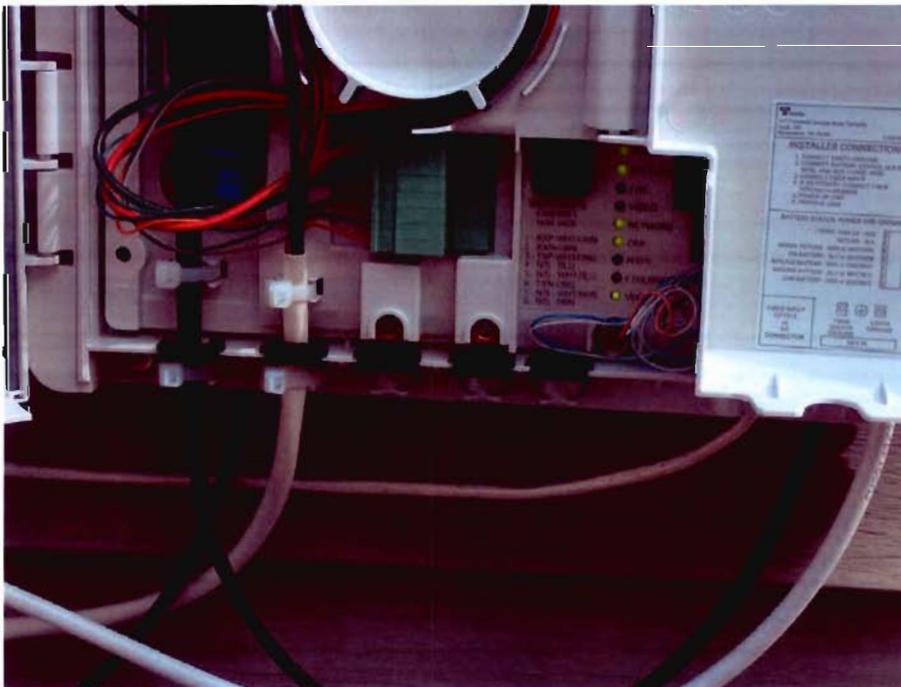
**Photo 12 - Pole # 4, [REDACTED] Breezy Lane.
FiOS not grounded, no ground conductor.**

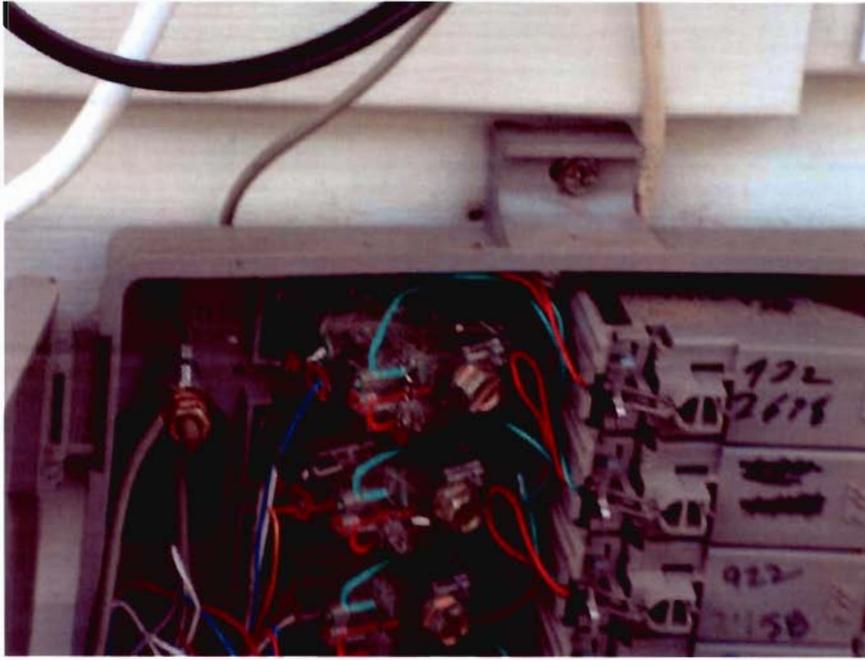
**Photo 13 - No pole #, [REDACTED] 16th Street.
FiOS ground conductor connected to grounding screw in copper terminal.**

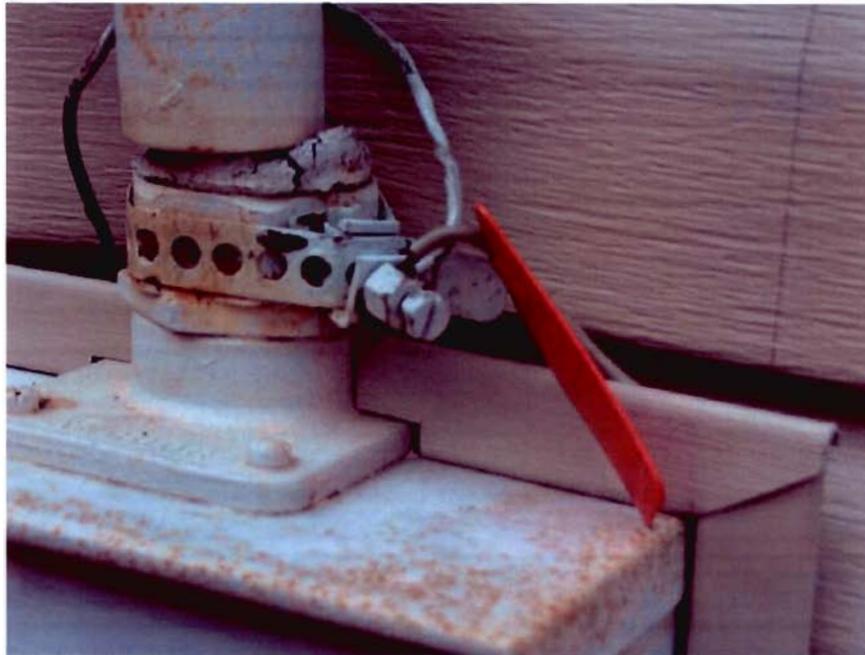
**Photo 14 - No pole #, [REDACTED] Sound Beach Avenue
FiOS ground conductor connected to CATV ground.**

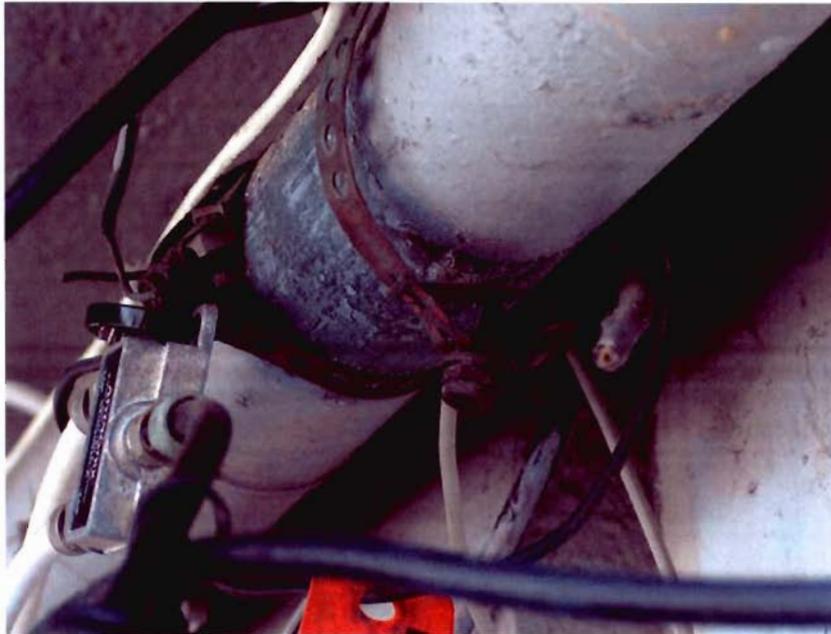
Photo 1

Pole 14, [REDACTED] Oceanpoint Street, Cedarhurst.
CATV ground conductor disconnected and FiOS ground conductor attached to loose CATV pipe strap.

- 1) Pole 14, [REDACTED] Oceanpoint Street.
FiOS ground conductor attached to loose pipe strap. (Photo 1)
- 2) Pole 12, [REDACTED] Oceanpoint Street.
FiOS and CATV ground conductor attached to same single conductor pipe strap.
- 3) Pole 10, [REDACTED] Oceanpoint Street.
FiOS not grounded. (Photo 2)
- 4) Pole 10, [REDACTED] Oceanpoint Street.
FiOS not grounded.
- 5) Pole 112, [REDACTED] Cedarhurst Avenue.
FiOS ground conductor spliced at copper terminal.

CATV ground conductor disconnected and FiOS ground conductor attached to loose CATV pipe strap. (Photo 1)

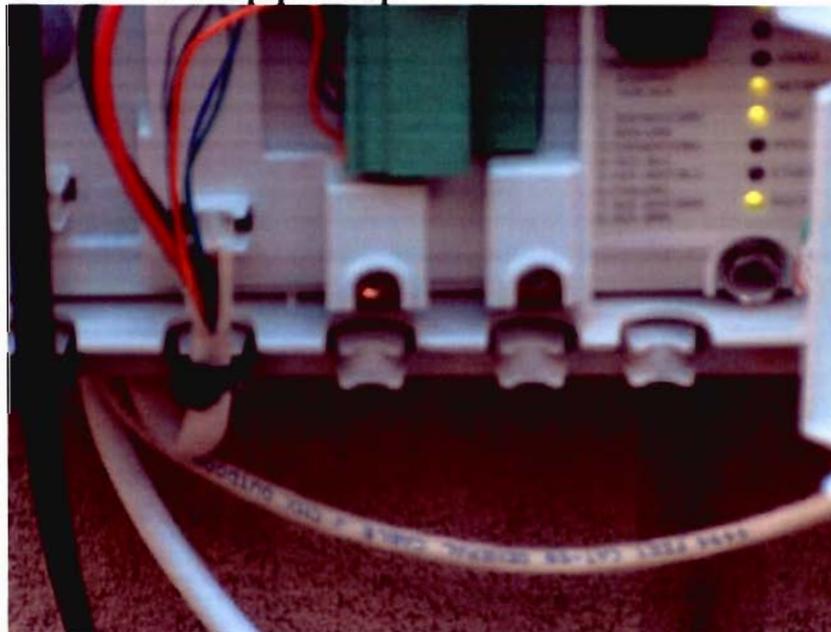
Photo 2

Pole 10, [REDACTED] Oceanpoint Street, Cedarhurst.
FiOS not grounded.

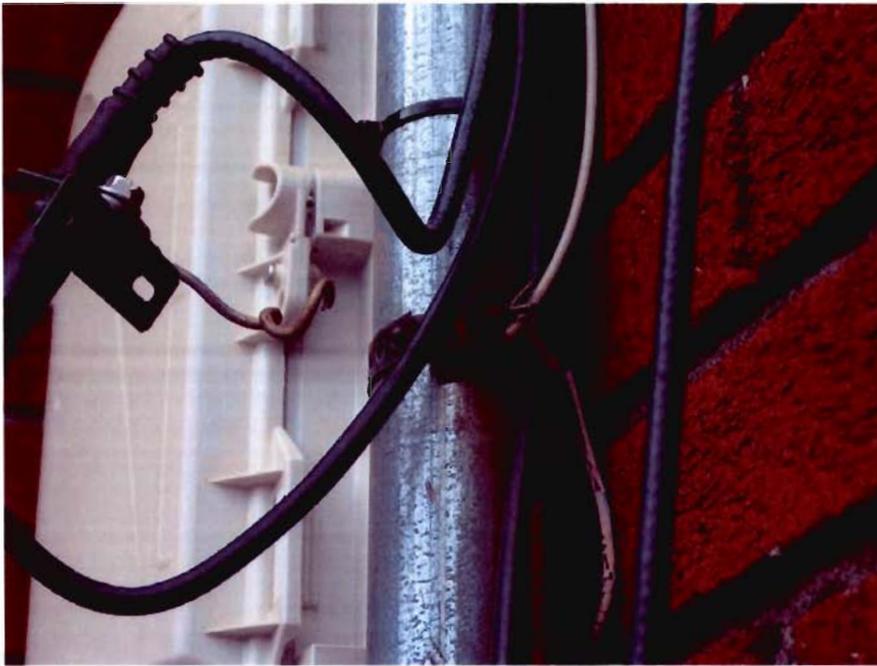
Photo 15 - Pole # 5, [REDACTED] Bayville Avenue and Sound Beach Avenue, [REDACTED]

Two FiOS services connected to same CATV ground.

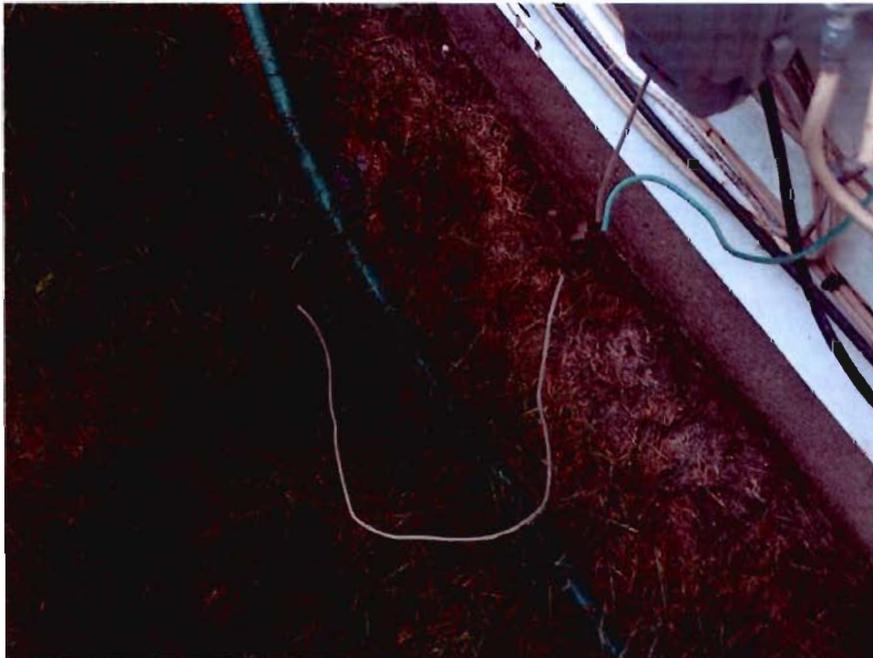
Photo 16 - Pole # 1, [REDACTED] Austin Street.
FiOS not grounded, unattached ground conductor.

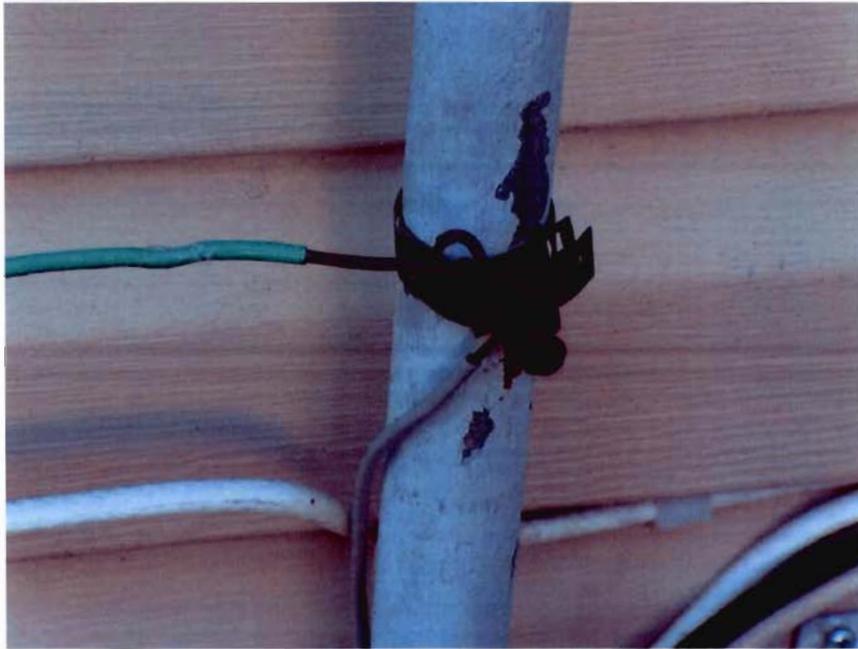
Photo 3

Pole 4, [REDACTED] 12th Street, Huntington.

FiOS and Satellite service ground conductors on same loose single conductor pipe strap.

9) Pole 4, [REDACTED] 12th Street.
FiOS and Satellite service ground conductors on same loose single conductor pipe strap. (Photo 3)

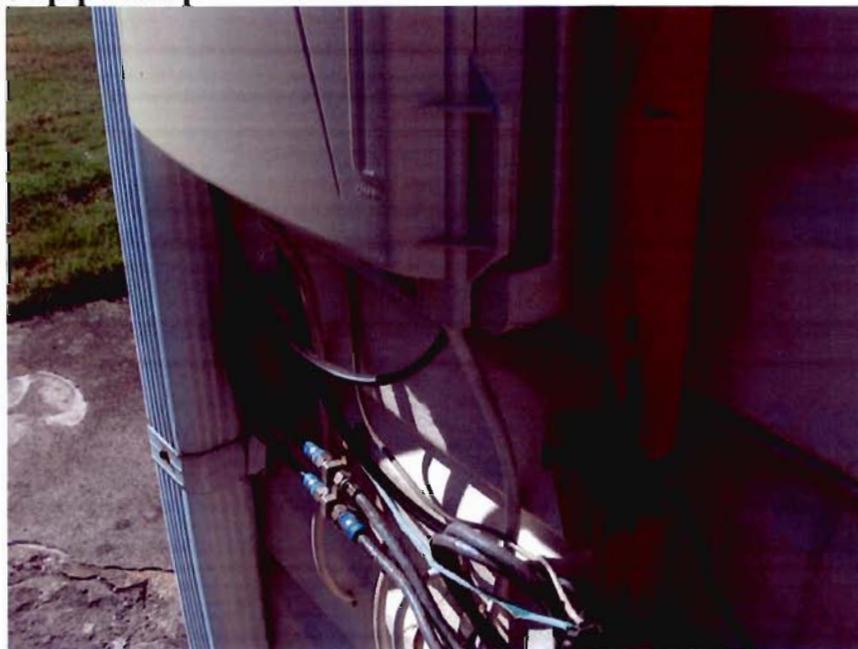
Photo 4

Pole 8, [REDACTED] 12th Street, Huntington.

FiOS and Satellite service ground conductors on same loose single conductor pipe strap.

11) Pole 8, [REDACTED] 12th Street.
FiOS and Satellite service ground conductors on same loose single conductor pipe strap. (Photo 4)

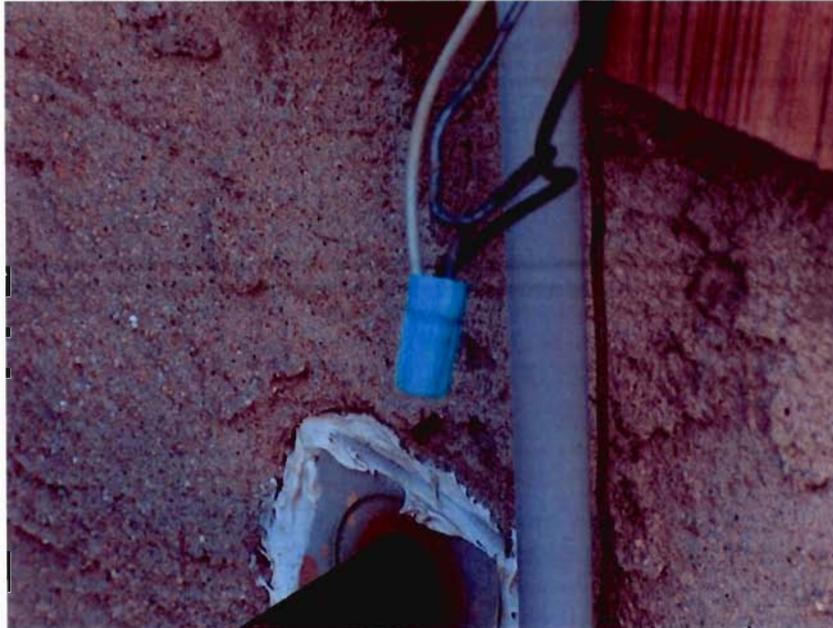
Photo 5

Pole 11, [REDACTED] Bayberry Drive, Huntington.
FiOS spliced into CATV ground conductor using wire nut.

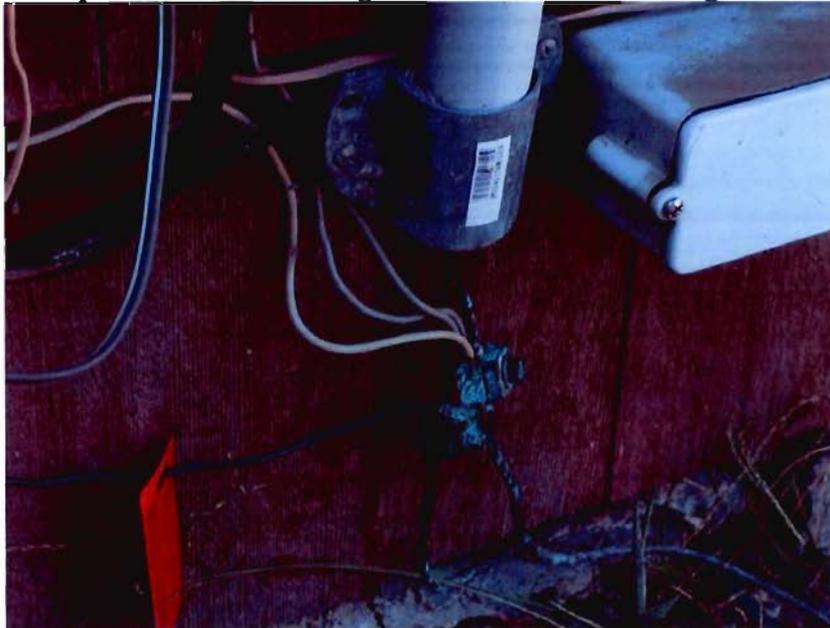
Photo 6

Pole 4, [REDACTED] Bayberry Drive, Huntington.
FiOS and two copper telephone ground conductors under same Fargo clamp.

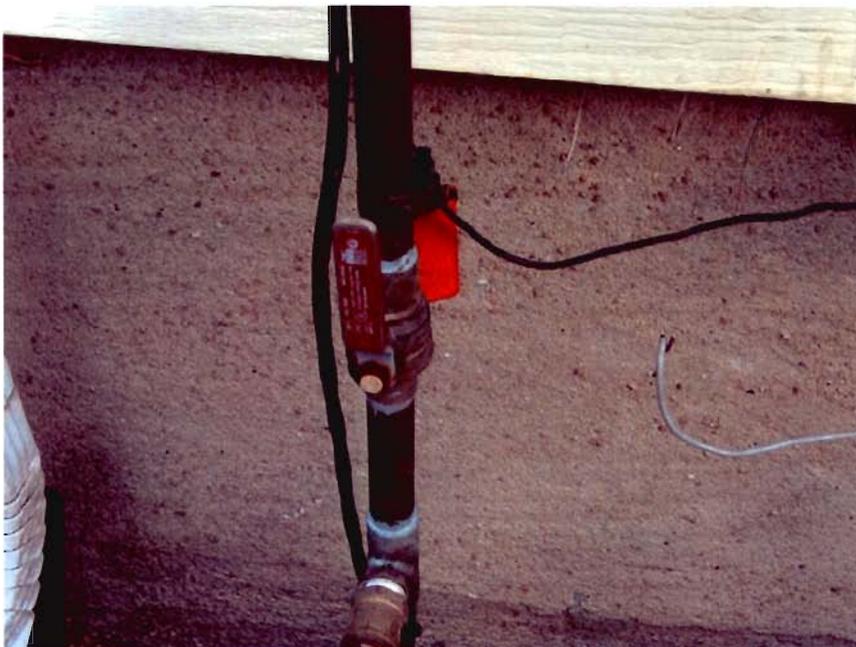
Photo 8

Pole 45, [REDACTED] Grand Boulevard, Massapequa Park.
FiOS ground conductor disconnected.

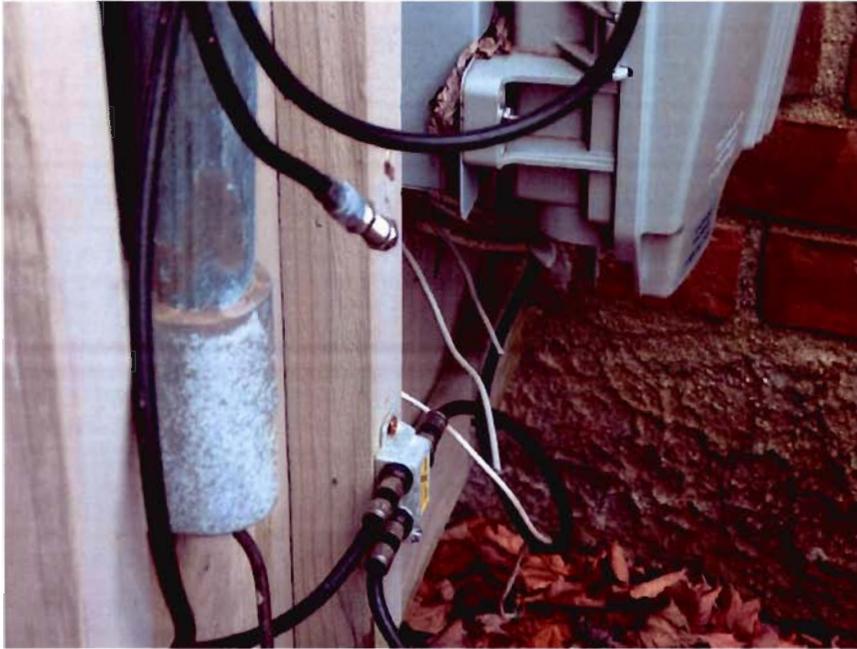
Photo 9

Pole 5, [REDACTED] Henry Street, Massapequa Park.
FiOS ground conductor not attached at Optical Network Terminal.

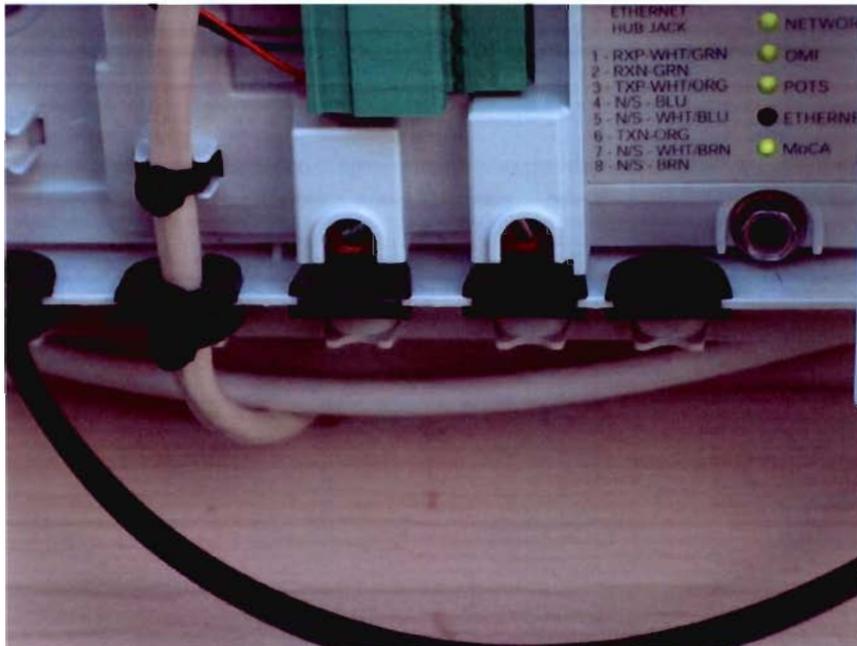
Photo 10

Pole 21, [REDACTED] Saint Marks Avenue, Freeport.
FiOS not grounded.
