DPS Installation Review: FiOS Related Customer Premises Installation Audits

October 2007

AUDIT REPORTS
(Individual Reports Attached)

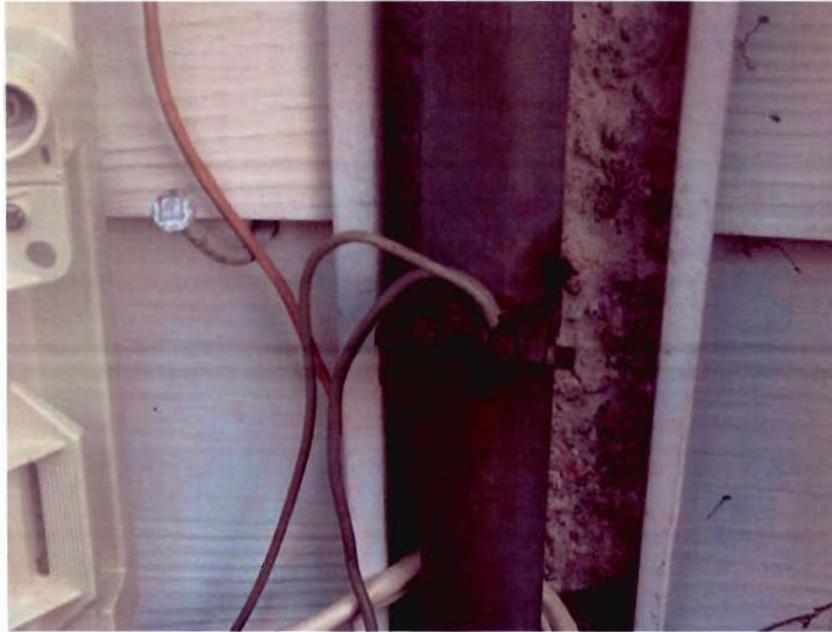
Photo 11

Pole 2, [REDACTED] Prospect Avenue, East Rockaway.

FiOS and copper telephone ground conductors attached to same single conductor pipe strap.

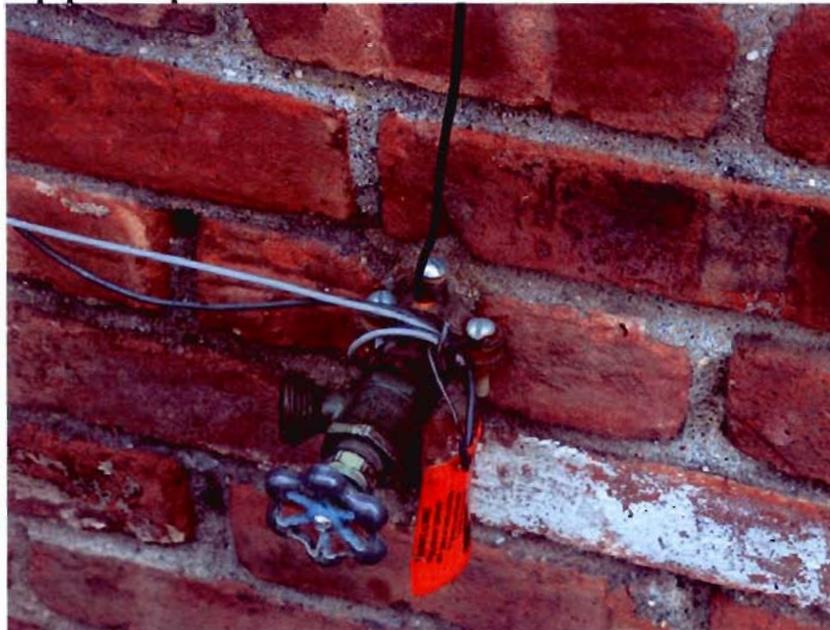
Photo 12

Pole 4, [REDACTED] Munson Place, Freeport.

FiOS and CATV conductors attached to same single conductor pipe strap.

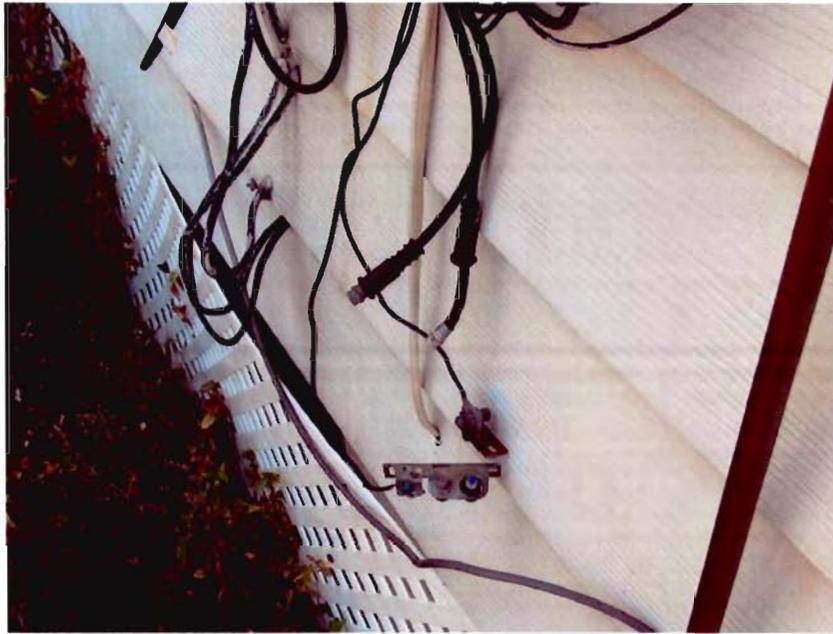
Photo 13

Pole 115, [REDACTED] Cedarhurst Avenue, Cedarhurst.

FiOS used CATV coaxial wire and disconnected CATV from ground blocks. CATV drop not properly terminated.

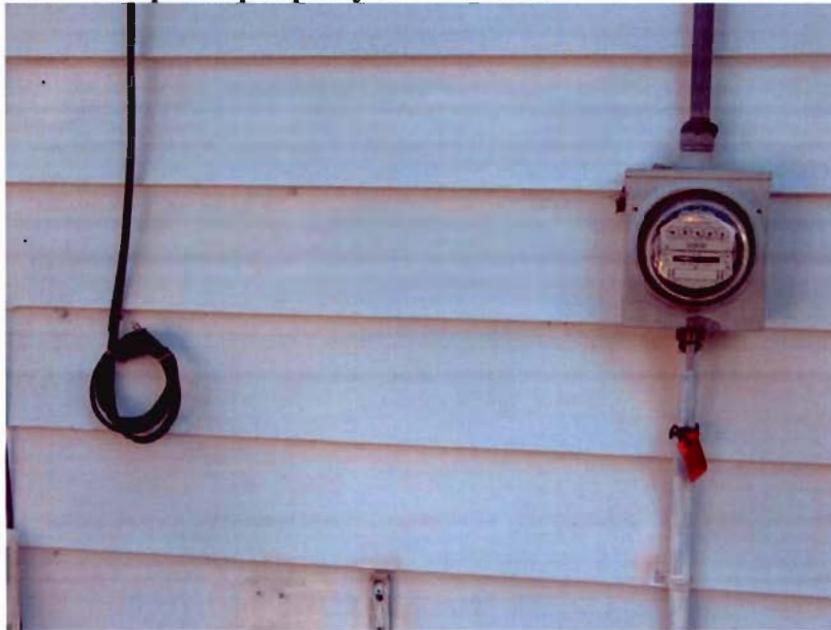
Photo 14

Pole 6, [REDACTED] 12th Street, Huntington.

FiOS removed CATV ground block and ground conductor.

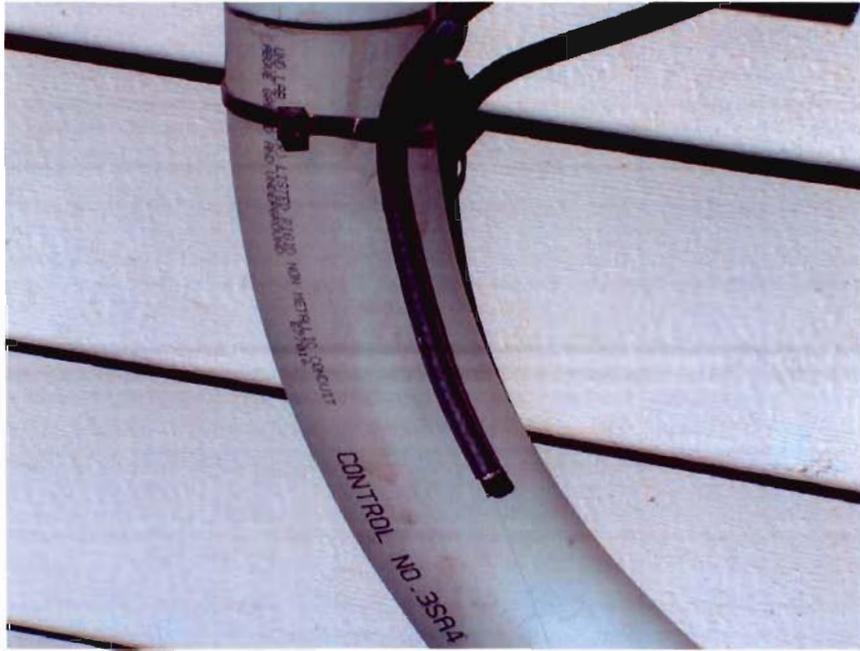
Photo 15

No pole number, [REDACTED] Bayberry Drive, Huntington.
FiOS cut and used CATV coaxial wire. CATV left ungrounded with no termination.

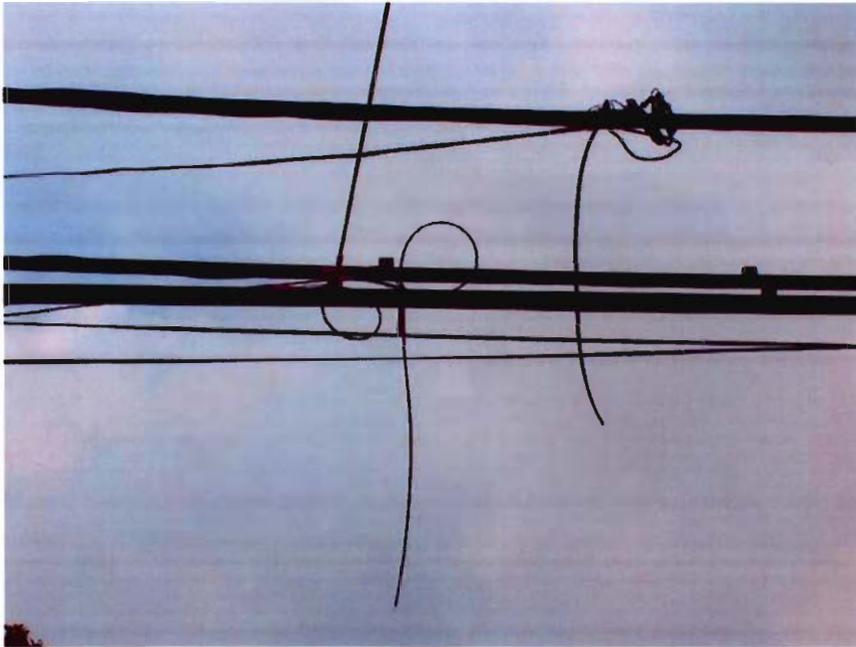
Photo 16

Pole 78, next to [REDACTED] South Long beach Avenue, Freeport.
FiOS cut CATV at mid span attachment and removed to house.

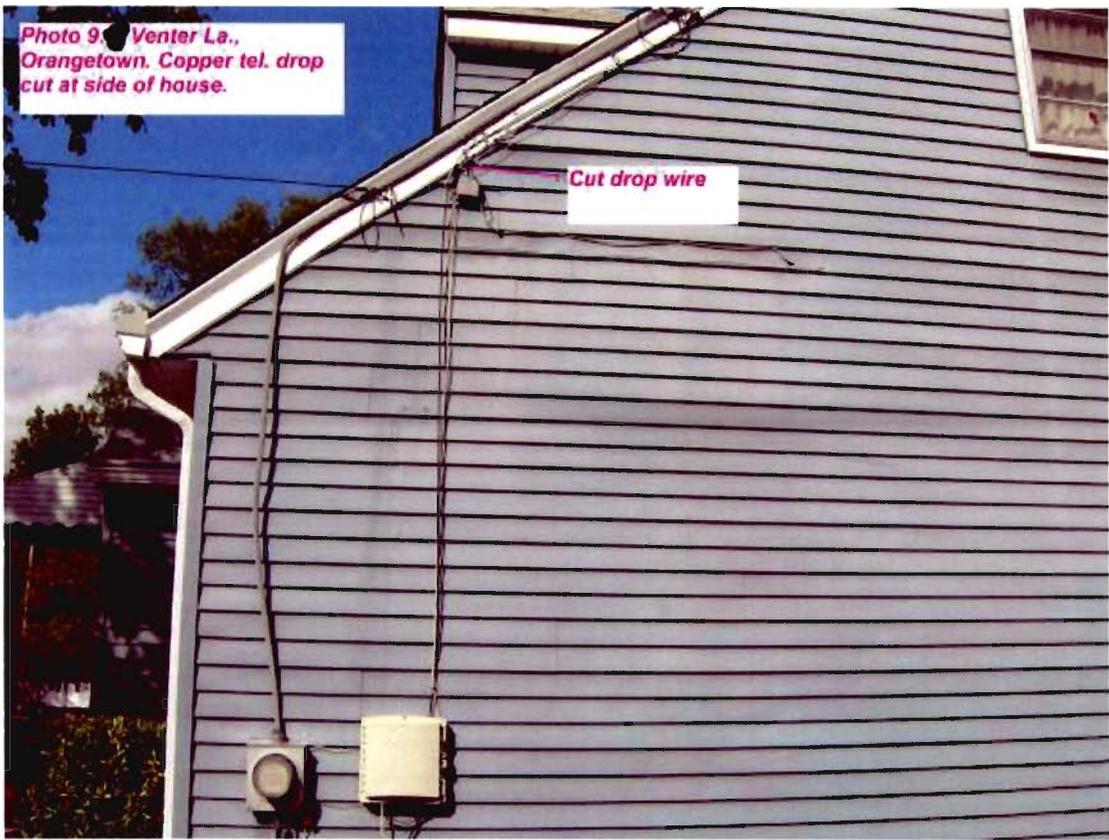
Photo 9 Venter La.,
Orangetown. Copper tel. drop
cut at side of house.

Cut drop wire
