RESULTS OF OUTSIDE PLANT INSPECTION
OF VERIZON FIOS INSTALLATIONS

In Nassau and Suffolk Counties

Report No. S039-08-4224

RESULTS OF OUTSIDE PLANT INSPECTION
OF VERIZON FiOS INSTALLATIONS

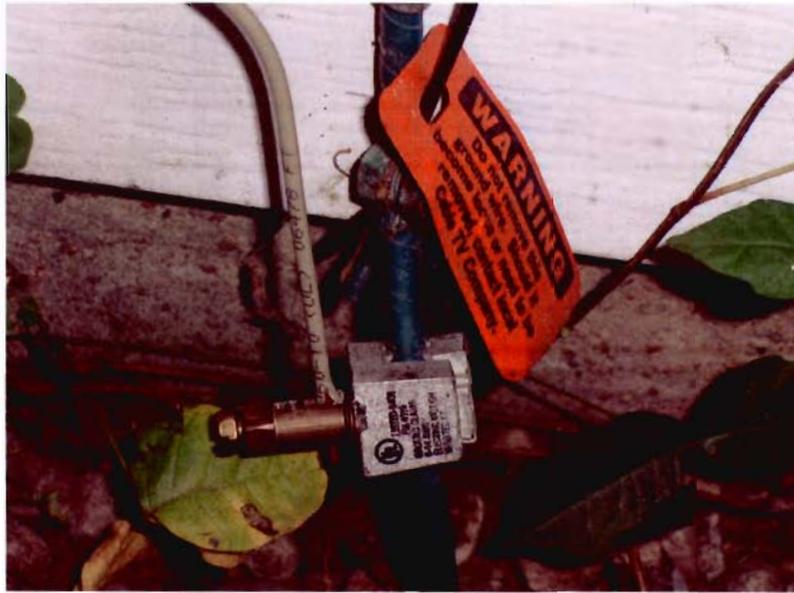
Photo 1

Bushwick Ave, Brentwood.
FiOS ground conductor attached to loose clamp on power ground. Insulation not removed from power ground prior to clamp installation. (Photo 1)
- 3)

**FiOS ground conductor attached to loose clamp on power ground.
Insulation not removed from power ground prior to clamp installation.**

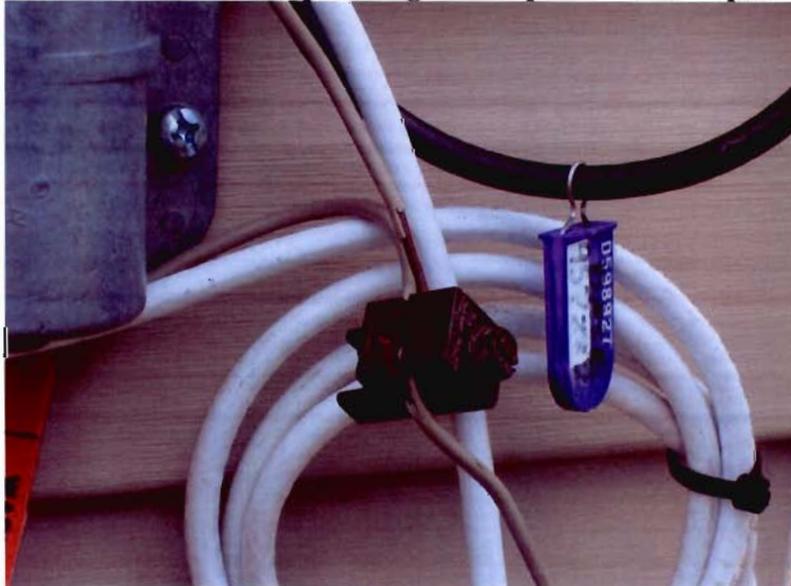
Photo 2

Bushwick Ave, Brentwood.
FiOS # 10 ground conductor taped onto copper telephone # 10 ground conductor with Fargo clamp. (Photo 2)
- 4)

**FiOS # 10 ground conductor tap onto copper telephone
10 ground conductor with Fargo clamp.**

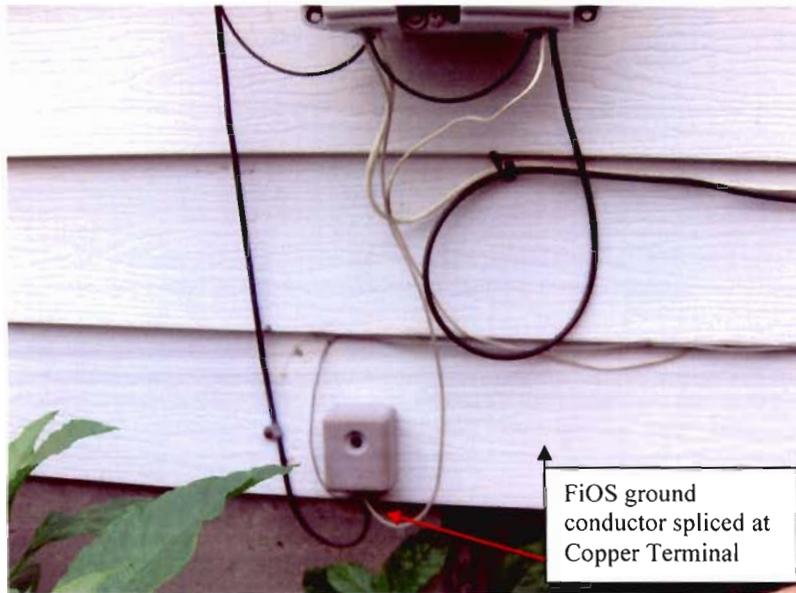
Photo 3

Heyward Street, Brentwood.
FiOS ground conductor spliced at copper terminal. Copper terminal ground conductor attaches to pipe strap on conduit from output of meter pan. **(Photo 3)**
- 6)

FiOS ground conductor spliced at copper terminal. Copper terminal ground conductor attaches to pipe strap on conduit from output of meter pan.

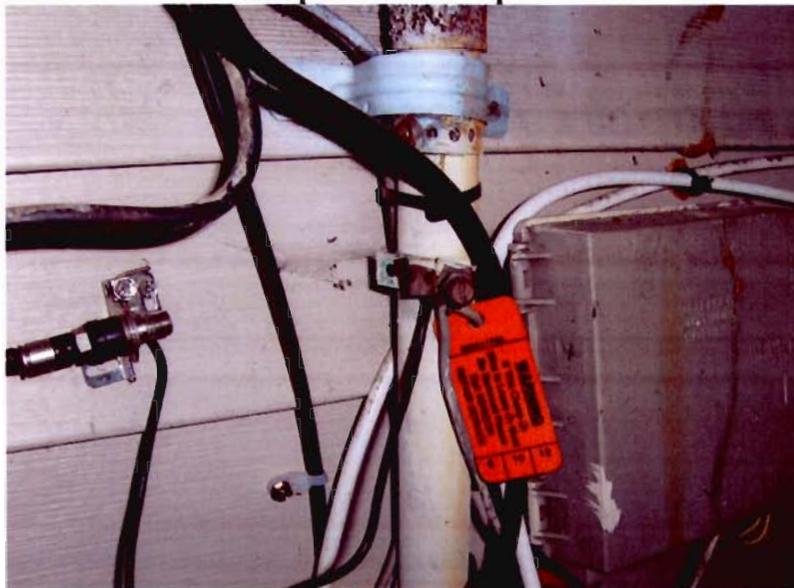
Photo 5

Sallow Lane, Brentwood .
FiOS, Copper Telephone and CATV ground conductors attached to same single conductor pipe strap on conduit from output of meter pan. **(Photo 5)**
- 8)

FiOS, copper telephone and CATV ground conductors attached to same single conductor pipe strap on conduit from output of meter pan.

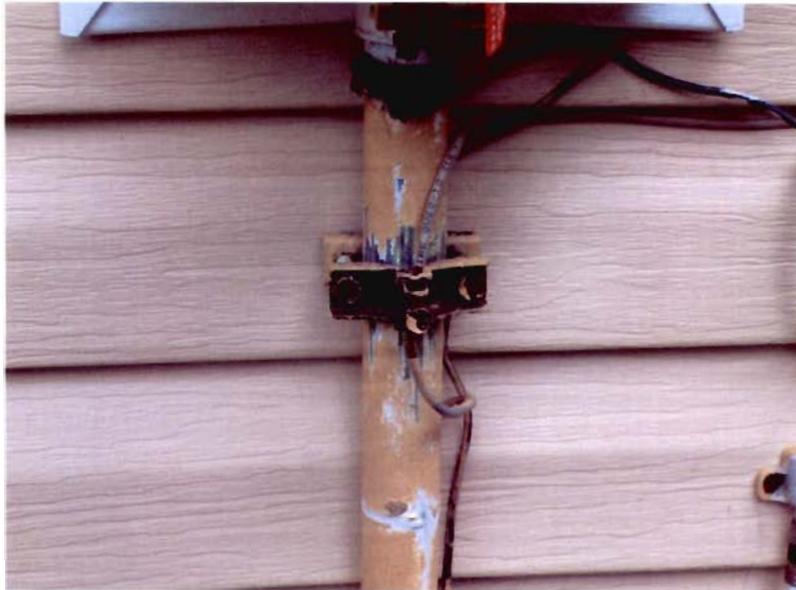
Photo 6

Trush Drive, Brentwood.
FiOS and copper telephone ground conductors attached to same single conductor pipe clamp on conduit from output of meter pan. **(Photo 6)**

FiOS and copper telephone ground conductors attached to same single conductor pipe clamp on conduit from output of meter pan.

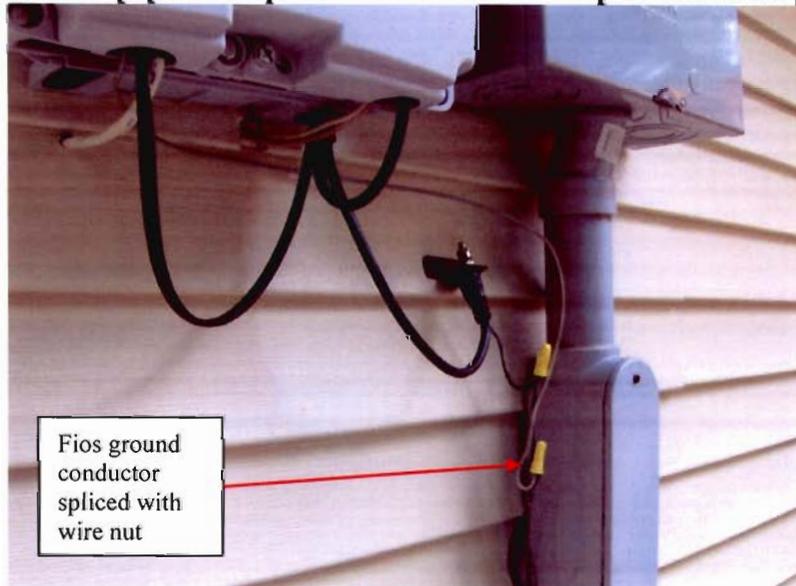
Photo 7

Partridge Drive, Commack.
FiOS ground conductor spliced with wire nut before it attaches to the same single conductor driven electrode clamp as CATV and Power. **(Photo 7)**
- 11)

FiOS ground conductor spliced with wire nut

FiOS ground conductor spliced with wire nut before it attaches to same single conductor driven electrode clamp as CATV and Power.

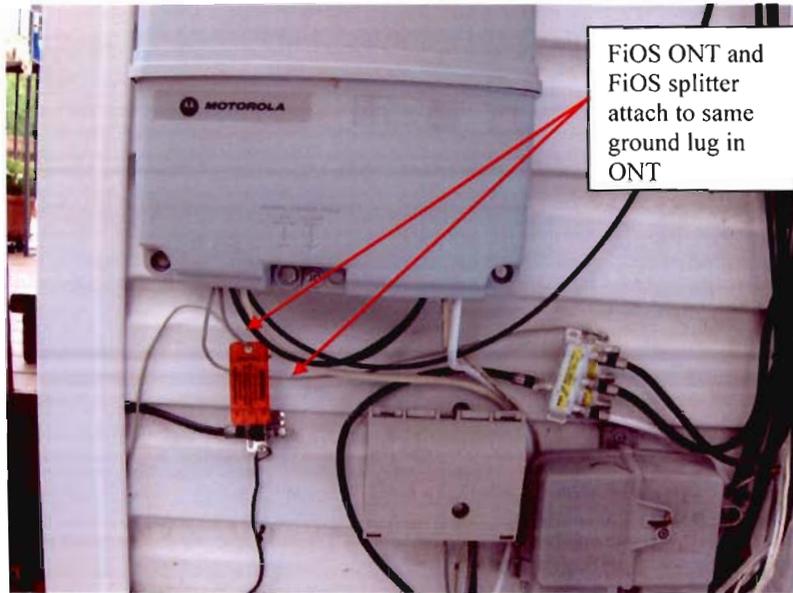
Photo 10

FiOS ONT and
FiOS splitter
attach to same
ground lug in
ONT

FiOS Optical Network Terminal has two ground conductors attached to the same single conductor ground lug. FiOS and copper telephone ground conductors attached to the same single conductor pipe strap on conduit from output of meter pan.

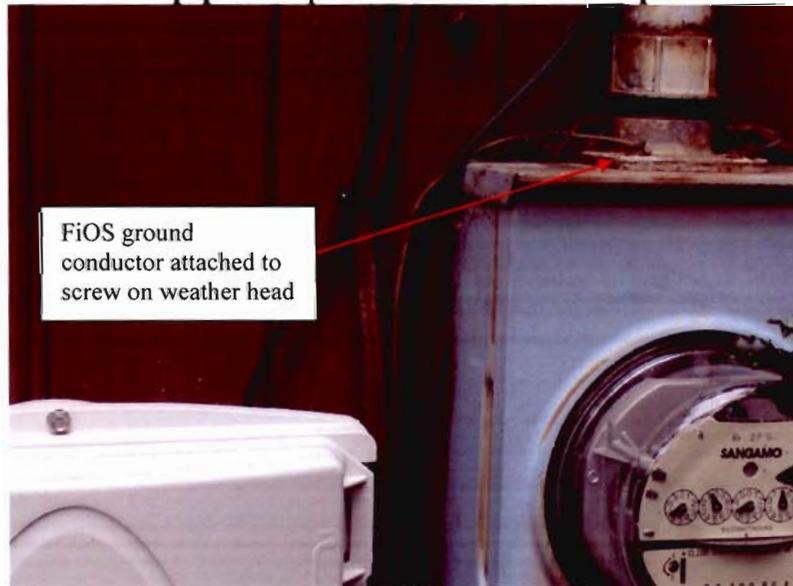
Photo 11

FiOS ground
conductor attached to
screw on weather head

FiOS ground conductor wrapped around screw on weather head of meter pan.

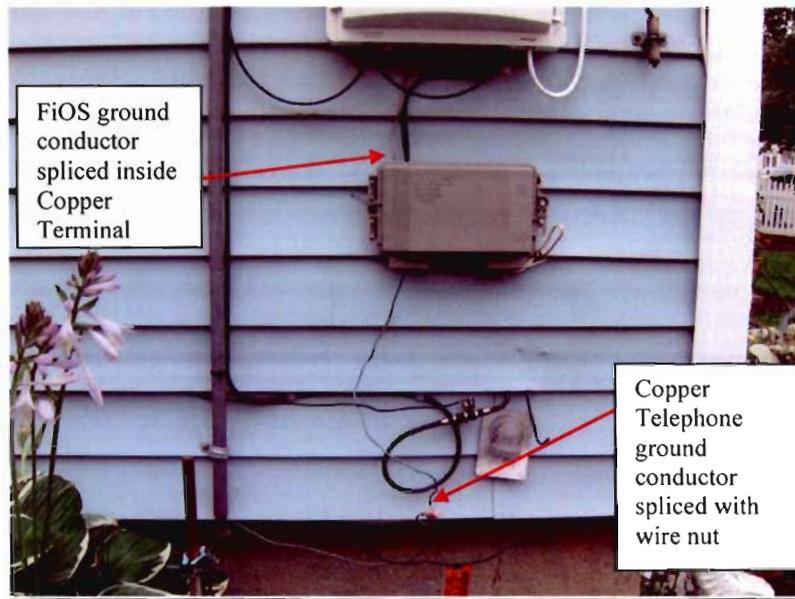
Photo 12

FiOS ground conductor spliced at copper terminal. Copper telephone ground conductor spliced with wire nut before it attaches to same single conductor split bolt on power ground as CATV .

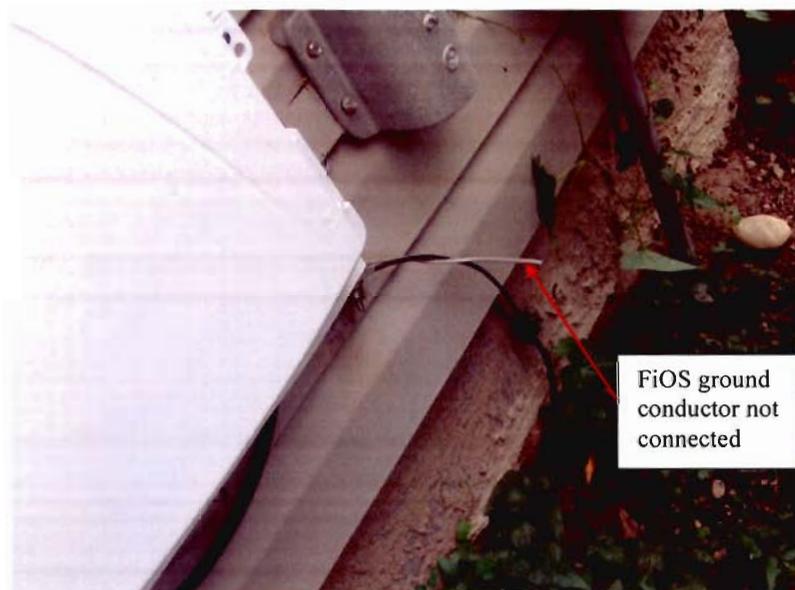
Photo 13

Ground conductor from FiOS Optical Network Terminal not connected. Power ground 6 inches away.

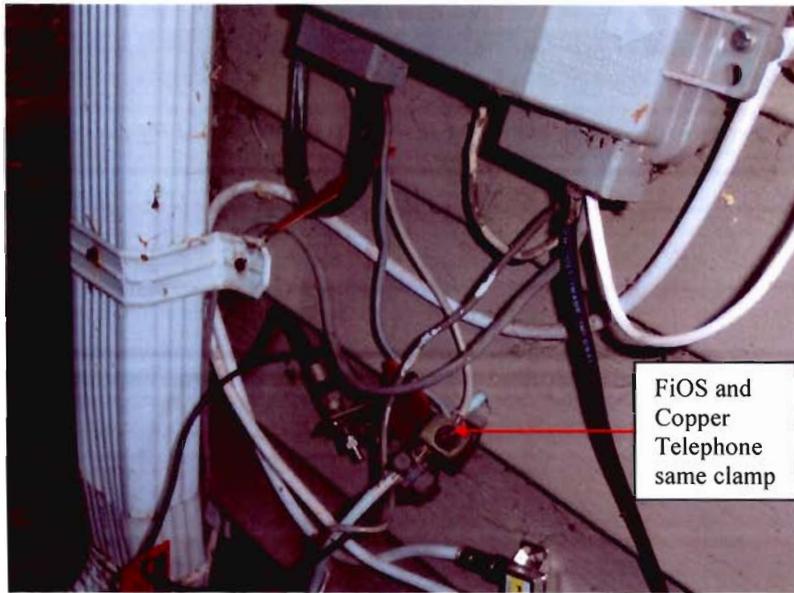
Photo 14

FiOS and
Copper
Telephone
same clamp

FiOS and copper telephone attached to same loose single conductor Fargo clamp on power ground.

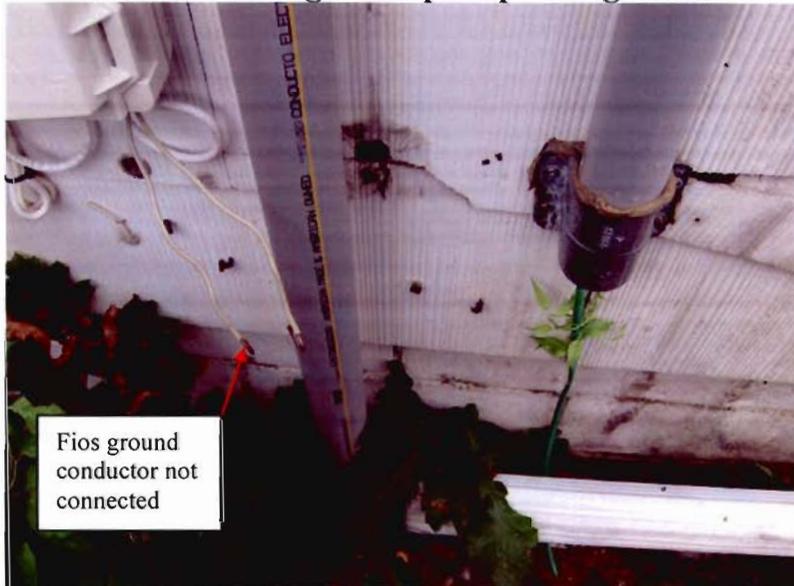
Photo 15

FiOS ground
conductor not
connected

Ground conductor from FiOS Optical Network Terminal not connected. Power ground 2 feet away.

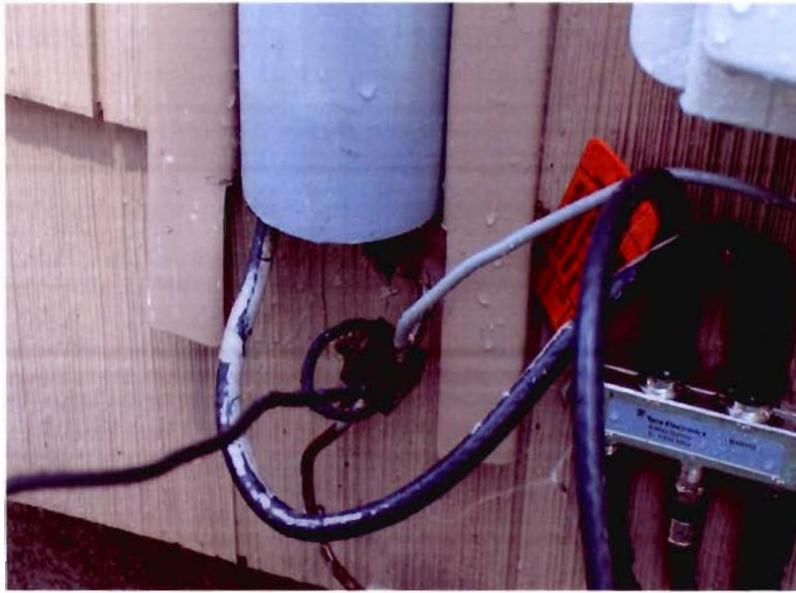
Photo 16

FiOS and CATV ground conductor attached to same single conductor Fargo clamp on power ground.

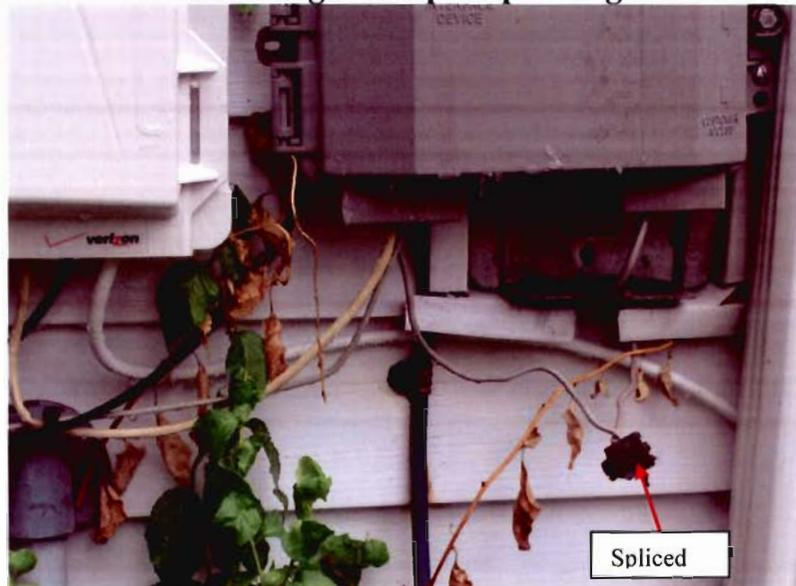
Photo 17

FiOS ground conductor spliced at copper terminal. Copper telephone ground conductor spliced with Fargo clamp before entering inside. Couldn't verify ground connection, no access.

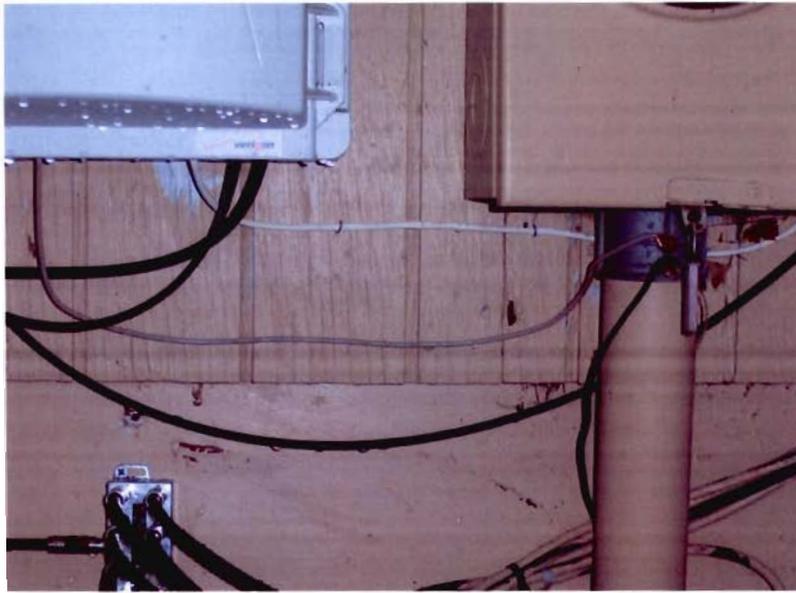
Photo 19

Woodland Drive, Smithtown.
FiOS ground conductor wrapped around screw on conduit connector at meter pan.

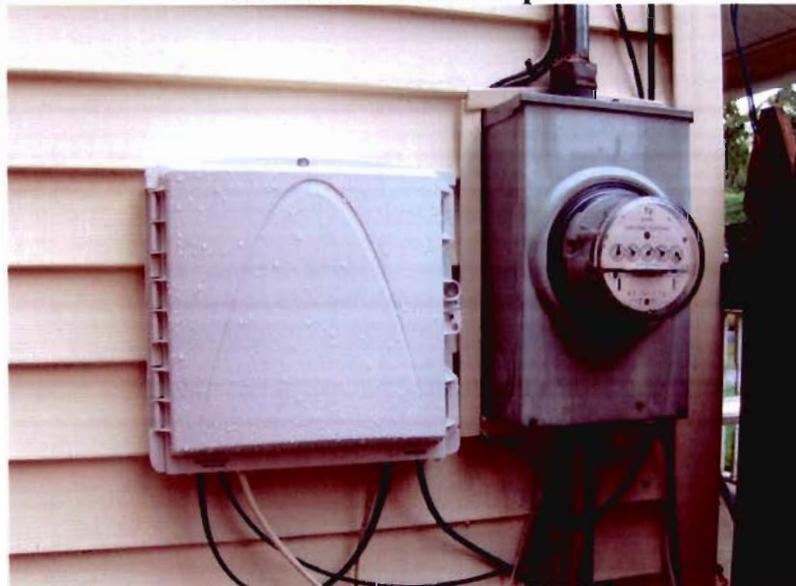
Photo 20

Park Avenue, Huntington.
FiOS not grounded. Meter pan weather head or output conduit 1 ½ feet away.

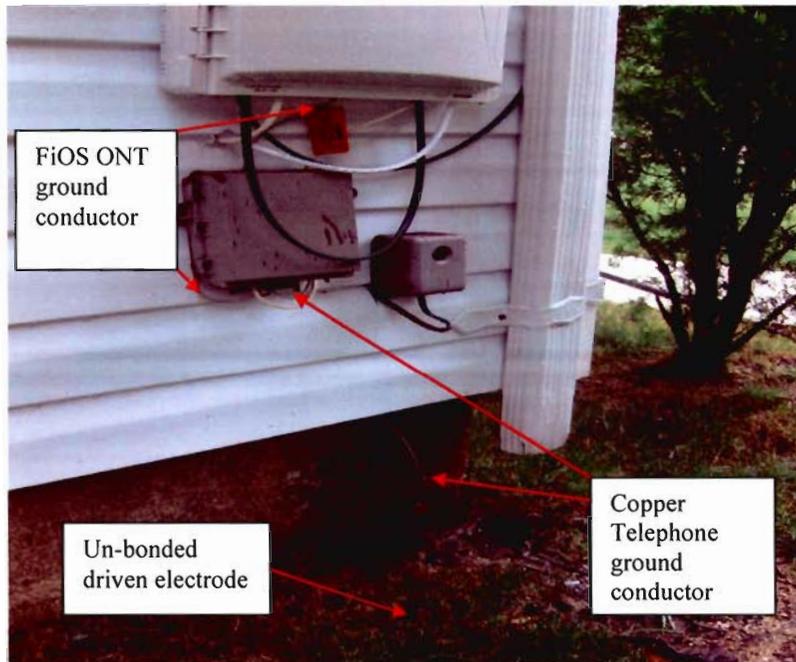
Photo 21

FiOS ground conductor spliced at copper terminal. Copper telephone ground conductor attached to un-bonded driven electrode.

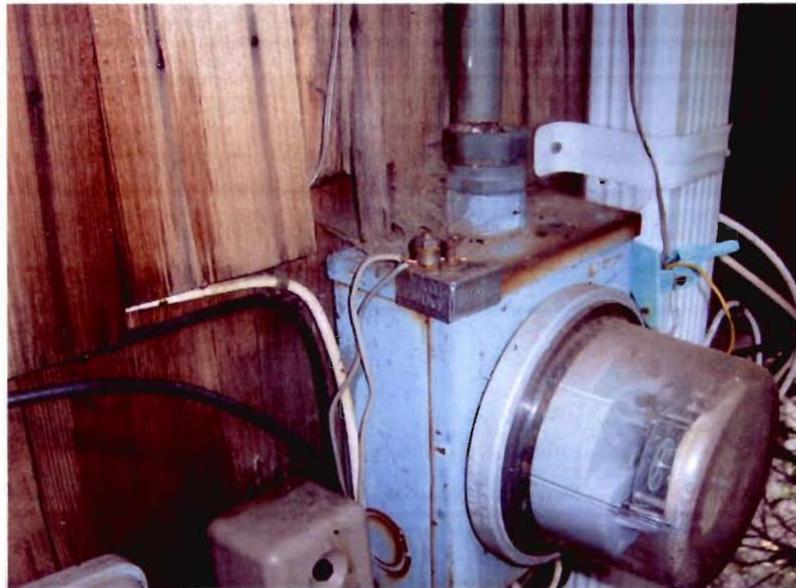
Photo 22

FiOS and Copper Telephone attached to same single conductor corner clamp on meter pan.

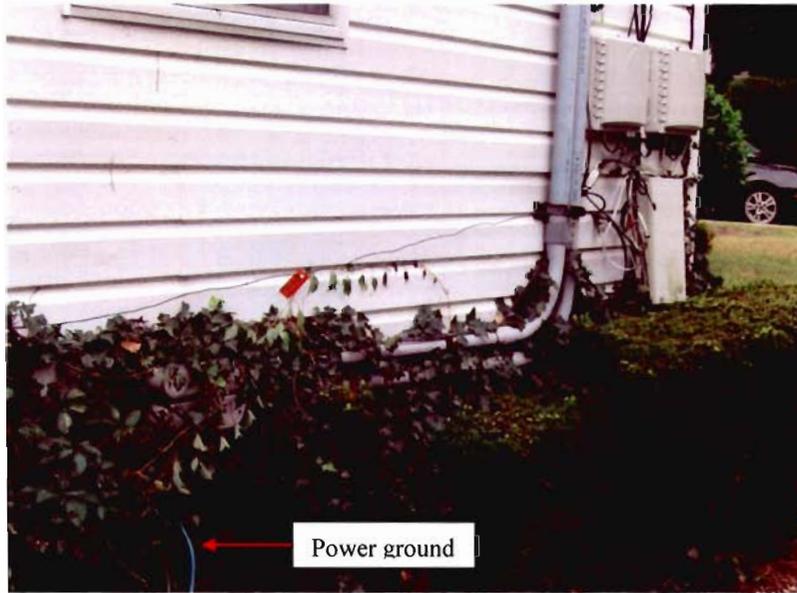
Photo 23

- 33) [REDACTED] West Neck Road, Huntington.
FiOS not grounded. Power ground 7 feet away. **(Photo 23)**
- 34) [REDACTED] West Neck Road, Huntington.
FiOS ground conductor spliced at copper terminal. Copper telephone ground conductor spliced with Fargo clamp inside terminal before entering inside. Couldn't verify ground connection, no access. **(Photo 23)**

(ONT-1) FiOS not grounded. Power ground 7 feet away.
(ONT-2) FiOS ground conductor spliced at copper terminal. Copper telephone ground conductor spliced with Fargo clamp inside terminal before entering inside. Couldn't verify ground connection, no access.

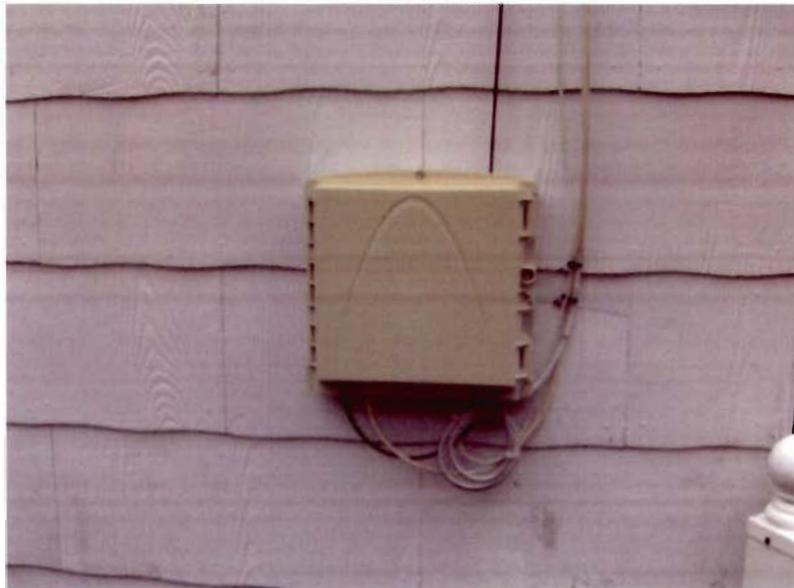
Photo 24

█ Fulton Street, Farmingdale.
FiOS not grounded.

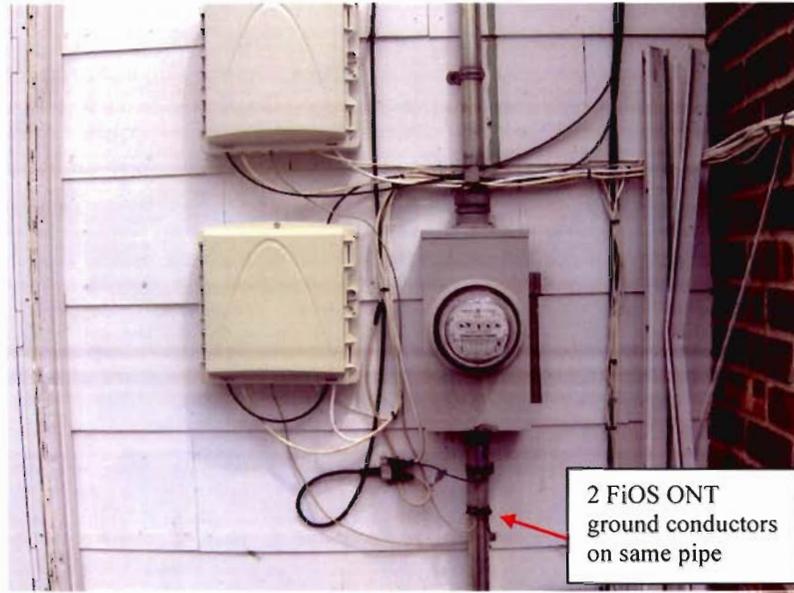
Photo 25

FiOS ground conductor attached to same single conductor pipe strap on conduit to output from meter pan as second FiOS Optical Network Terminal. (Photo 25)

FiOS ground conductor attached to same single conductor pipe strap on conduit from output of meter pan as second FiOS Optical Network Terminal.

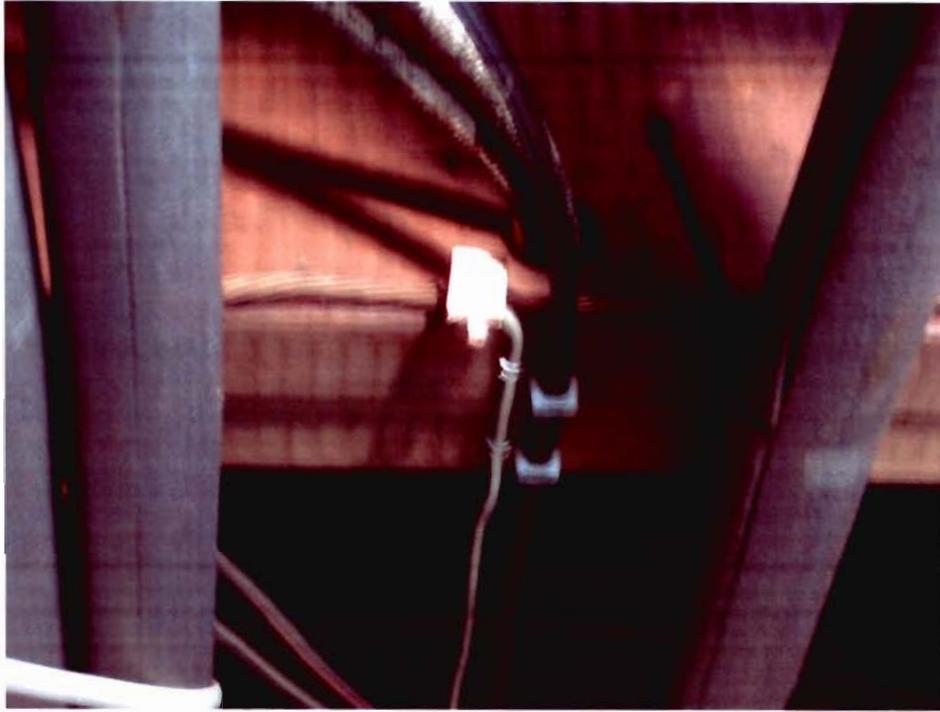
Photo 1 – [REDACTED] Ponderosa Dr., FiOS grounded to power ground.

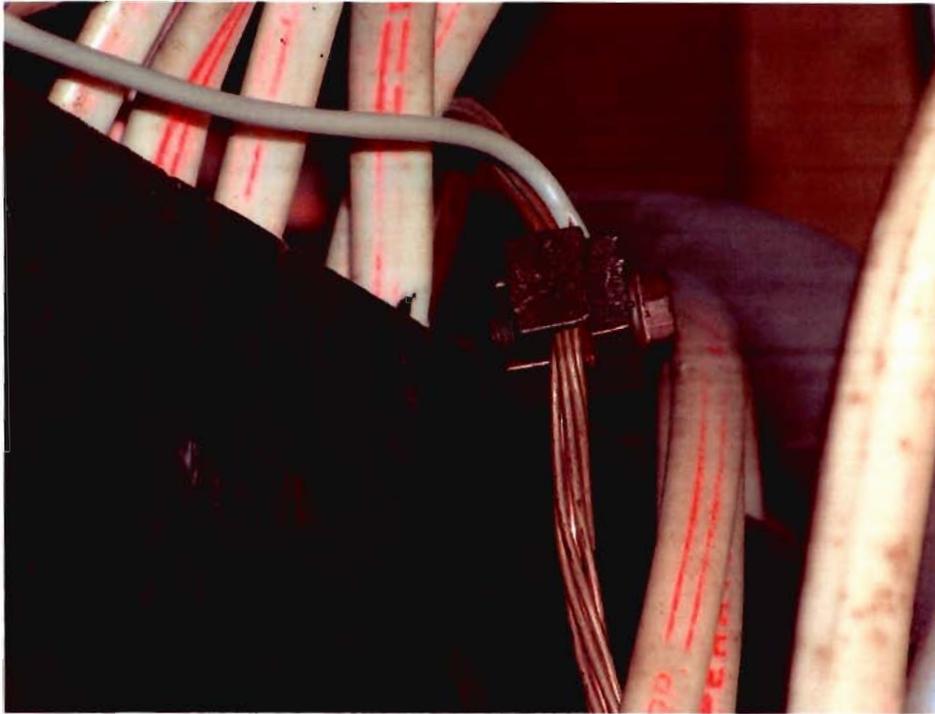
Photo 2 - [REDACTED] Rollingwood, FiOS grounded to power ground.

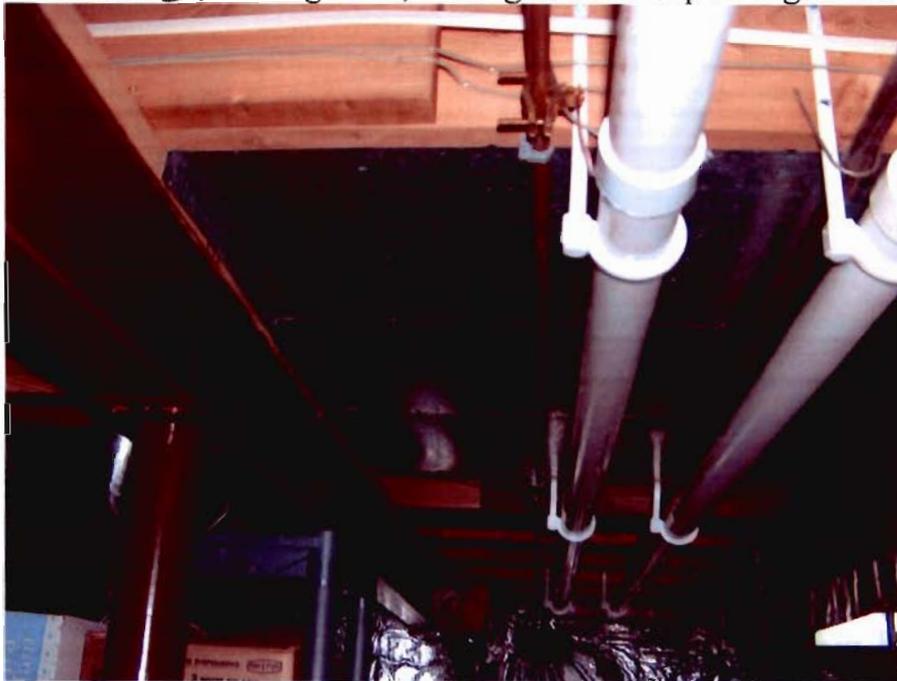
FiOS ground conductor clamped to cold water pipe that is greater than 5 feet from water line point of entry. (Approximately 15 ft.) (Photo 3)

Photo 3 - [REDACTED] Cobblestone Ln., FiOS ground conductor clamped to cold water pipe approximately 15 ft. from water service entrance.

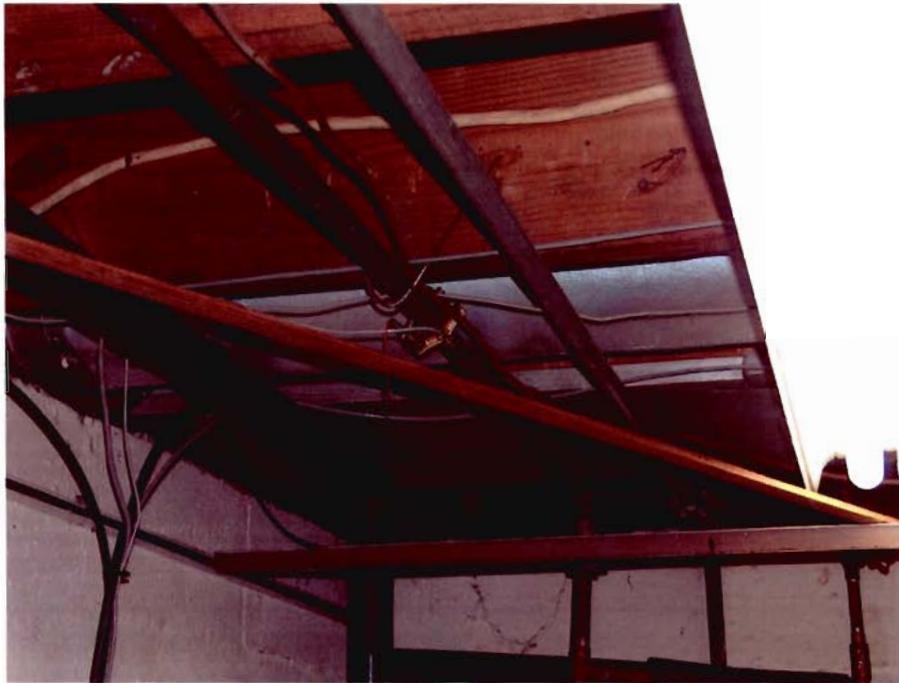
FiOS ground conductor clamped to cold water pipe that is greater than 5 ft. from water line point of entry. (Approximately 20 ft.) (Photo 4)

Photo 4 - ■ Darlich Ave., FiOS ground conductor clamped to cold water pipe approximately 20 ft. from water service entrance.

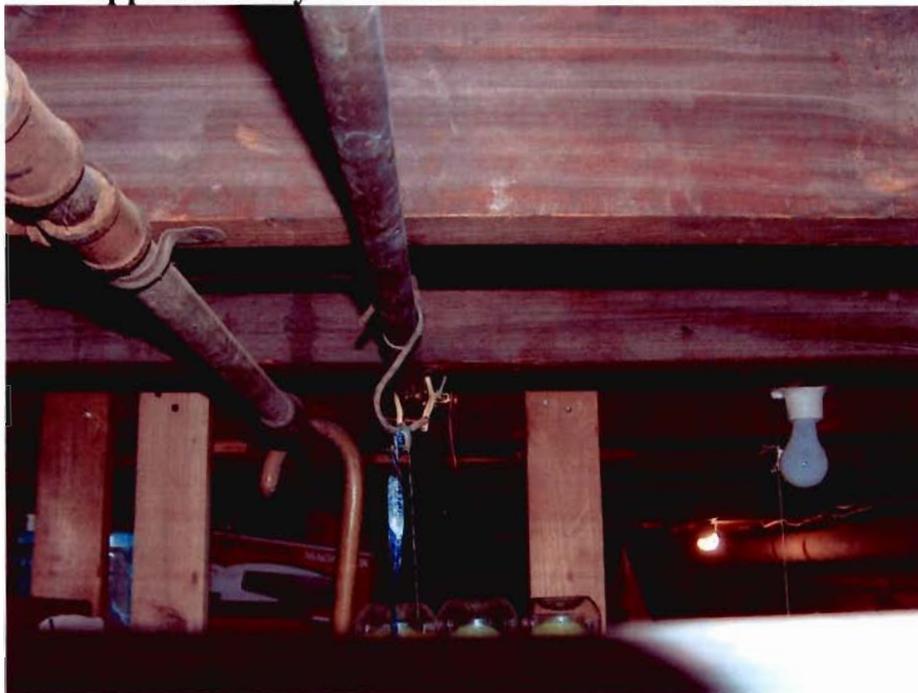
FiOS ground conductor clamped to cold water pipe that is greater than 5 ft. from water line point of entry. (Approximately 15ft.) (Photo 5)

Photo 5 - ■ Hawkins Ave, FiOS ground conductor clamped to cold water pipe approximately 15 ft. from water service entrance.

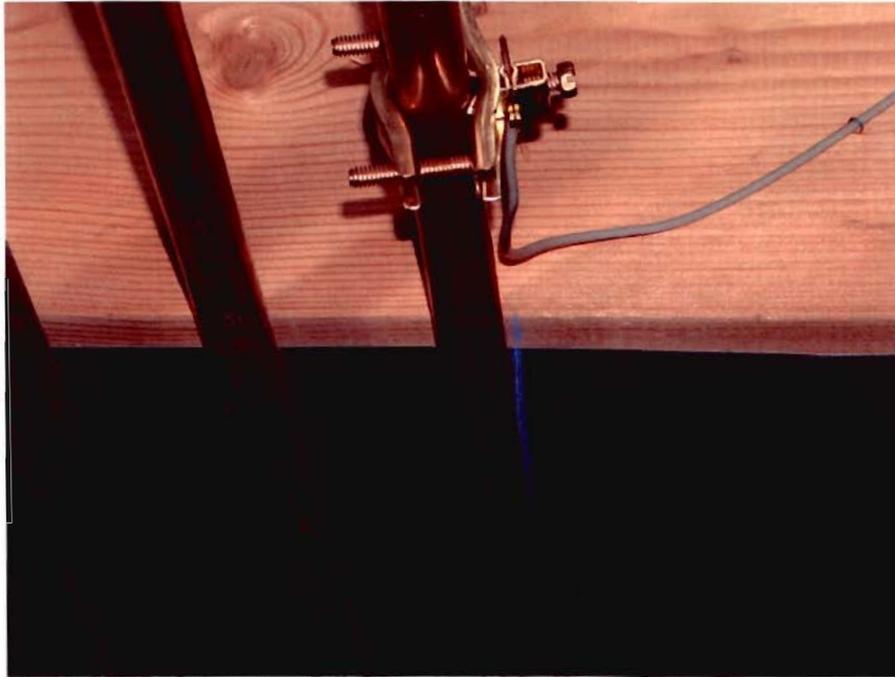
FiOS ground conductor clamped to cold water pipe that is greater than 5 feet from water line point of entry. (Approximately 15 ft.) (Photo 6)

Photo 6 - [REDACTED] Scherff Rd, FiOS ground conductor clamped to cold water pipe approximately 15 ft. from water service entrance.

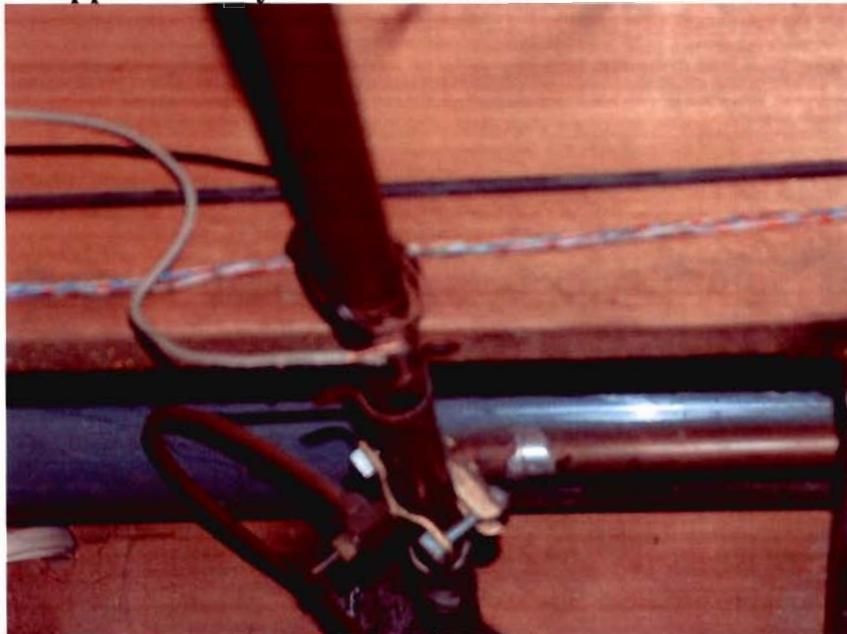
FiOS ground conductor clamped to cold water pipe that is greater than 5 feet from water line point of entry. FiOS and unknown ground conductors attached to same single conductor strap. (Photo 7)

Photo 7 - [REDACTED] Bridle Path, FiOS ground conductor clamped to cold water pipe greater than 5 ft. from water service entrance. FiOS and unknown ground conductors attached to same single conductor strap.

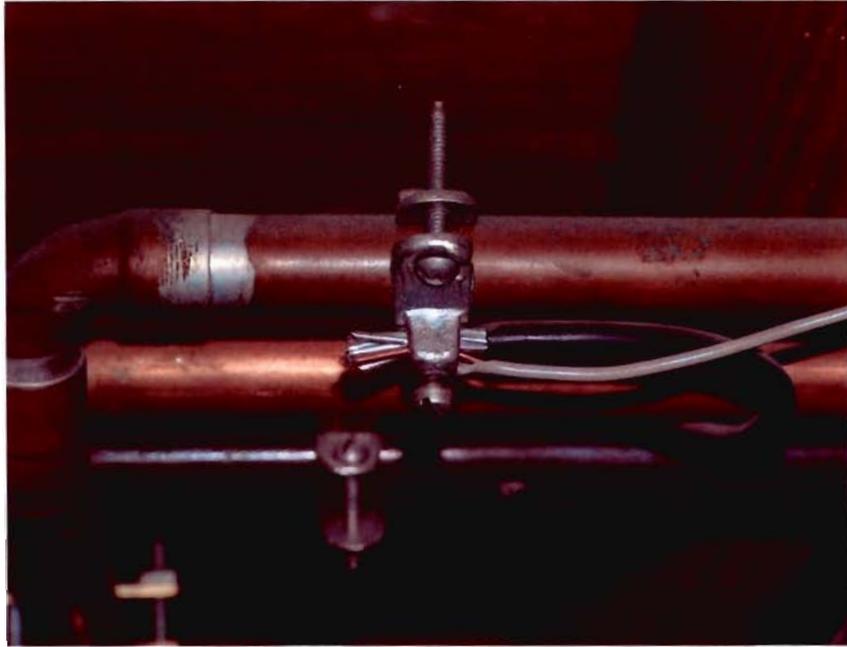
FiOS ground conductor clamped to cold water pipe that is greater than 5 ft. from water line point of entry. FiOS ground conductor and gas pipe bond conductor attached to same single conductor clamp. (Photo 8)

Photo 8 - [REDACTED] Bridle Path, FiOS ground conductor clamped to cold water pipe greater than 5 ft. from water service entrance. FiOS ground conductor and gas pipe bond conductor attached to same single conductor clamp.

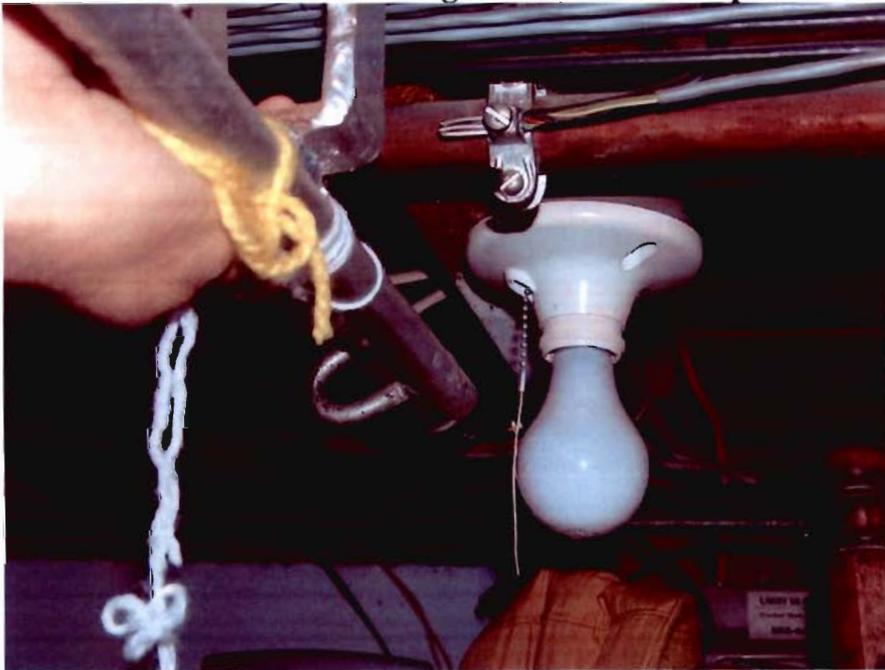
FiOS ground conductor and unknown conductor attached to same single conductor clamp. (Photo 9)

Photo 9 - [REDACTED] Bridle Path, FiOS ground conductor and unknown conductor attached to same single conductor clamp.

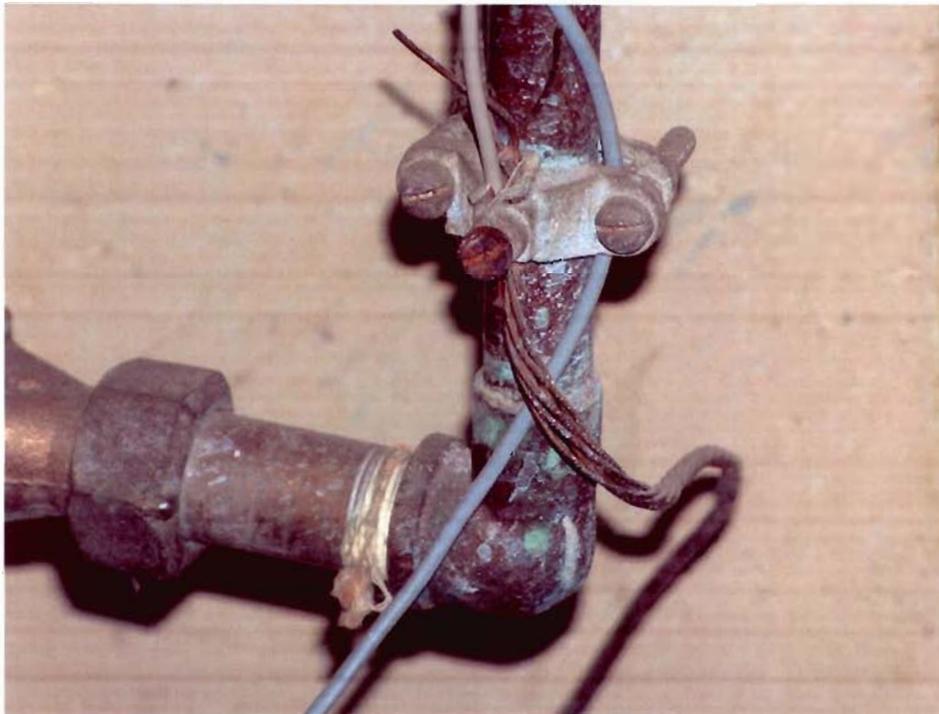
FiOS ground conductor and unknown conductor attached to same single conductor clamp. (Photo 11)

Photo 11 - Heather Hill Dr., FiOS ground conductor and unknown conductor attached to same single conductor clamp.

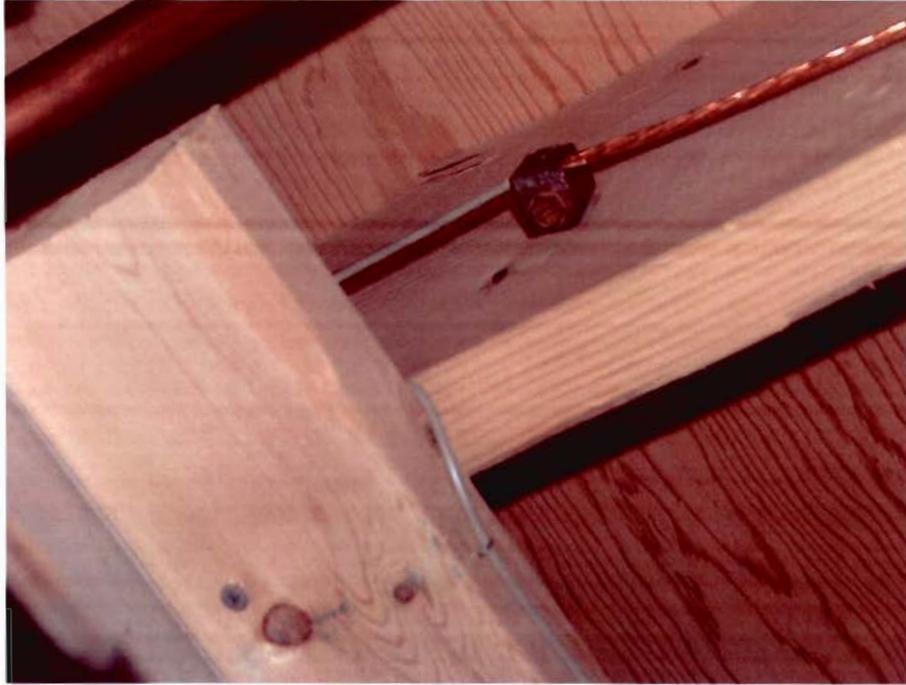
Photo 12 - Brook Ln. FiOS grounded to electric ground.

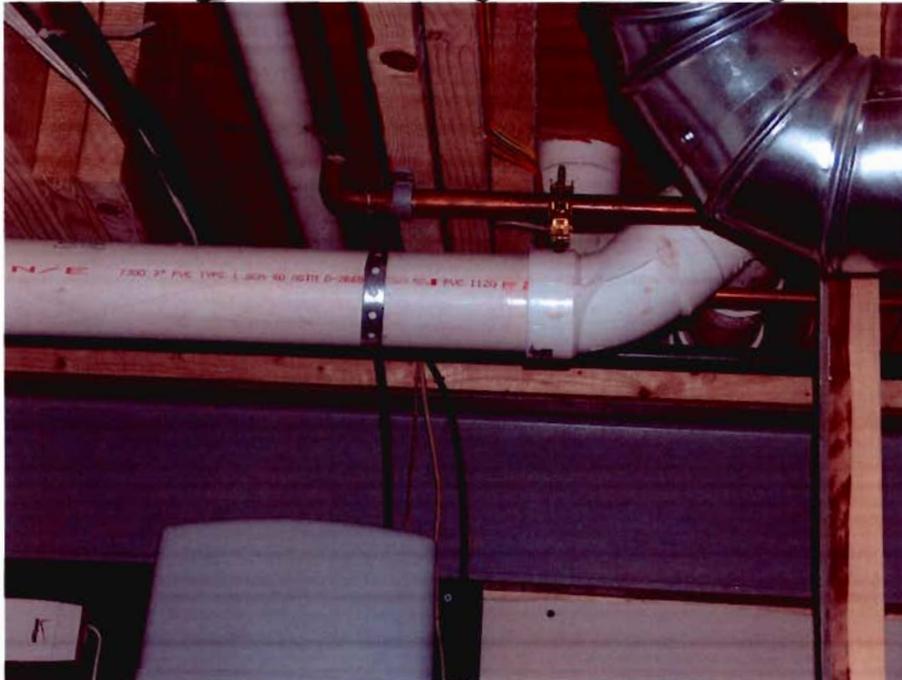
FiOS ground conductor clamped to cold water pipe that is greater than 5 ft. from water line point of entry. (Approximately 15 ft.) (Photo 13)

Photo 13 - █ Brook Ln. **FiOS ground conductor clamped to cold water pipe approximately 15 ft. from water service entrance.**
