INVESTIGATION BY THE CITY OF NEW YORK INTO THE NORTHWEST QUEENS JULY 2006 POWER OUTAGES

March 2, 2007

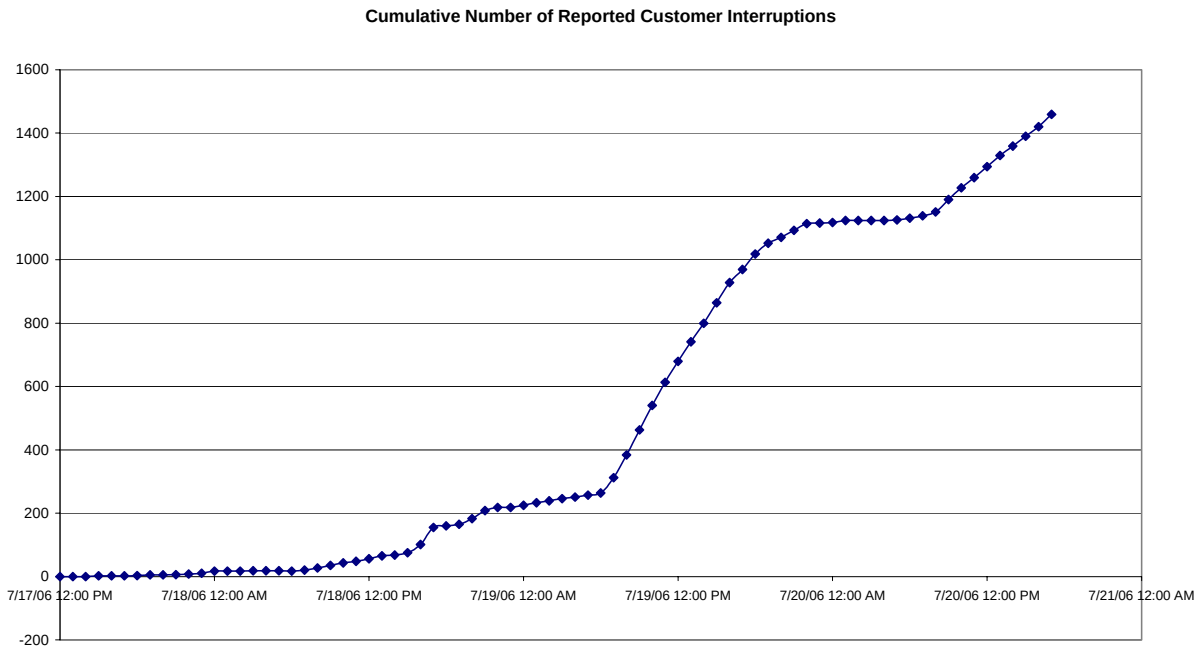
Figure 3.3.2-1 – Cumulative Number of Reported Customer Interruptions on Long Island City Network From July 17-21, 2006

In response to observations that the number of customers interrupted might be larger than the quantities shown in Figure 3.3.2-1, Con Edison conducted a survey on the evening of July 20th. Based on the survey, Con Edison estimated that 25,000 customers were without power on Friday, July 21st.

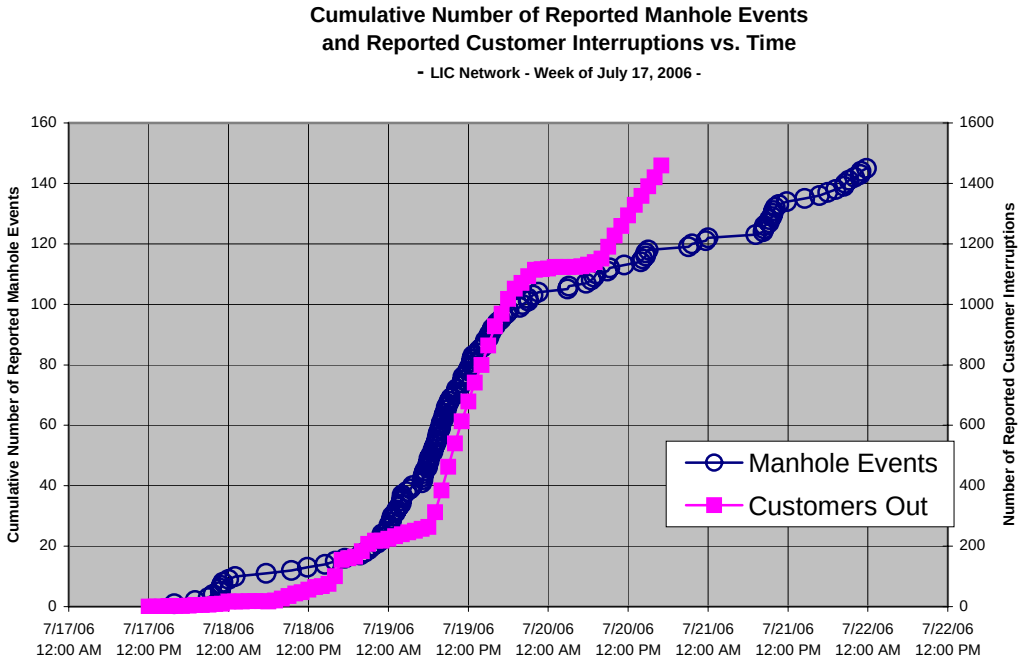
Figure 3.3.2-2 – Cumulative Number of Reported Manhole Events and Customer Interruptions vs. Time

Other mechanisms exist that can indirectly indicate significant secondary damage and potentially customer interruptions. Manhole events are reported to the control center, and the number is tracked. Figure 3.3.2-2 below shows the number of Long Island City network manhole events that were reported to Con Edison during the week of July 17, 2006. Figure 3.3.2-2 also shows the number of reported customer interruptions to Con Edison during that period.[23] There is a correlation between the number of manhole events and the number of reported customer interruptions.

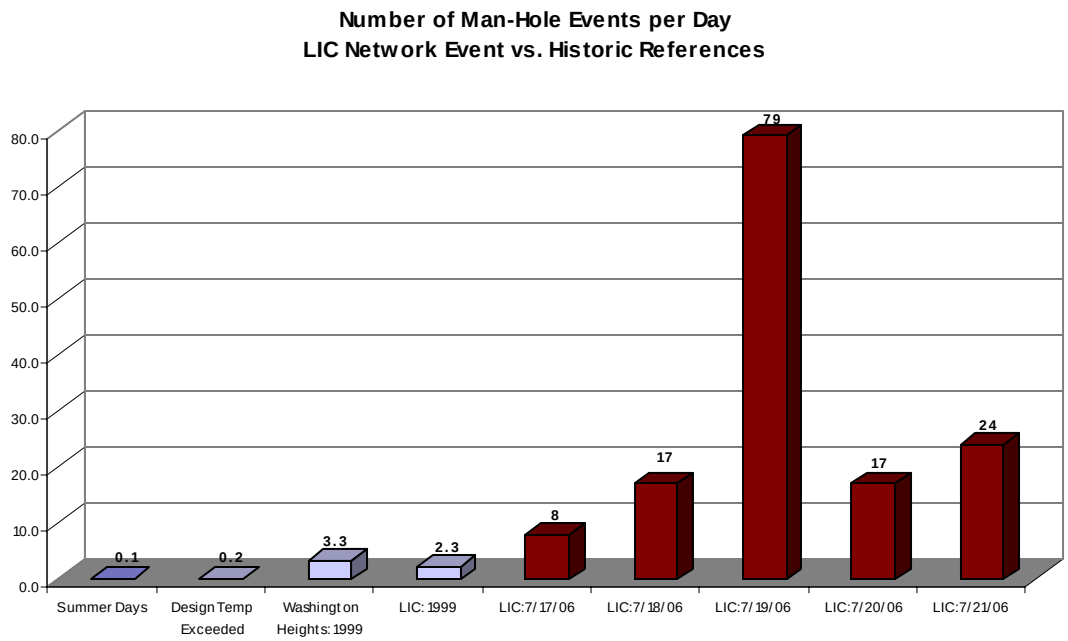
Figure 3.3.2-3 – Number of Manhole Events Per Day, for the Long Island City Network and Selected Reference Points

Figure 3.3.2-3 below shows the number of manhole events that occurred per day for the Long Island City network event and selected reference points. The right side of Figure 3.3.2-3 shows the reported manhole events per day for the Long Island City event, July 17 through

July 21. The left side of the figure shows the reported manhole events per day for selected reference points, including a network average for summer days, days when the design temperature is exceeded, the per-day average for the Washington Heights event during July 1999, and the per-day average for the Long Island City network during the same period in July 1999.

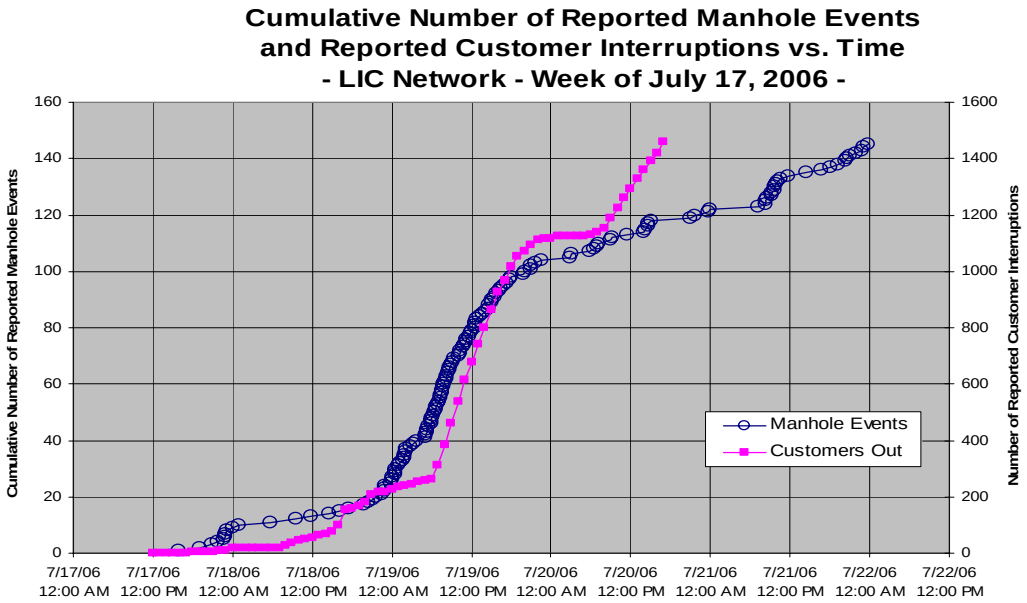
During the initial phase of the Long Island City network event the emergency response crews were dedicated to the response to manhole events with priority given to those with Fire Department units on site awaiting relief by the Con Edison crews. As the number of these events continued to escalate many of the other trouble ticket items were backlogged pending the availability of crews for response. The rising number of reported manhole events (e.g., explosions, fires, smoking structures) and customer outages should have alerted Con Edison control center and management personnel to the growing problems within the secondary cable system in the early hours of Wednesday, July 19th as demonstrated by the graphical representation shown in Figure 3.3.6-1 below.

Had sufficient response personnel been mobilized at this point in time Con Edison would have been able to address the secondary damage and customer outage approximately two days in advance of when they actually began to respond appropriately to these events.

Following the Thursday overnight survey, Con Edison finally realized that the customer outage count was dramatically understated and the magnitude of the secondary system damage was much greater than it initially thought. As a result, in response to the actual magnitude of the electric system conditions, the response to this portion of the system was finally initiated at the appropriate level on Friday, July 21st.

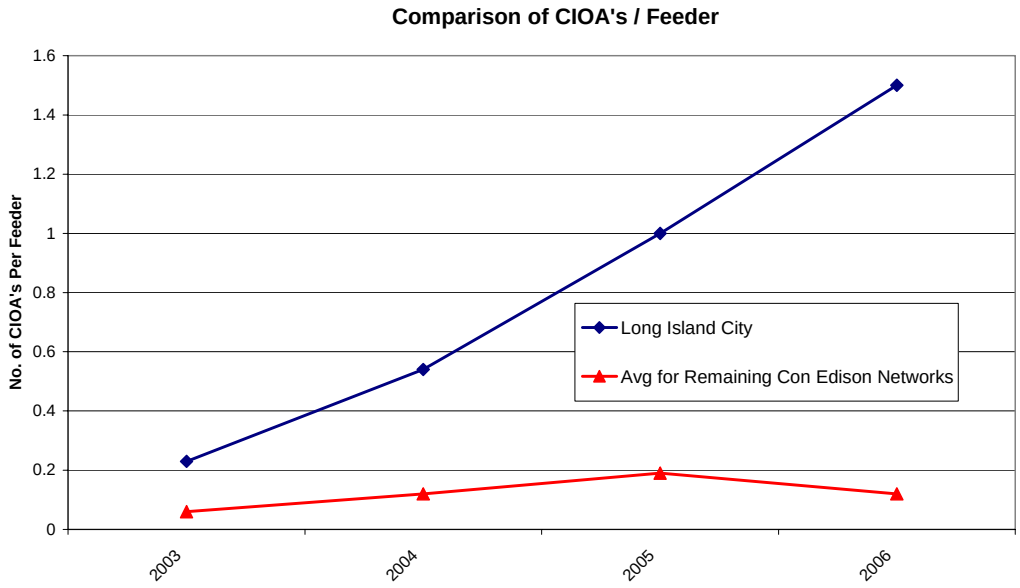
Figure 4.1-2 – Number of CIOA's/Feeder for Long Island City Network and Remainder of Con Edison Networks

experienced by other Con Edison networks from 2003 through 2006. Figure 4.1-2 also illustrates that the number of CIOA's on the Long Island City network has been increasing since 2003.

The high number of CIOAs may be partially explained by the relatively long feeders on the Long Island City network. The average feeder length on Long Island City's network is 12.41 miles, which is approximately 2 times longer than the average feeder length of 6.05 miles for all of Con Edison's networks. But the average feeder length does not account for all of the difference between the number of CIOAs for the Long Island City network and the Company's other networks. The increasing number of CIOAs per feeder on the Long Island City network should have been a cause of concern for Con Edison and should have been analyzed by Con Edison before the summer of 2006.

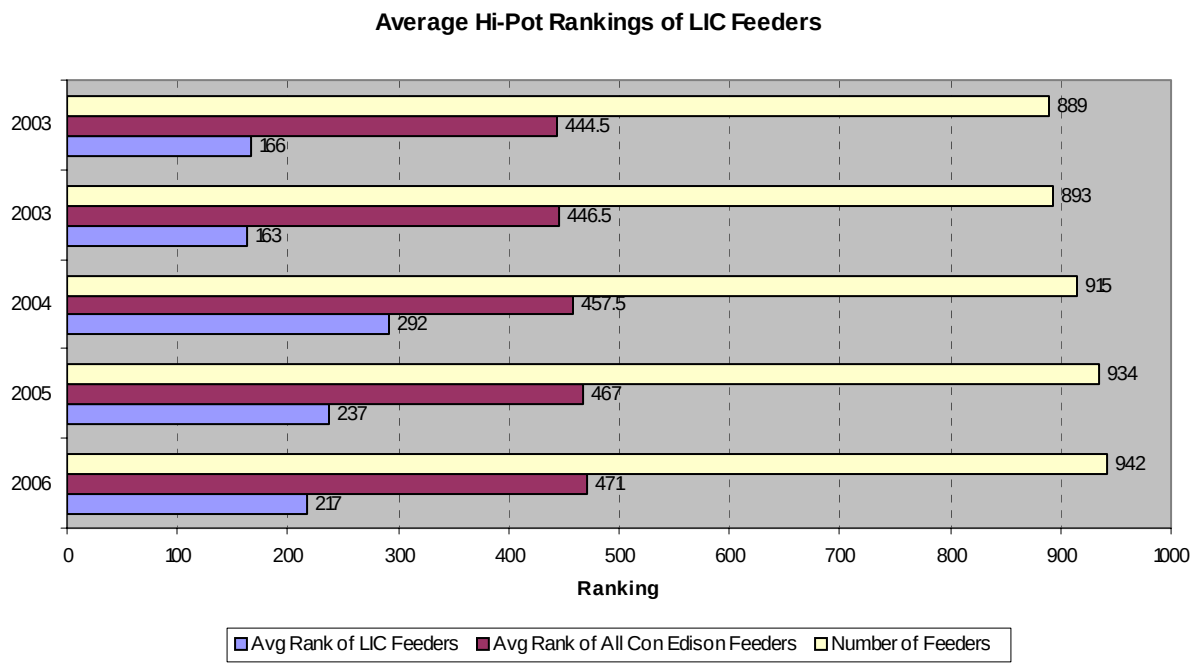
Figure 4.1-3 – Average Hi Pot Rankings of Long Island City Network Feeders Compared to All Con Edison Network Feeders[52]

network feeder. A noticeable improvement was made in the Long Island City network average feeder ranking in 2004, but the average ranking has been declining since that time.

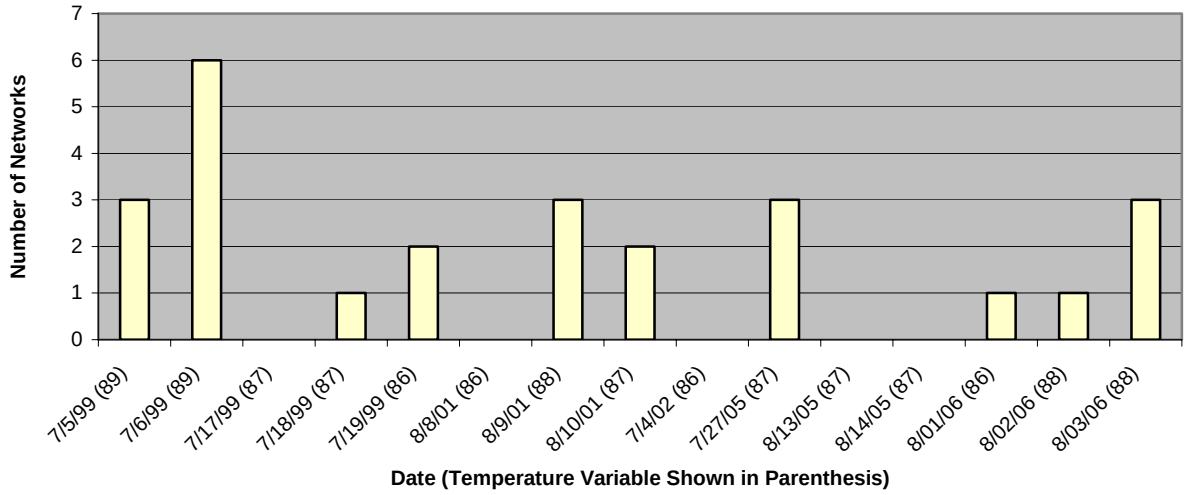
Figure 4.3-1 - Number of Networks Exceeding "n-2" Design Criterion During Extreme Heat Events When Three-Day Temperature Variable Design Criterion is Exceeded

A visual examination of the data in Figure 4.3-1 above illustrates that there is no upward trend in the number of networks exceeding the n-2 design criterion during extreme heat events. This can be concluded even if July 6, 1999 is not considered. From this perspective, the performance of Con Edison's networks during heat events has not been degrading since 1997.

In the past 11 years there have been fifteen days in which the temperature-variable design criterion of 86 degrees was exceeded. This is an average of approximately 1.4 times a year in which the temperature-variable design criteria has been exceeded.

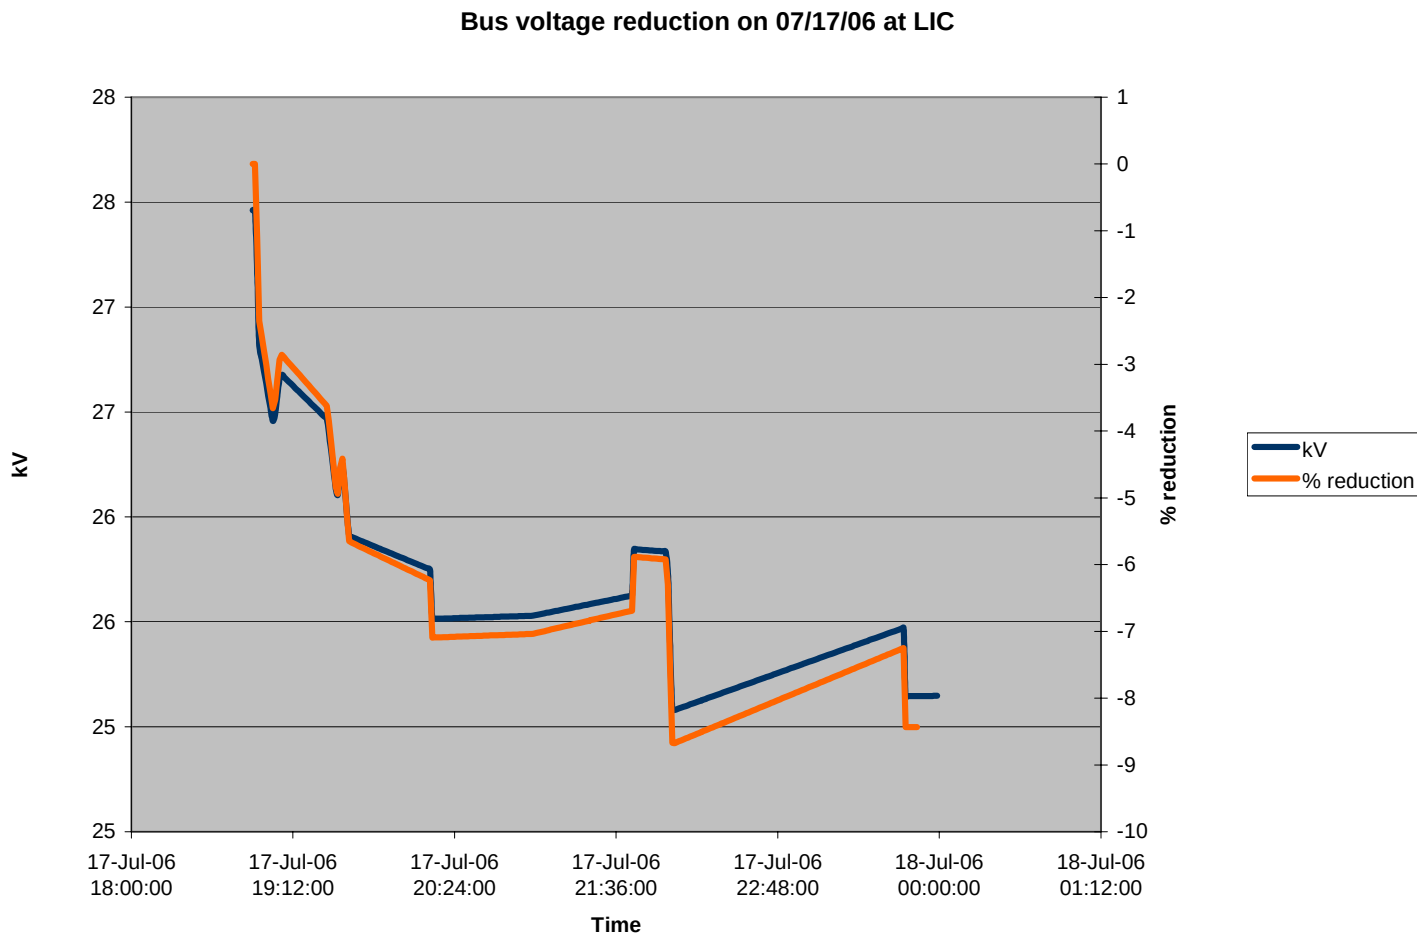
Figure 1

Voltage reduction on 07/17/06 during the Long Island City event

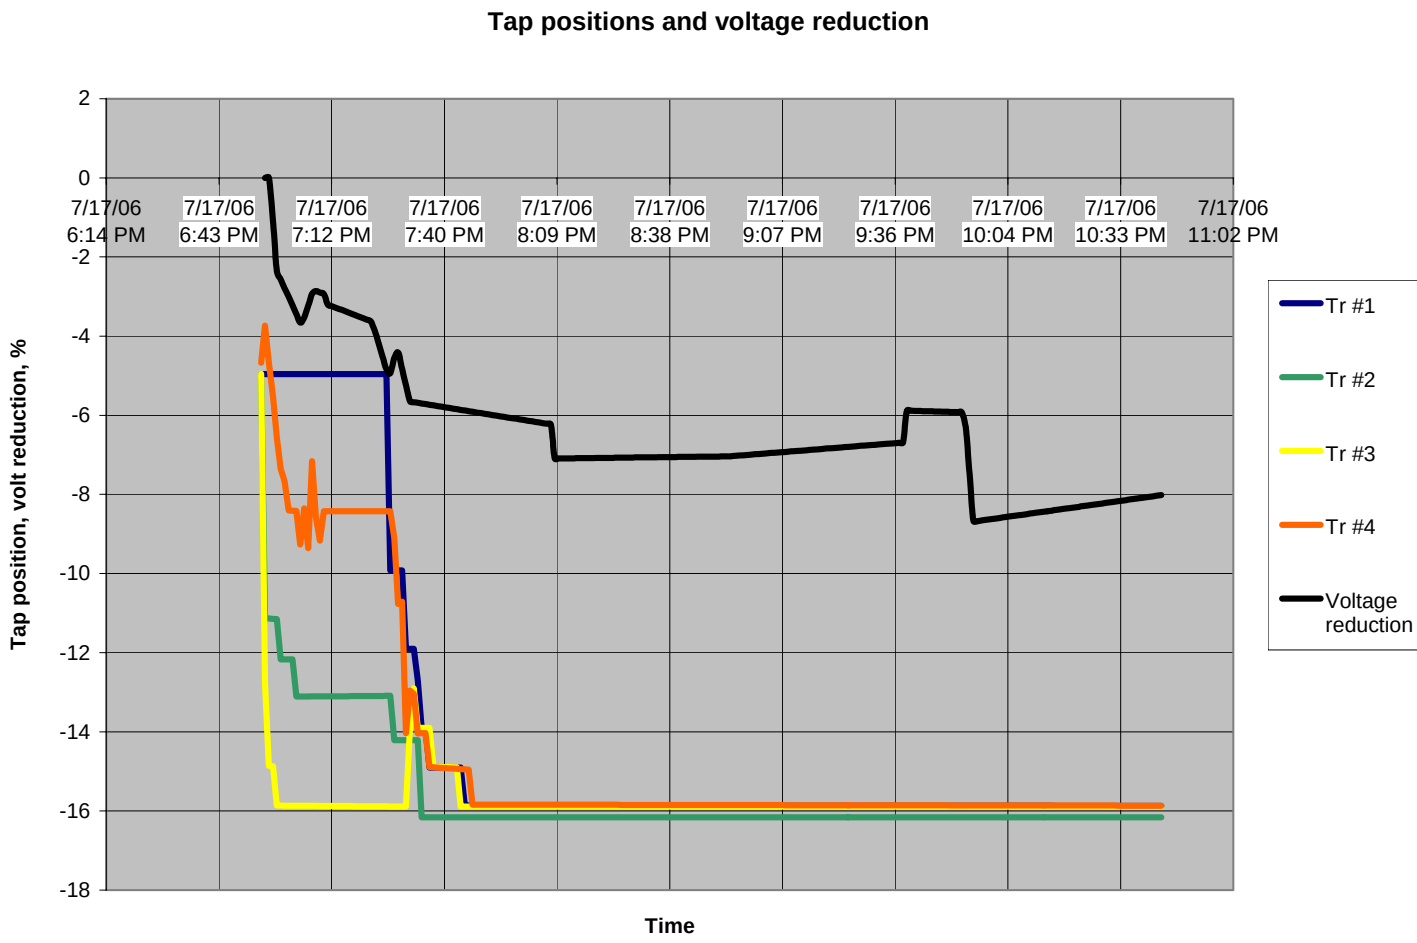
Figure 2

Change of tap position during voltage reduction

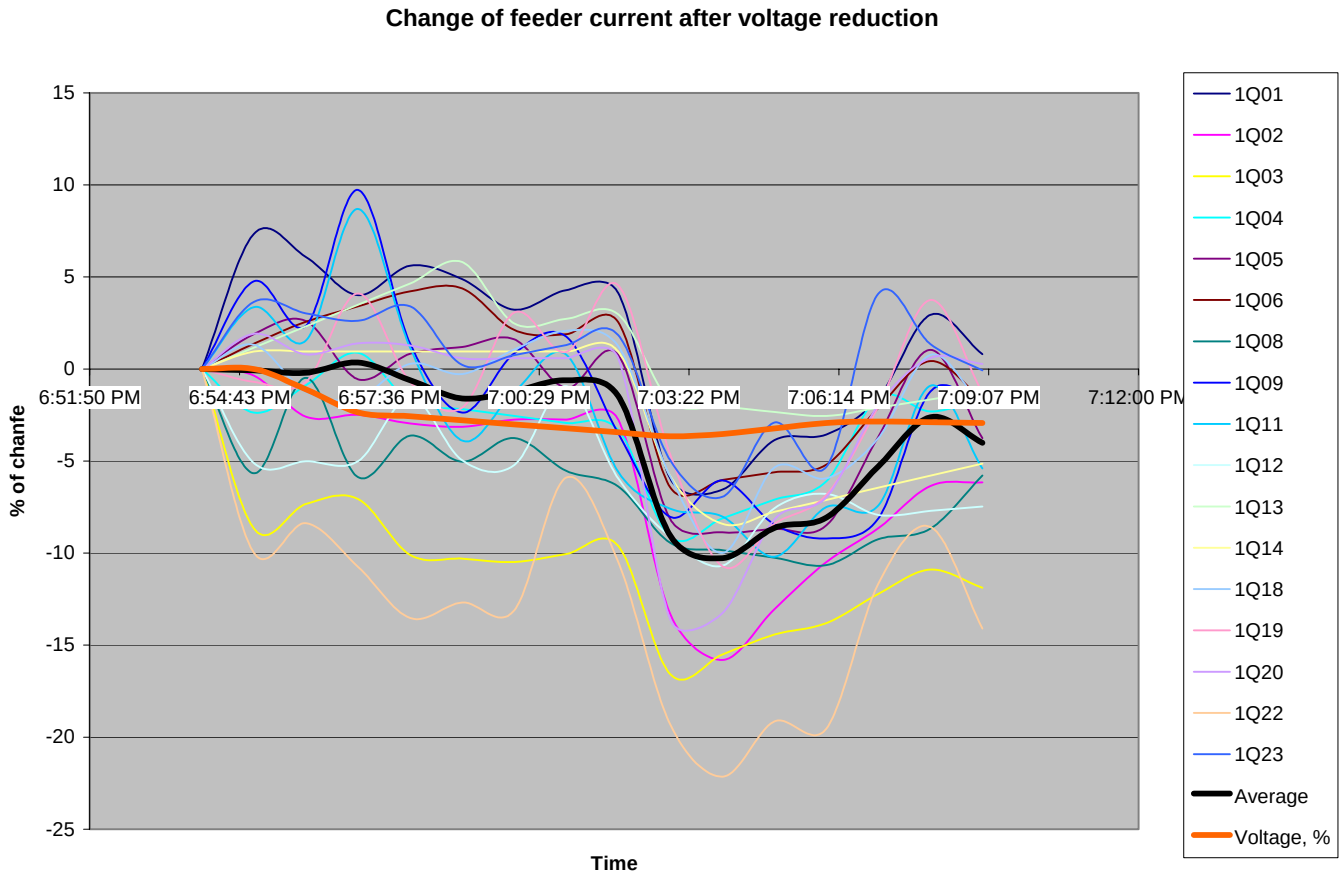
Change of feeder currents after voltage reduction

Figure 3 above shows the feeder loading between 18:54 and 19:03 on July 17, 2006. The data for this time interval could be used to associate the voltage reduction with currents through the feeders. There was only one activity recorded during this time interval, namely initiation of voltage reduction at 18:54. From Figure 3, it can be seen that the current increased in 10 feeders of 17, and decreased in 7 feeders right after this time. The average feeder current practically did not change.
