**RESULTS OF OUTSIDE PLANT INSPECTION  
OF VERIZON FiOS**

**In The  
County of Westchester**

**Report No. S036-08-4221**

**SUMMARY OF INSPECTION OF VERIZON FiOS FACILITIES IN THE COUNTY OF WESTCHESTER FOR UNSAFE AND NONSTANDARD SUBSCRIBER INSTALLATION PRACTICES.**

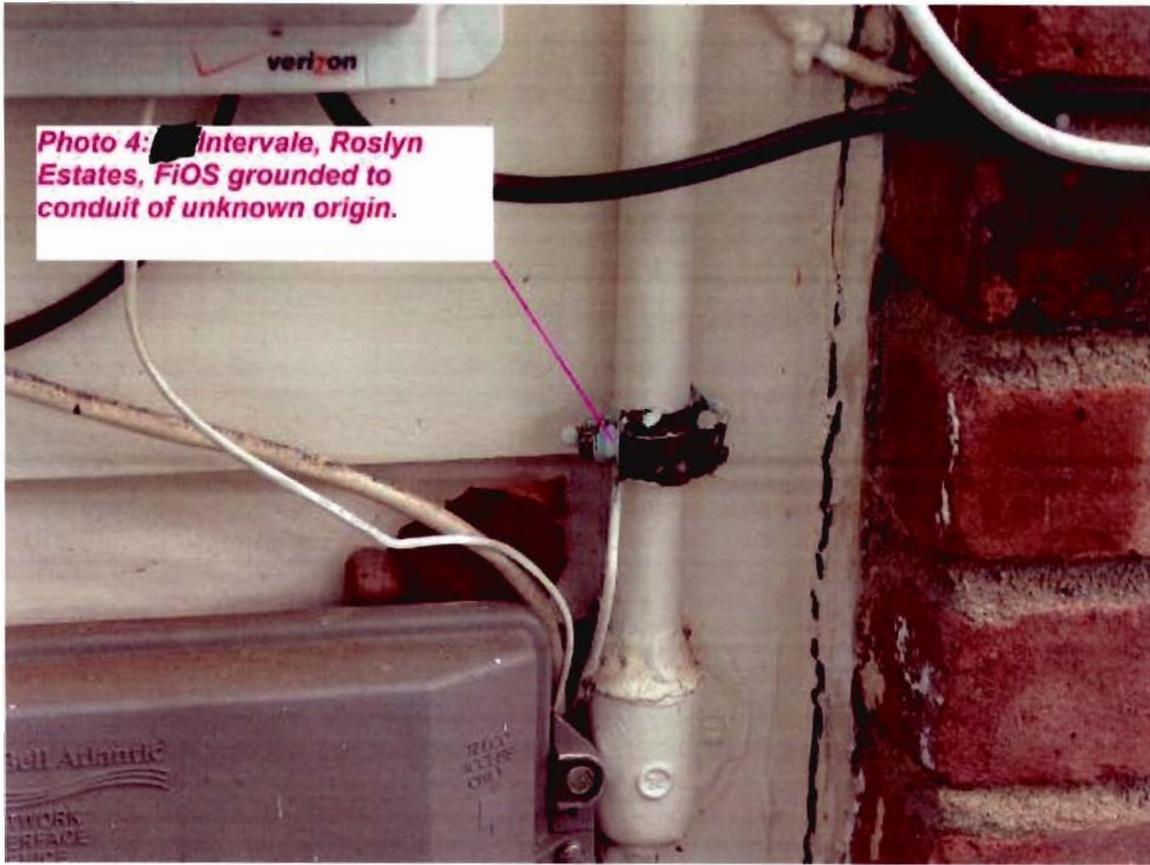
**FiOS grounded to conduit of unknown origin. (Photo 4)**

**Photo 4:** Intervale, Roslyn Estates, FiOS grounded to conduit of unknown origin.
