Orange & Rockland  
a conEdison, inc. company

**Re: Case 04-M-0159, Proceeding on the Motion of the Commission to  
Examine the Safety of Electric Transmission and Distribution Systems  
2007 Stray Voltage Detection and Electric Facility Inspection Report  
Consolidated Edison Company of New York, Inc.**

**Report on Orange and Rockland Utilities, Inc.'s  
Implementation of the Electric Safety Standards  
For the Period  
September 1, 2006 through November 30, 2007  
Case 04-M-0159**

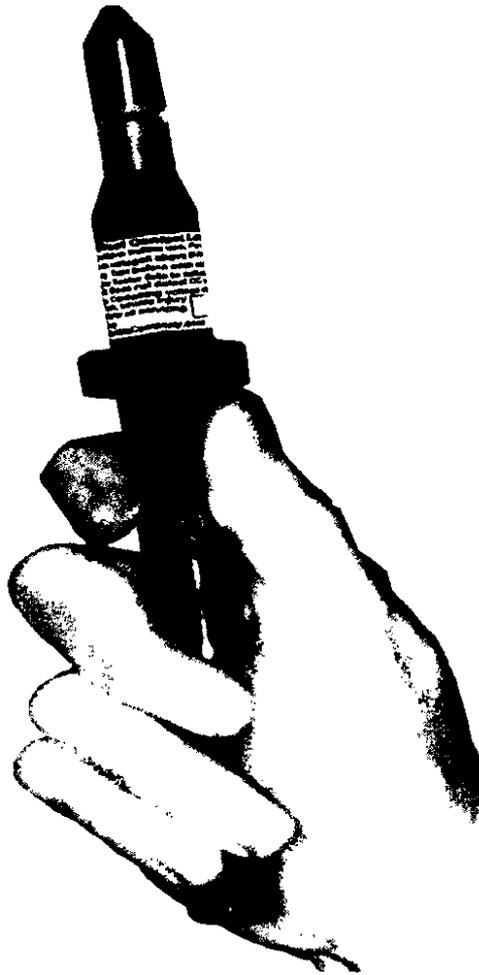
**Diagram 2**

**Stray Voltage Test Procedure**

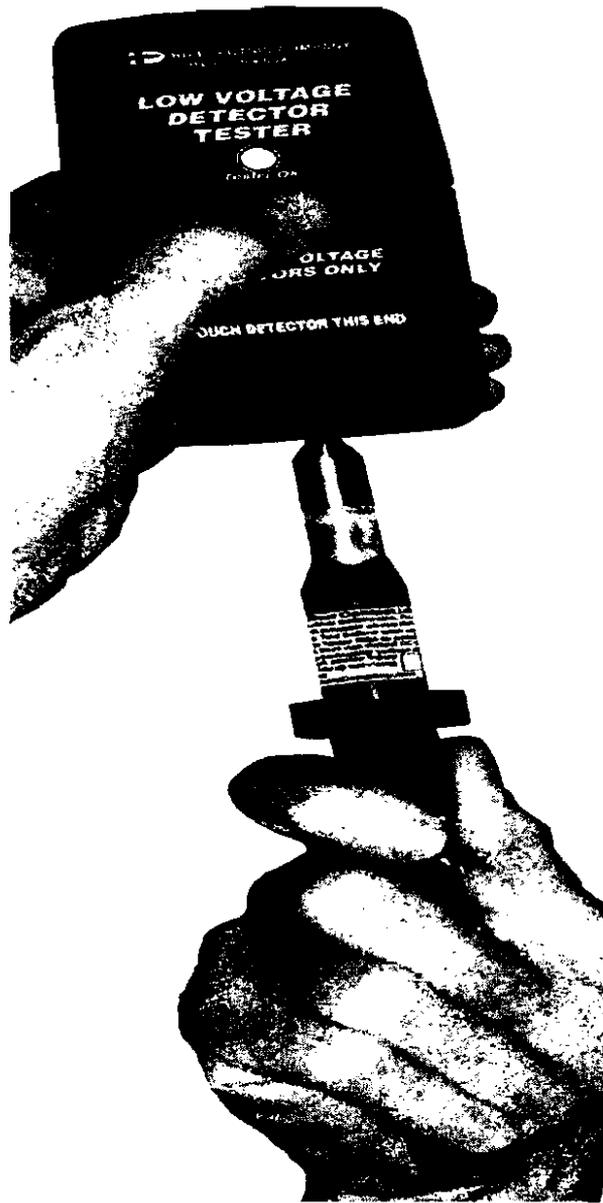
Diagram 5

Stray Voltage Test Procedure

To test the LV- S-5 Detector, hold the Tester as shown, (Diagram 5) press the ON button, hold the Detector as shown and make direct contact between the metal tip on the Detector and the metal pate on the Detector Tester. A red light on the Detector Tester indicates the battery is OK. A flashing red light on the Detector means voltage is detected. Replace the battery in the Tester with a 9V alkaline type when the red light is not visible. Note that both units should be hand held as shown for testing. Your hands are part of the test circuit and hand placement can affect test results.

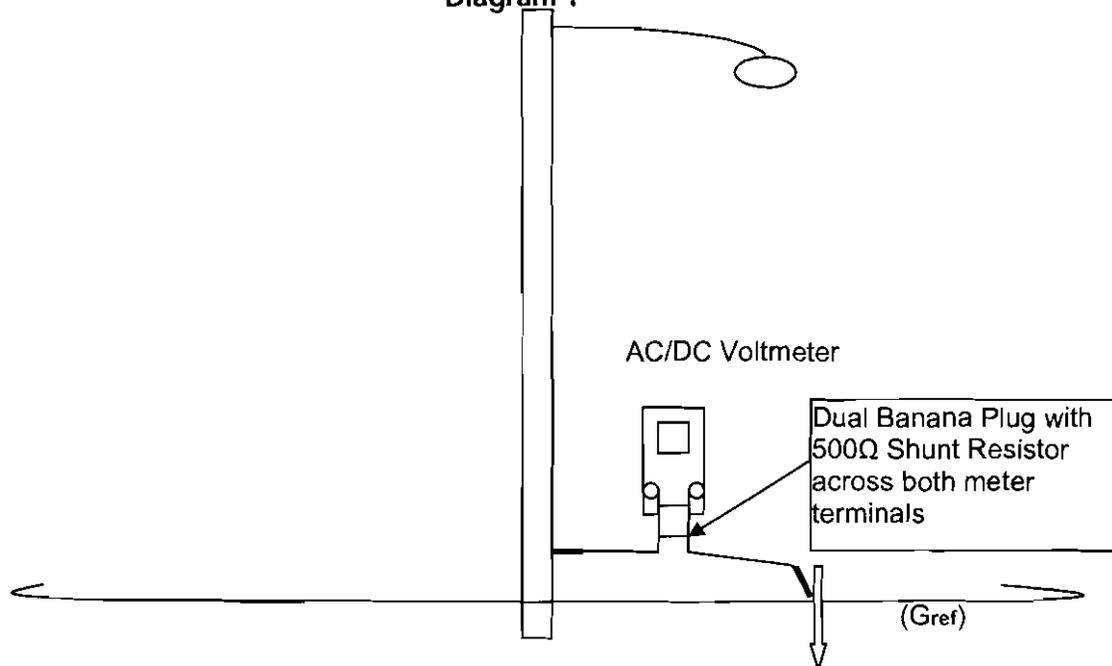
**Diagram 1**

- 3.) Place one end of the multi-meter lead with the 500Ω resistor inserted across the terminals on the streetlight to be tested and the other end on the temporary ground reference. (See Diagram 1 below for test points.) Record the voltage readings observed in the data sheets.

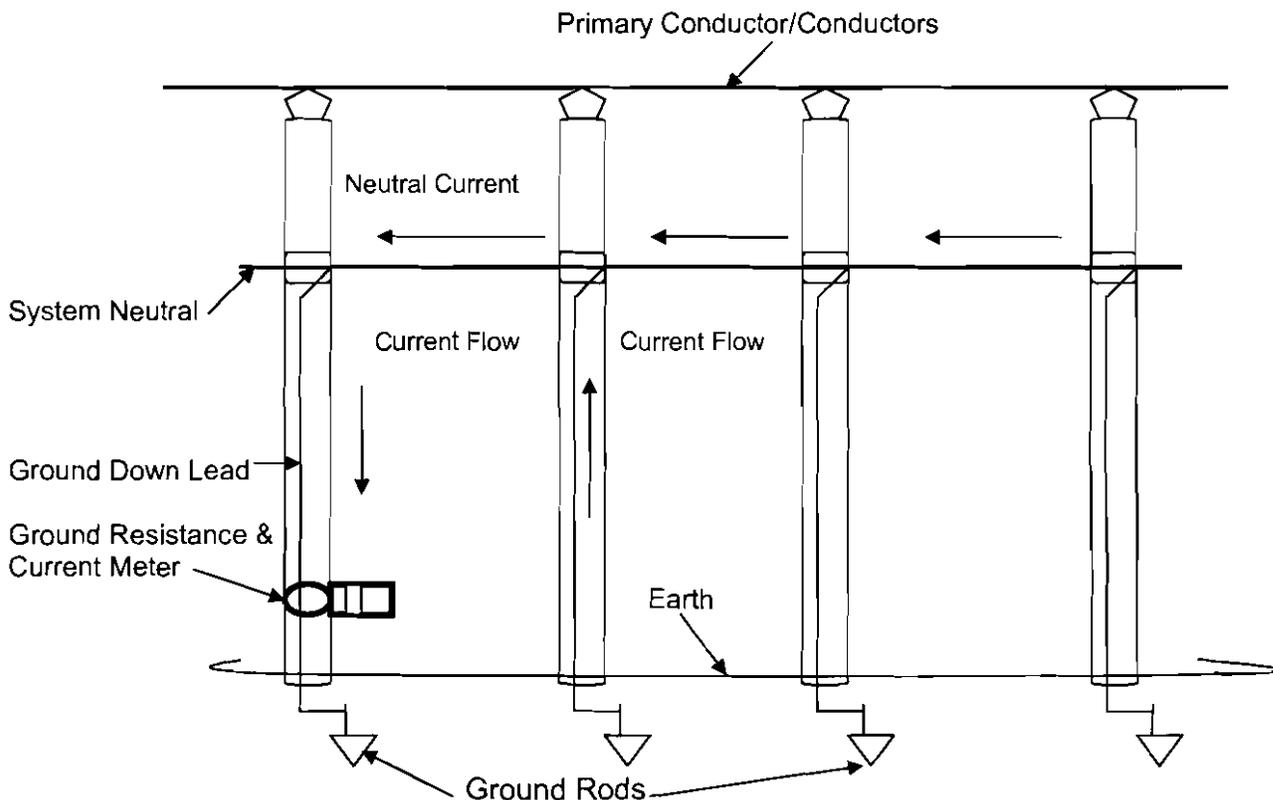
**Diagram 2**

**NOTE:** This step it to be repeated for every location where testing is performed on a multi-grounded WYE system. This test may be omitted if it is a ground down lead for an equipment location on a delta primary system.

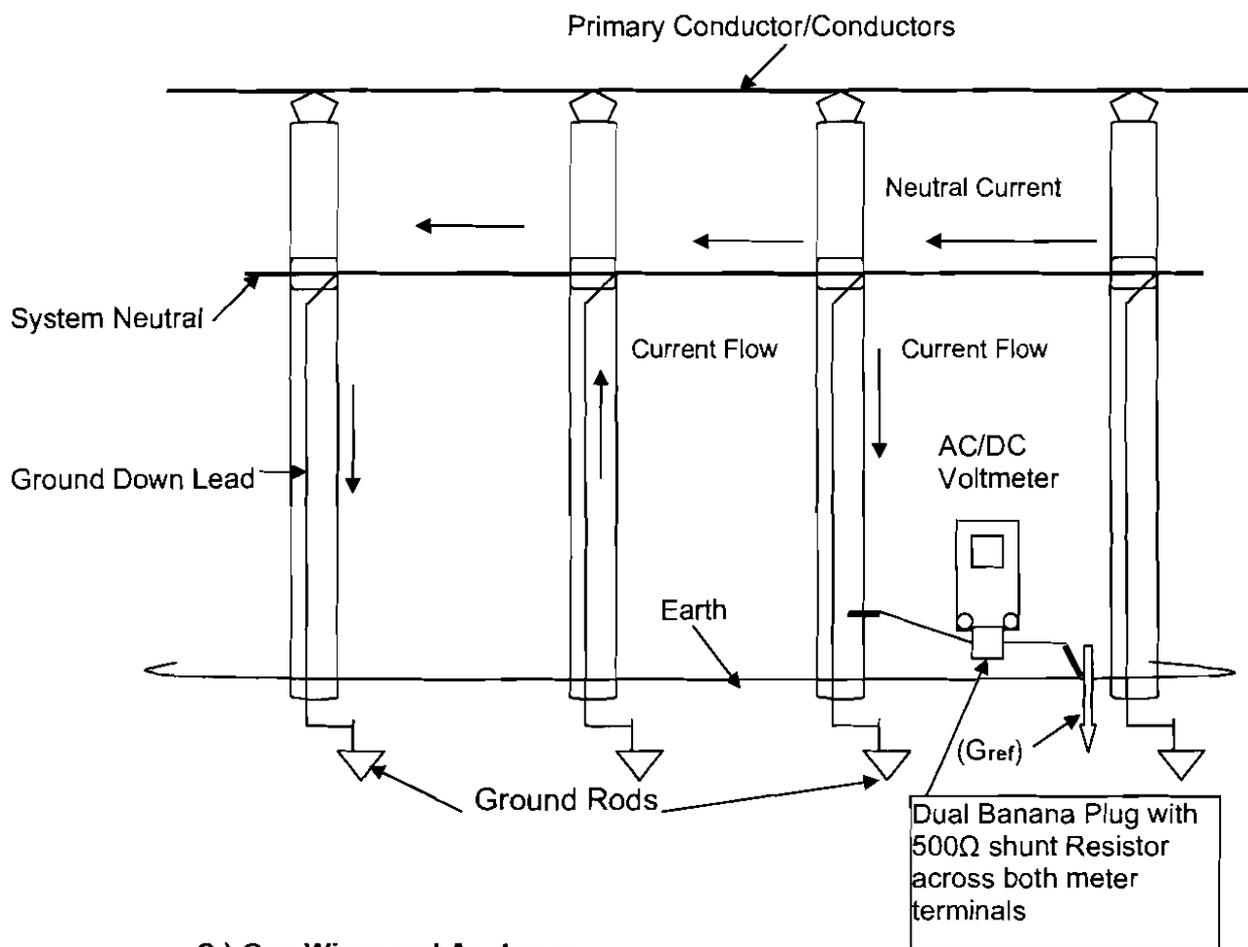
**Diagram 3**

3. Test for Neutral to Earth Voltage levels. Establish a temporary driven ground 4 feet from the ground down lead. Measure and document the open circuit voltage as described in note 3 above. Measure and document the voltage between the primary neutral ground down lead and the reference ground rod. (See Diagram 3) If a temporary ground reference cannot be established, refer to the instructions above.

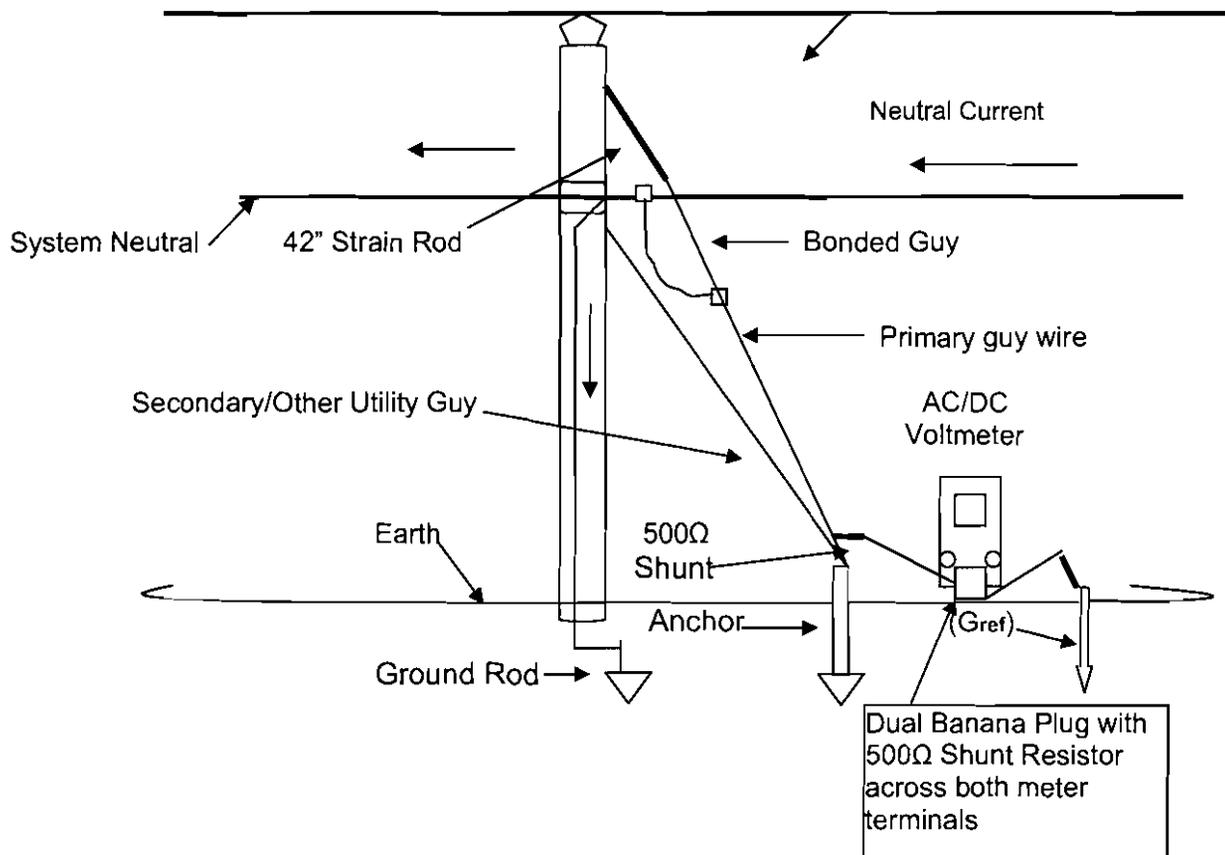
**Diagram 4**

- 1.) Perform a visual inspection of the facilities that supply power to the location, examine the bonding on the primary system neutral and all grounding connections, including the guy wire bond to the system neutral.
- 2.) Using the ground rod resistance tester, test and document the ground rod resistance and current (when present) at the location where stray voltage has been detected.
- 3.) Test for Neutral to Earth Voltage levels. Establish a temporary driven ground 4 feet from the guy wire anchor(s). Measure and document the open circuit voltage as described in note 3 above. Measure and document the voltage between the guy wire and anchors and the reference ground rod with a 500Ω shunt resistor installed. Record this voltage.

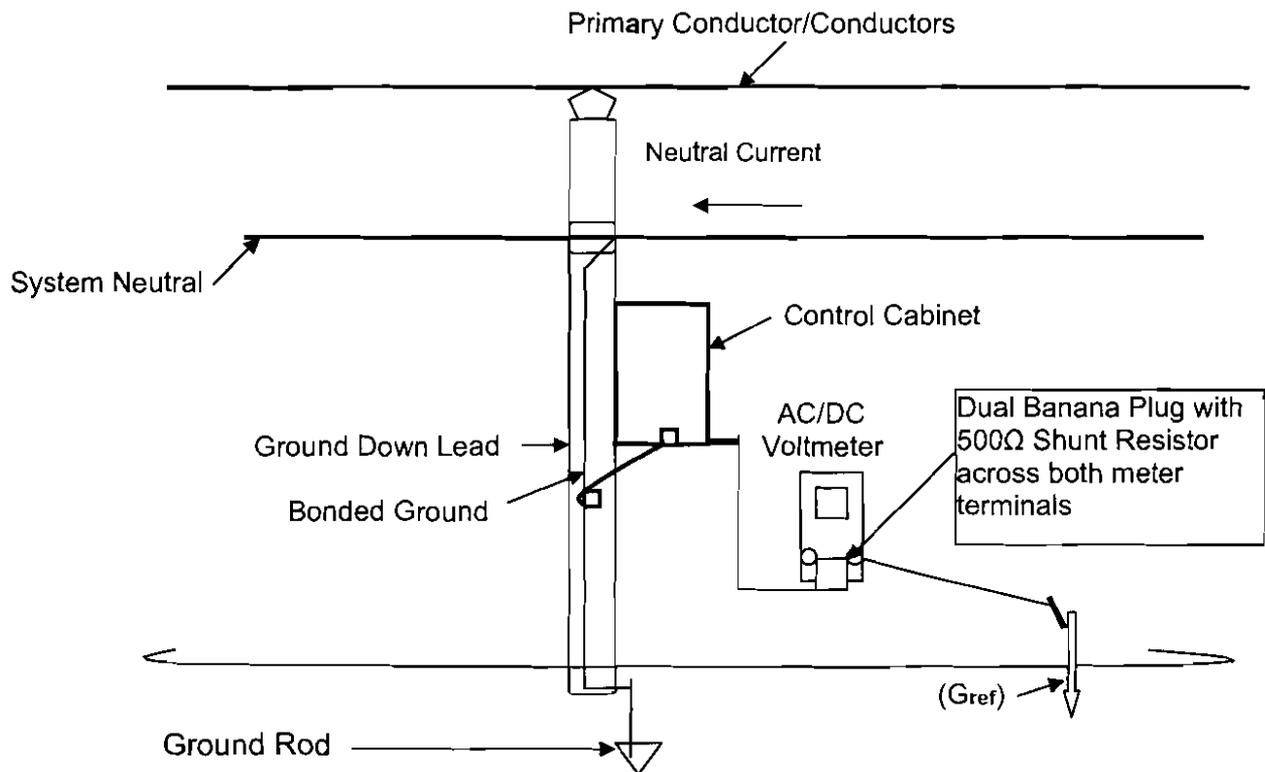
**Diagram 5**

- 1.) Perform a visual inspection of the facilities that supply power to the location, including the service entrance cable and all grounding connections. The control cabinet must be grounded externally. Examine for the presence of a ground connection and quality of the connection.
- 2.) Using the ground rod resistance tester, test and document the ground rod resistance and current at the location where stray voltage has been detected.
- 3.) Test for Neutral to Earth Voltage levels. Establish a temporary driven ground 4 feet from the ground down lead. Measure and document the open circuit voltage as described in note 3 above. Measure and document the voltage between the reference ground rod and control cabinet with a 500Ω shunt resistor installed.

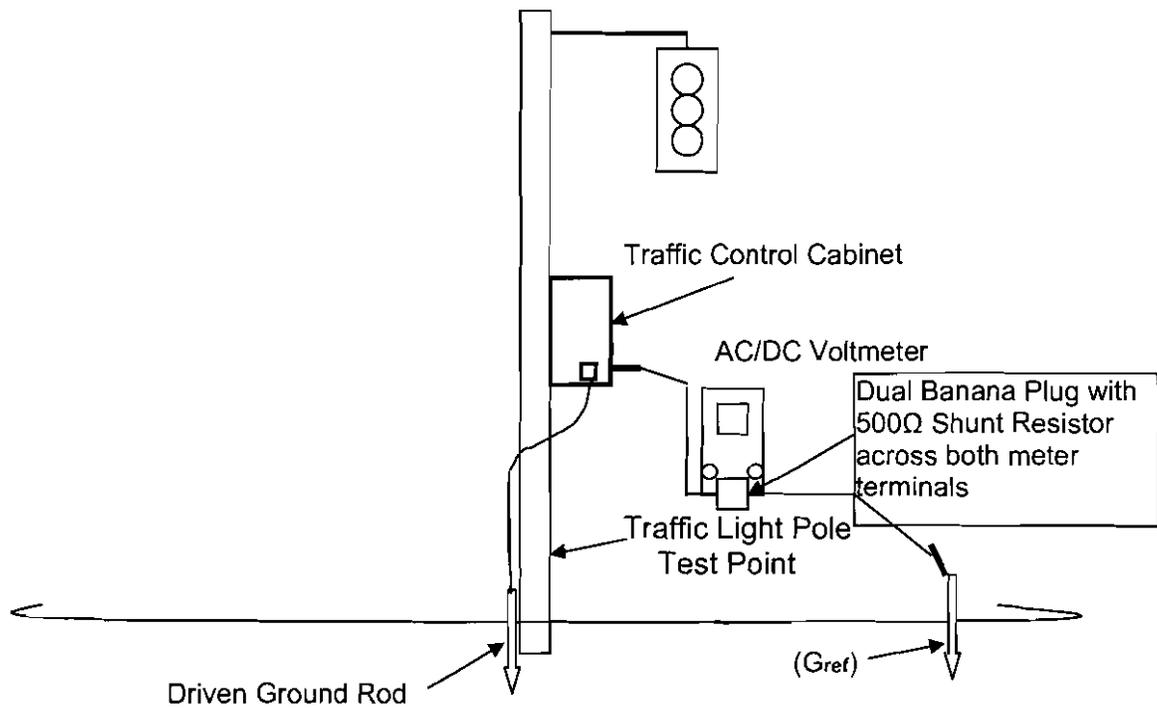
**Diagram 6**

- 1.) Perform a visual inspection of the facilities that supply power to the location, including the service entrance cable and all grounding connections. The control cabinet must be grounded externally. Examine for the presence of a ground connection and quality of the connection.
- 2.) Establish a temporary driven ground 4 feet from the ground down lead. Place one end of the multi-meter meter lead on the streetlight support structure to be tested and the other end on the ground reference. Measure and document the voltage between the test points. Record the voltage level in the data sheet in Appendix A.
- 3.) Place one end of the multi-meter lead with the 500Ω shunt resistor installed on the streetlight control cabinet to be tested and the other end on the ground reference. (See Diagram 1 below for test points.)

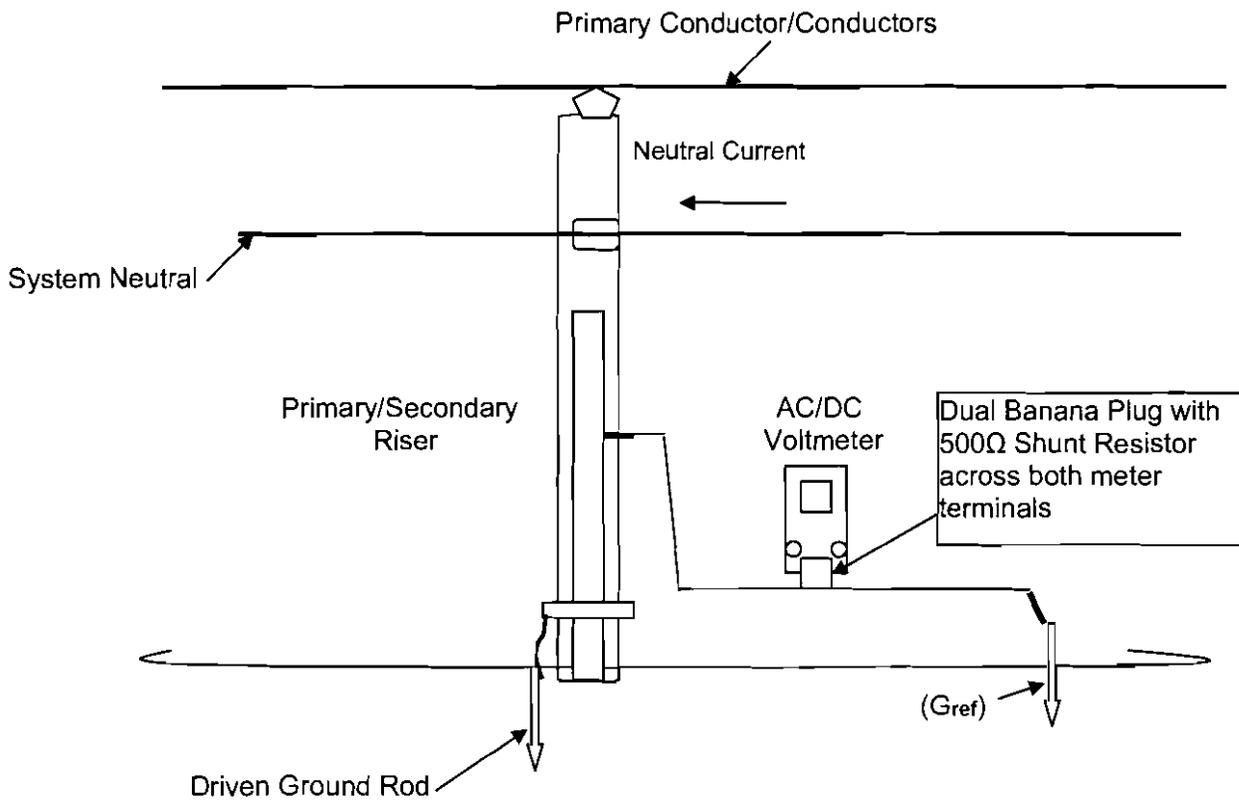
**Diagram 7**

- 1.) Perform a visual inspection of the facilities that supply power to the location, including the service entrance cable and all grounding connections.
- 2.) Establish a temporary driven ground 4 feet from the riser pole under test. Measure and document the open circuit voltage as described in note 3 above. Place one end of the multi-meter lead with the 500Ω shunt resistor installed on the steel conduit to be tested and the other end on the ground reference. Measure and document the voltage between the (See Diagram 1 below for test points.)

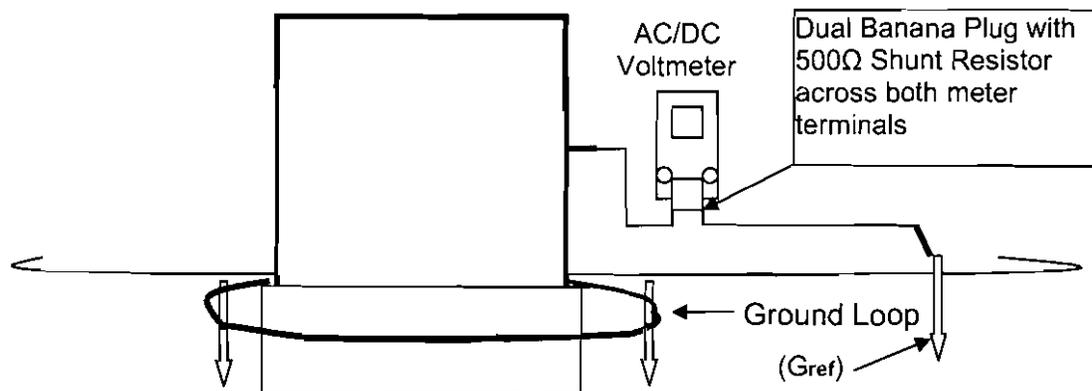
**Diagram 8**

Pad Mount Transformer & Box Pads  
U.G Switching Equipment

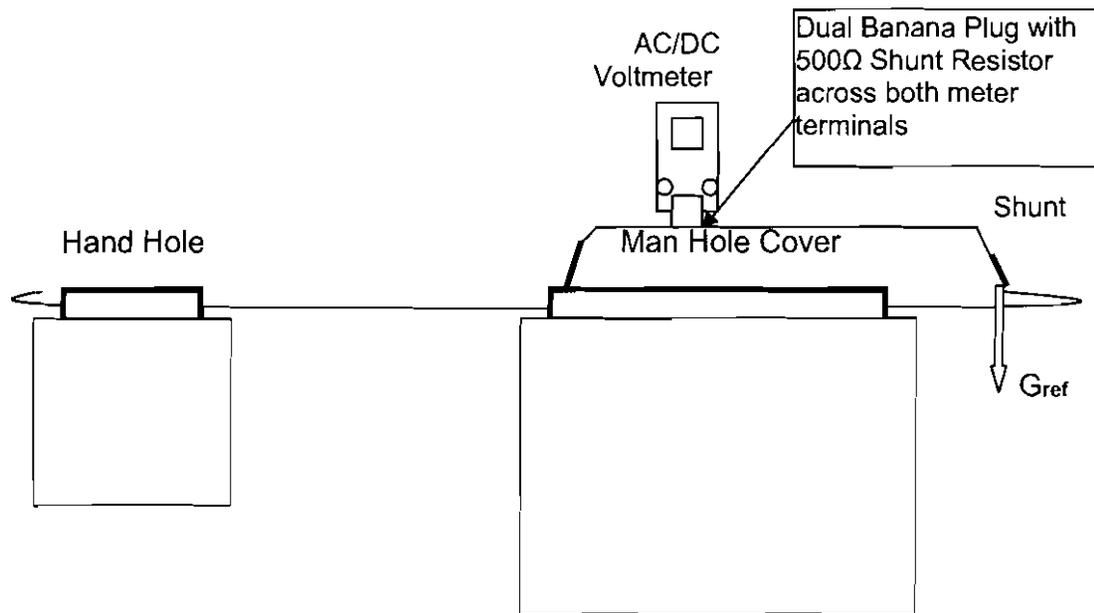
**Diagram 9**

end of the multi-meter lead with the 500Ω shunt resistor installed on the manhole or hand-hole cover to be tested and the other end on the ground reference. Measure and document the voltage between the test surface and the reference ground rod. (See Diagram 9 below for test points.)

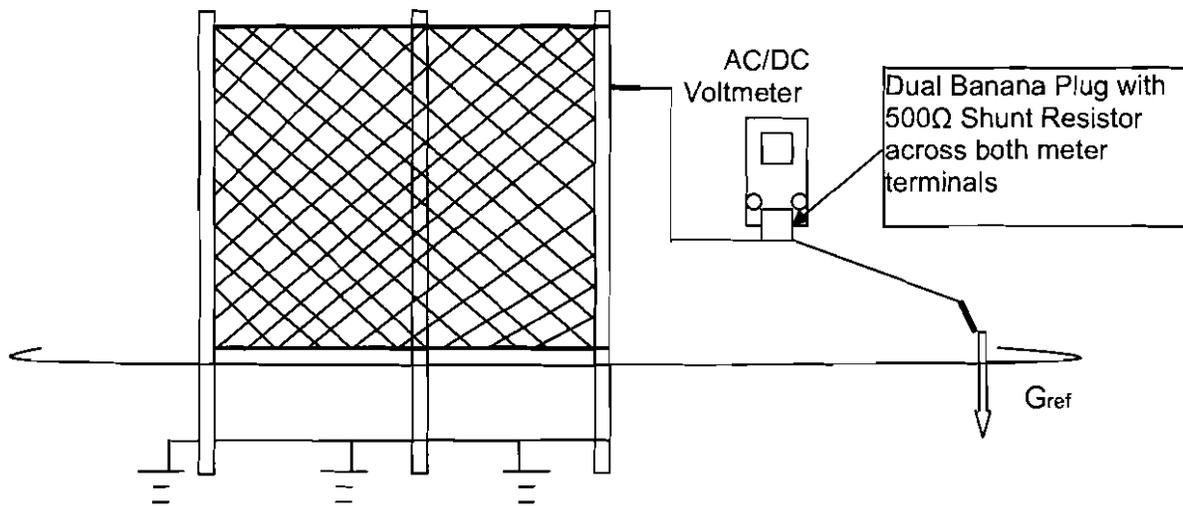
**Diagram 10**

be tested and the other end on the ground reference. Measure and document the voltage between the ground reference rod and the surface being tested.  
(See Diagram 10 below for test points.)
