**New York State Department of Public Service
Verizon New York, Inc.
Network Review Plan Compliance Audit
Final Report - Redacted**

The Liberty Consulting Group

September 14, 2010

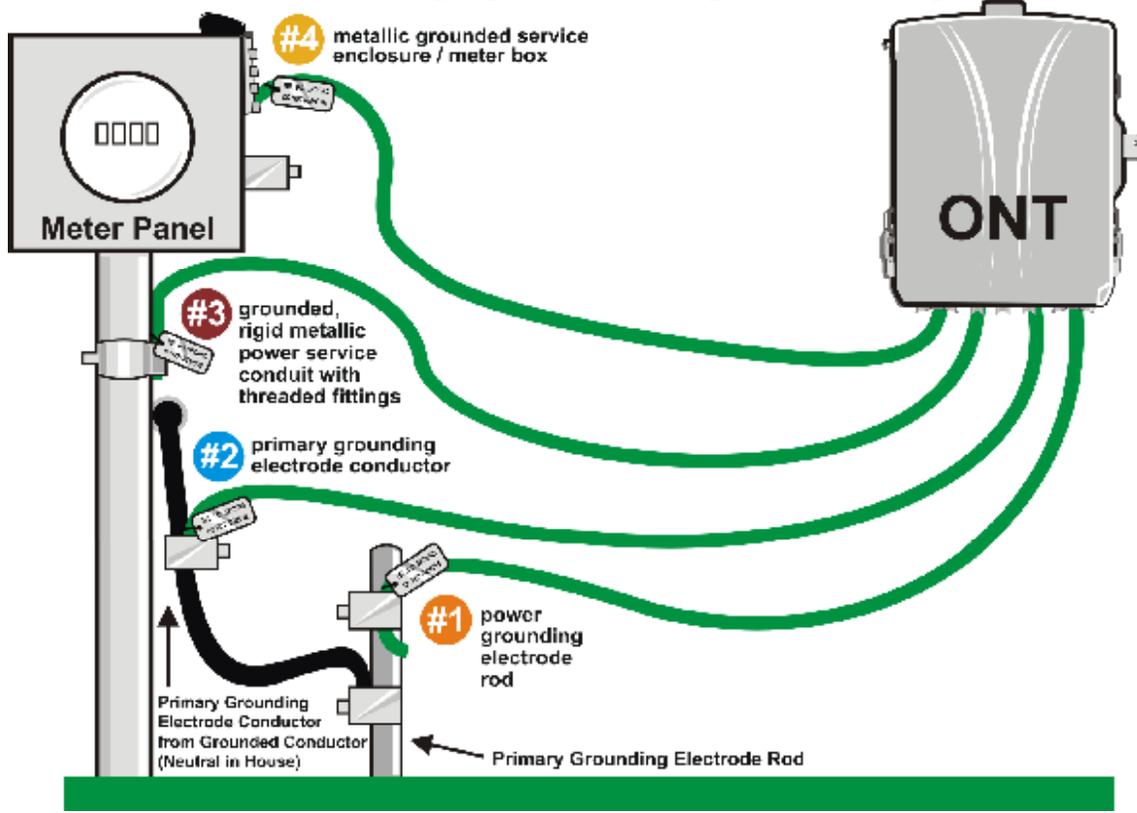
6. For installations where the ONT is mounted too far away from the power company ground source to allow the installer to use one of the four non-IBT grounding methods described above, a ground rod placed by the Verizon installer can be used. For this method to be compliant, the ground rod must be driven into the ground within 20 feet of the ONT. Additionally, the ground rod cannot be within six feet from any other ground rod or lighting protection system that may be found at the location. The 10 AWG wire exiting the ONT must be clamped to the newly installed ground rod. Using a separate clamp, the new Verizon-installed ground rod must be bonded to the primary (power company) ground rod using 6 AWG ground wire and clamped to the primary ground rod with a separate clamp. This is an acceptable grounding arrangement where the ONT is not connected to ground with one continuous length of ground wire. Additionally, the 6 AWG ground wire used to bond the ground rods together is not restricted by the 20 foot limitation rule. This wire can exceed 20 feet in length and does not need to be insulated. This is the only scenario in which the ground wire can exceed 20 feet.

Some Available Grounding Options for Proper Grounding of the ONT
